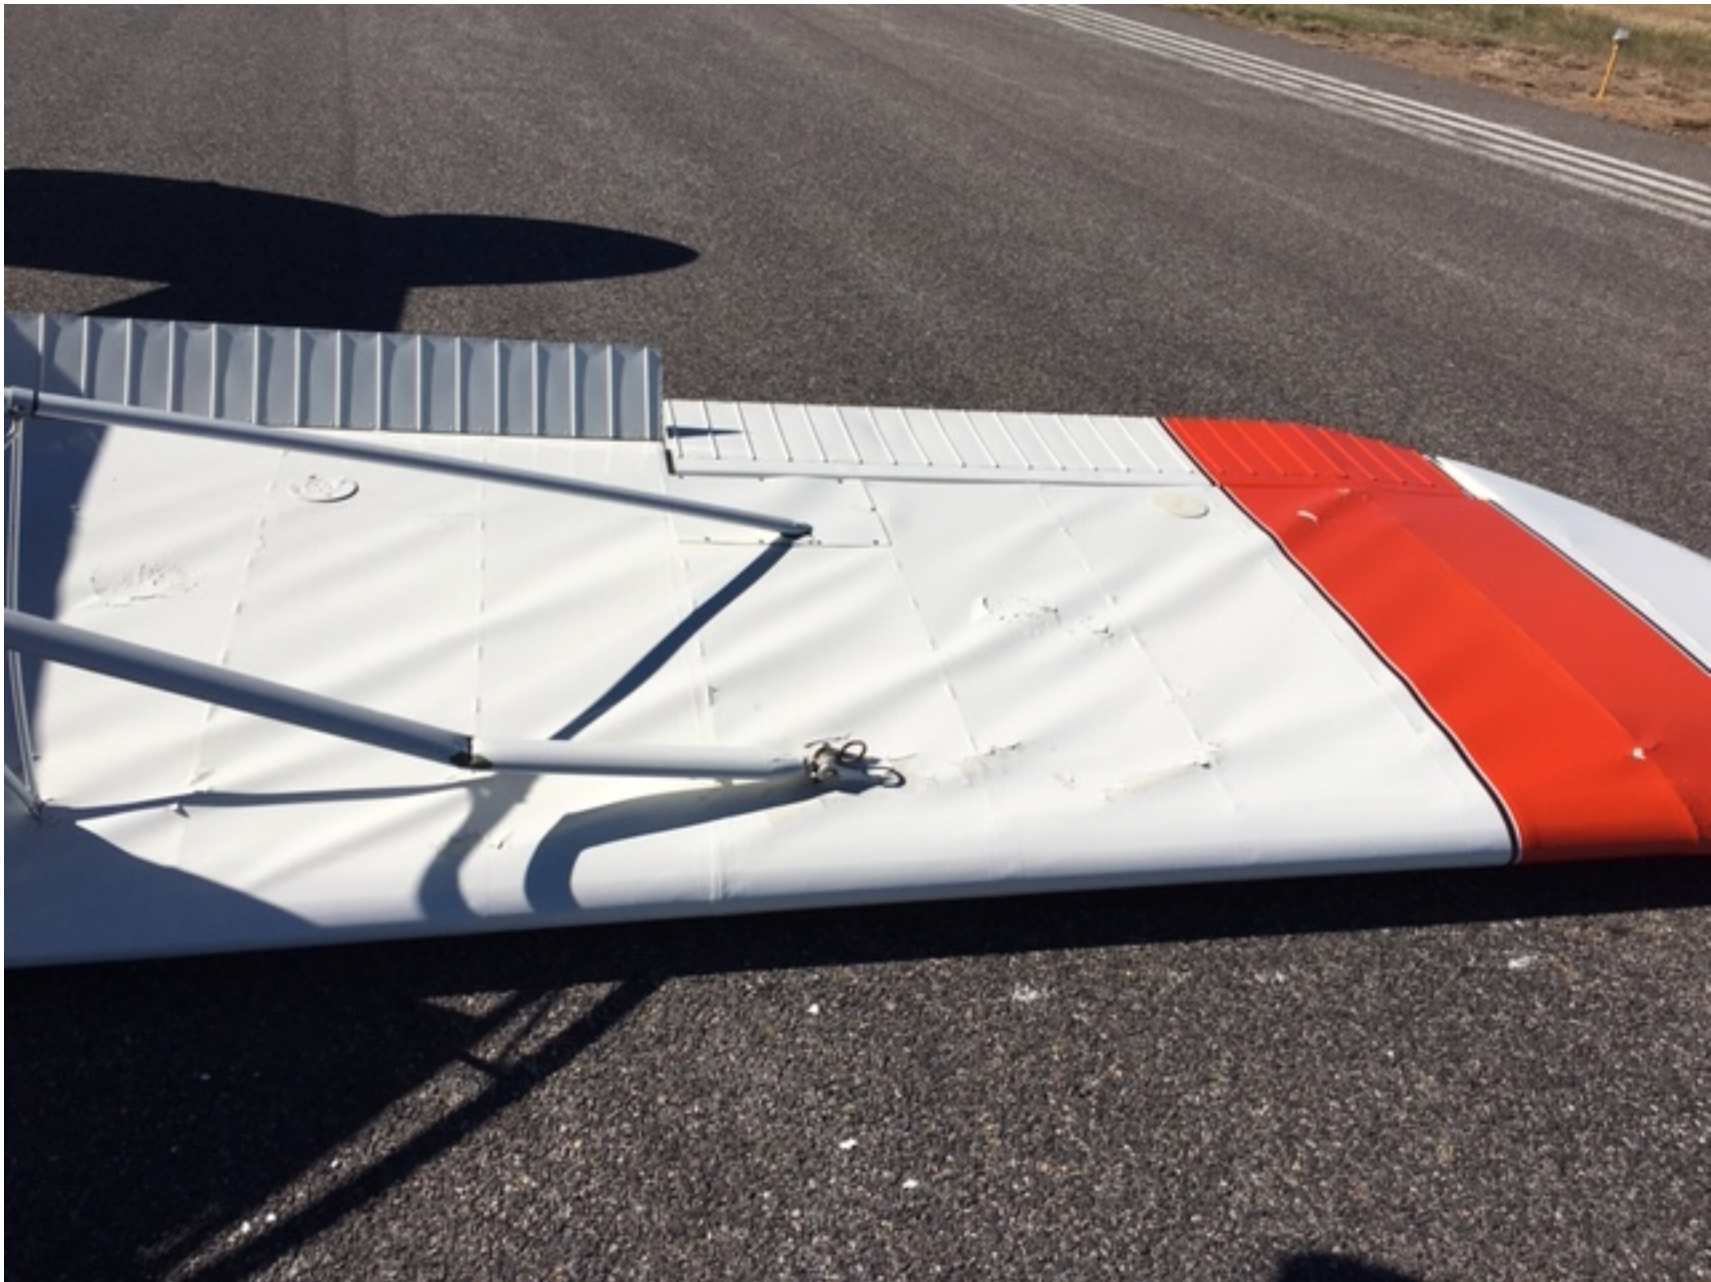
**Photo 1 – View of damaged right wing lift strut (Photo courtesy of Airport Operations)**

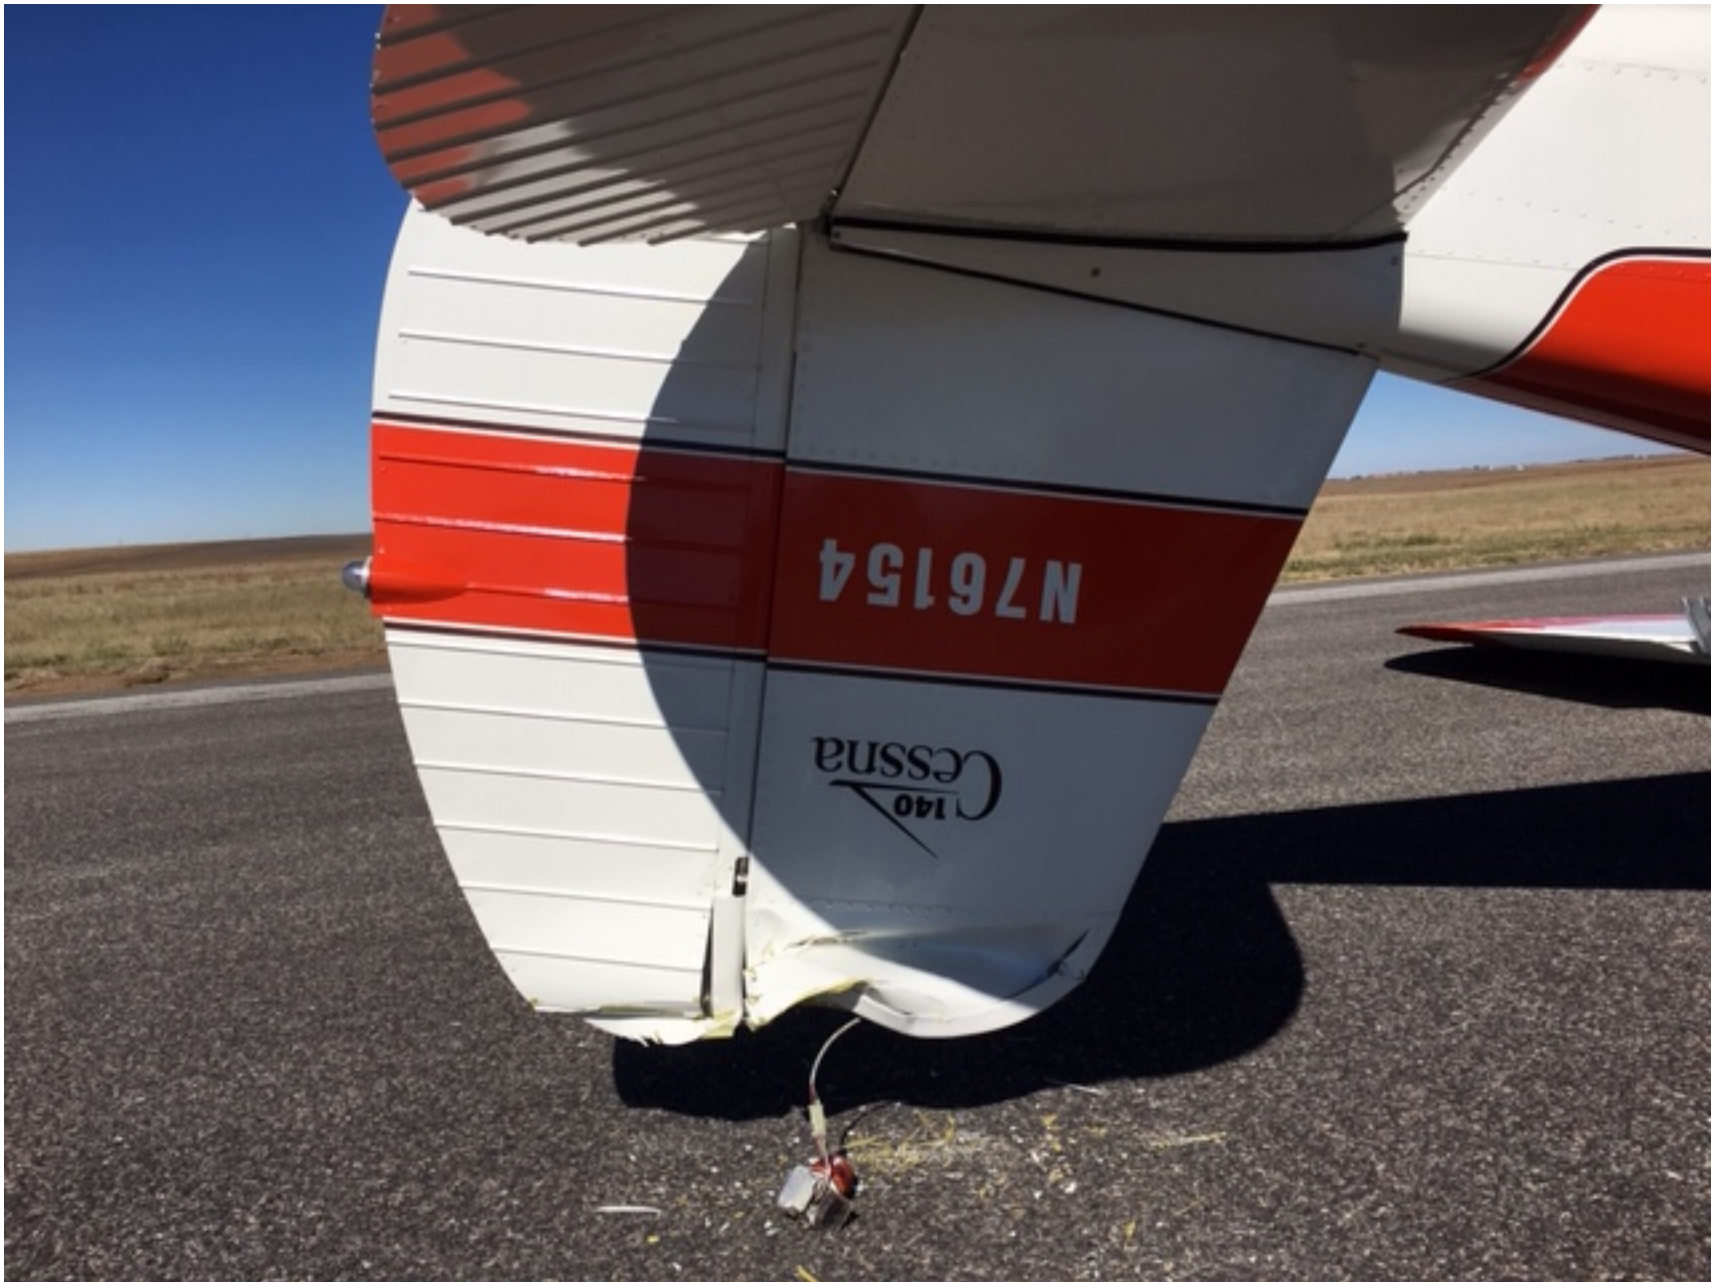
**Photo 2 – View of damaged vertical stabilizer and rudder (Photo courtesy of Airport Operations)**
