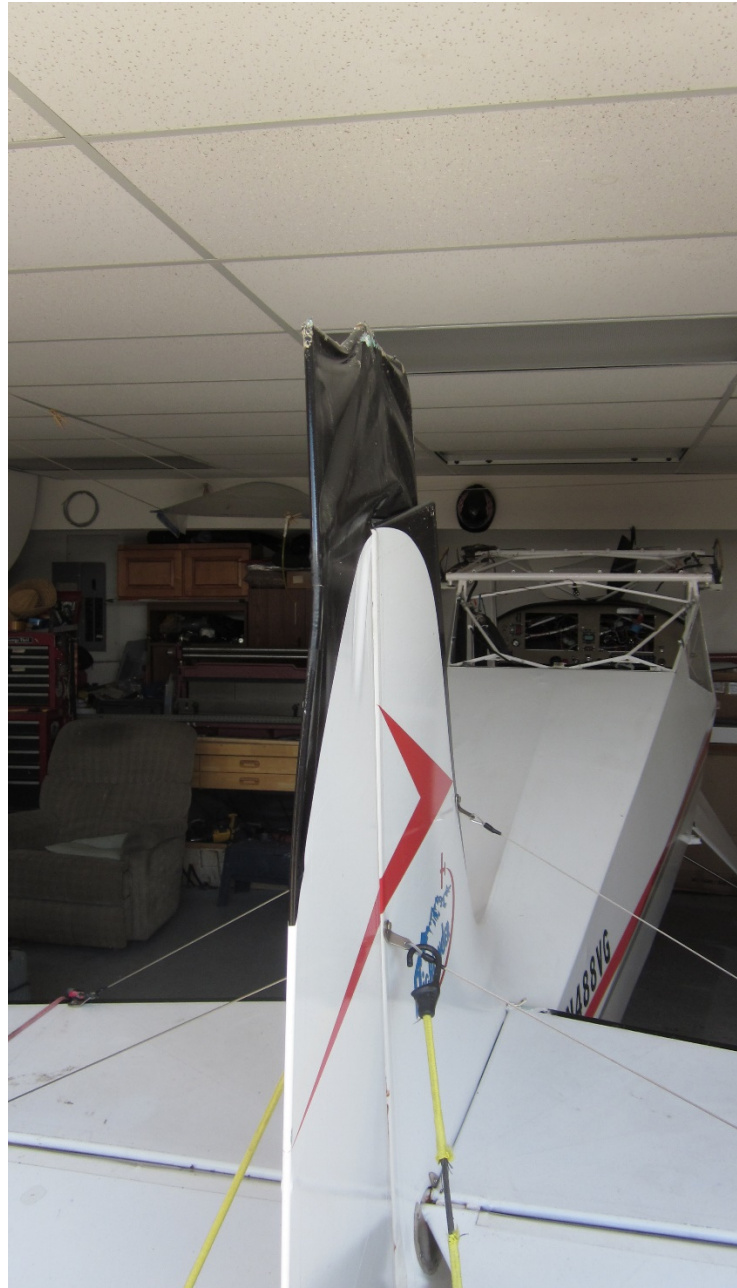
**Photo 1 – View of damaged rudder (Photo courtesy of the FAA)**

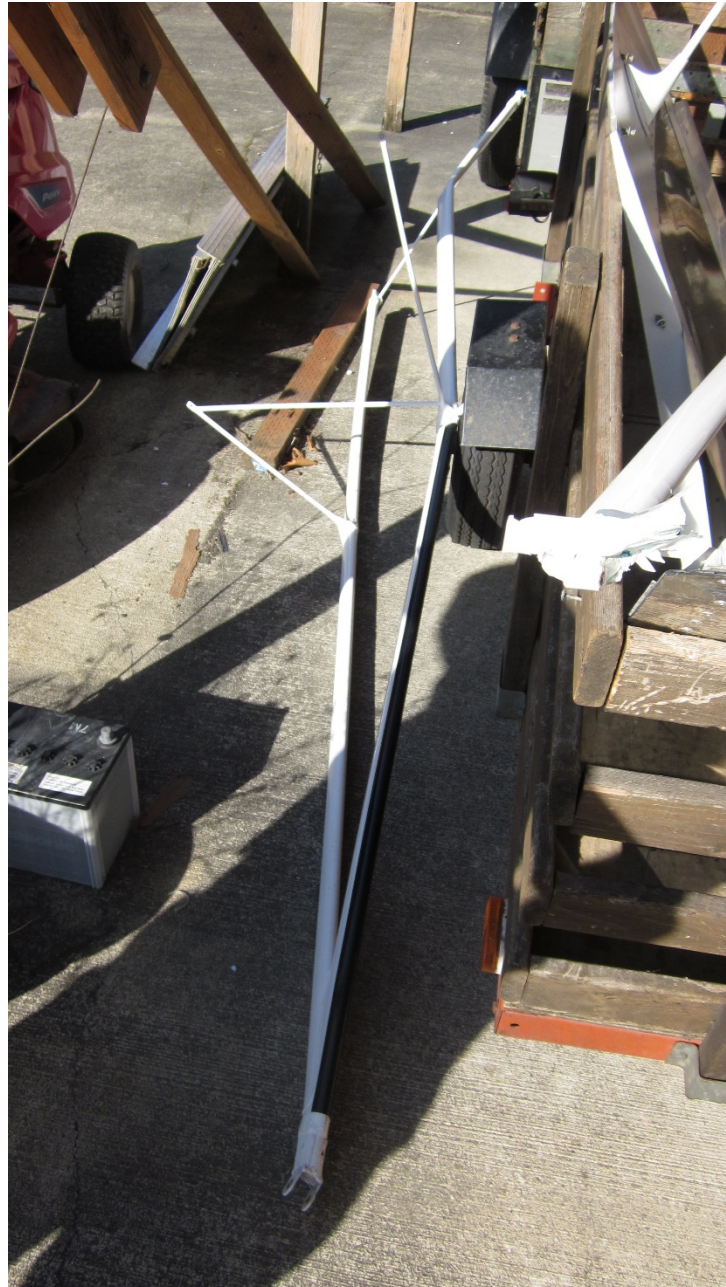
**Photo 2 – View of damaged left wing lift strut (Photo courtesy of the FAA)**

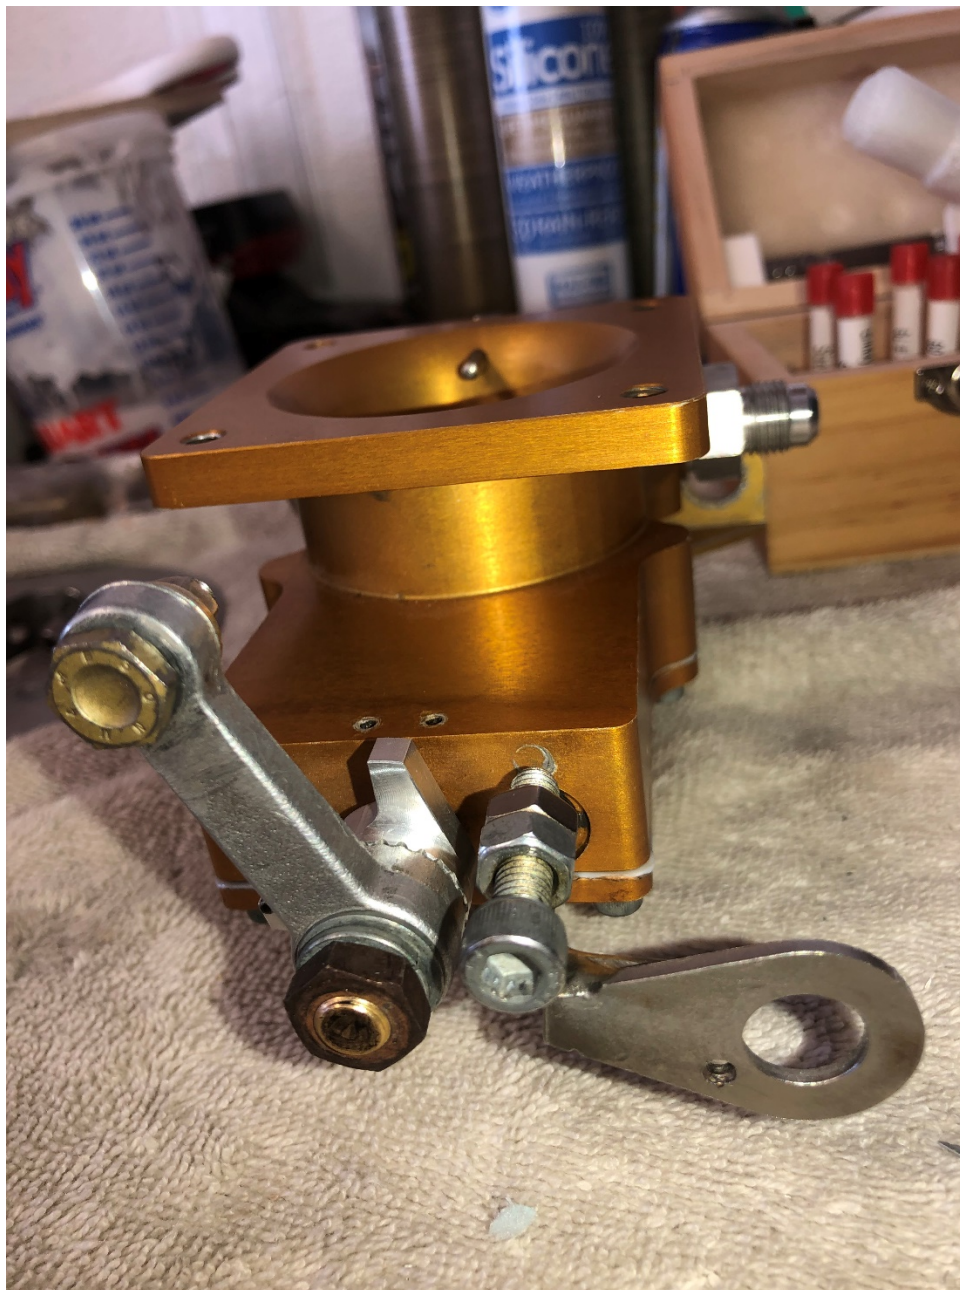
**Photo 3 – View of bent idle stop screw on modified carburetor (Photo courtesy of the FAA)**

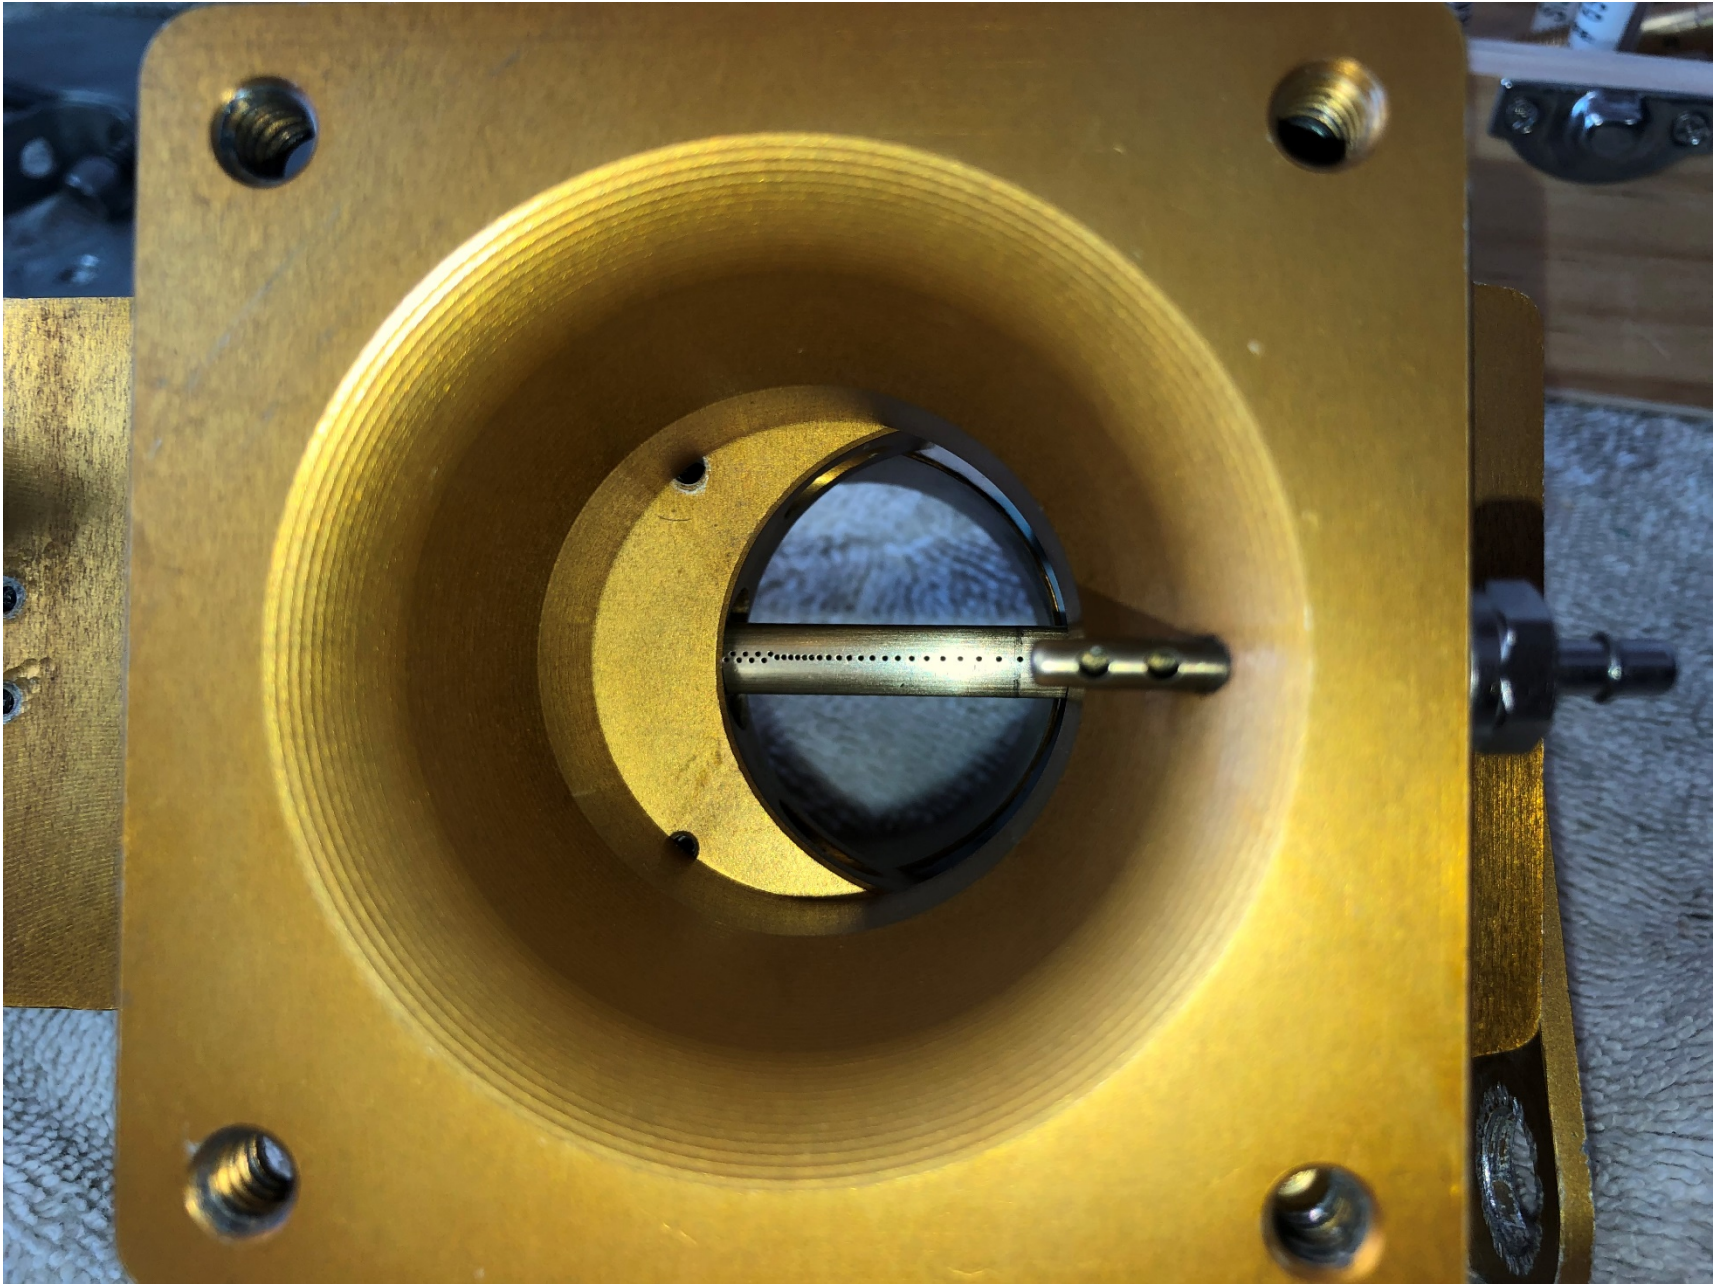
**Photo 4 – View of drilled holes into spray bar in carburetor (Photo courtesy of the FAA)**
