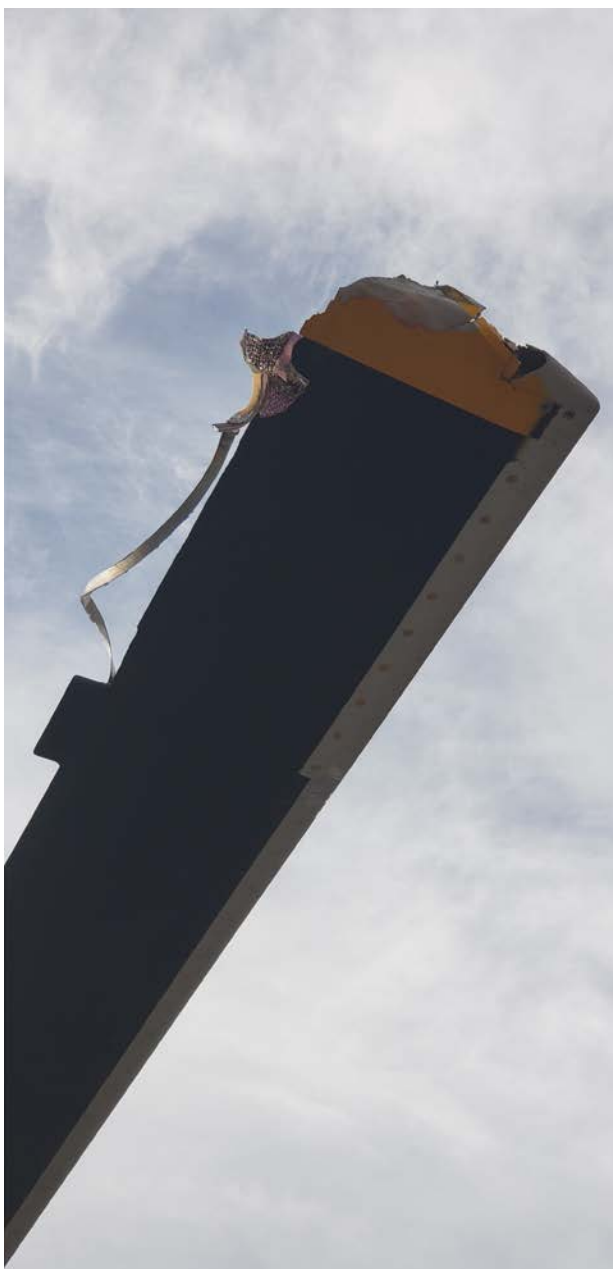
**Photo 1 – View of damaged main rotor blade (courtesy of the operator)**
