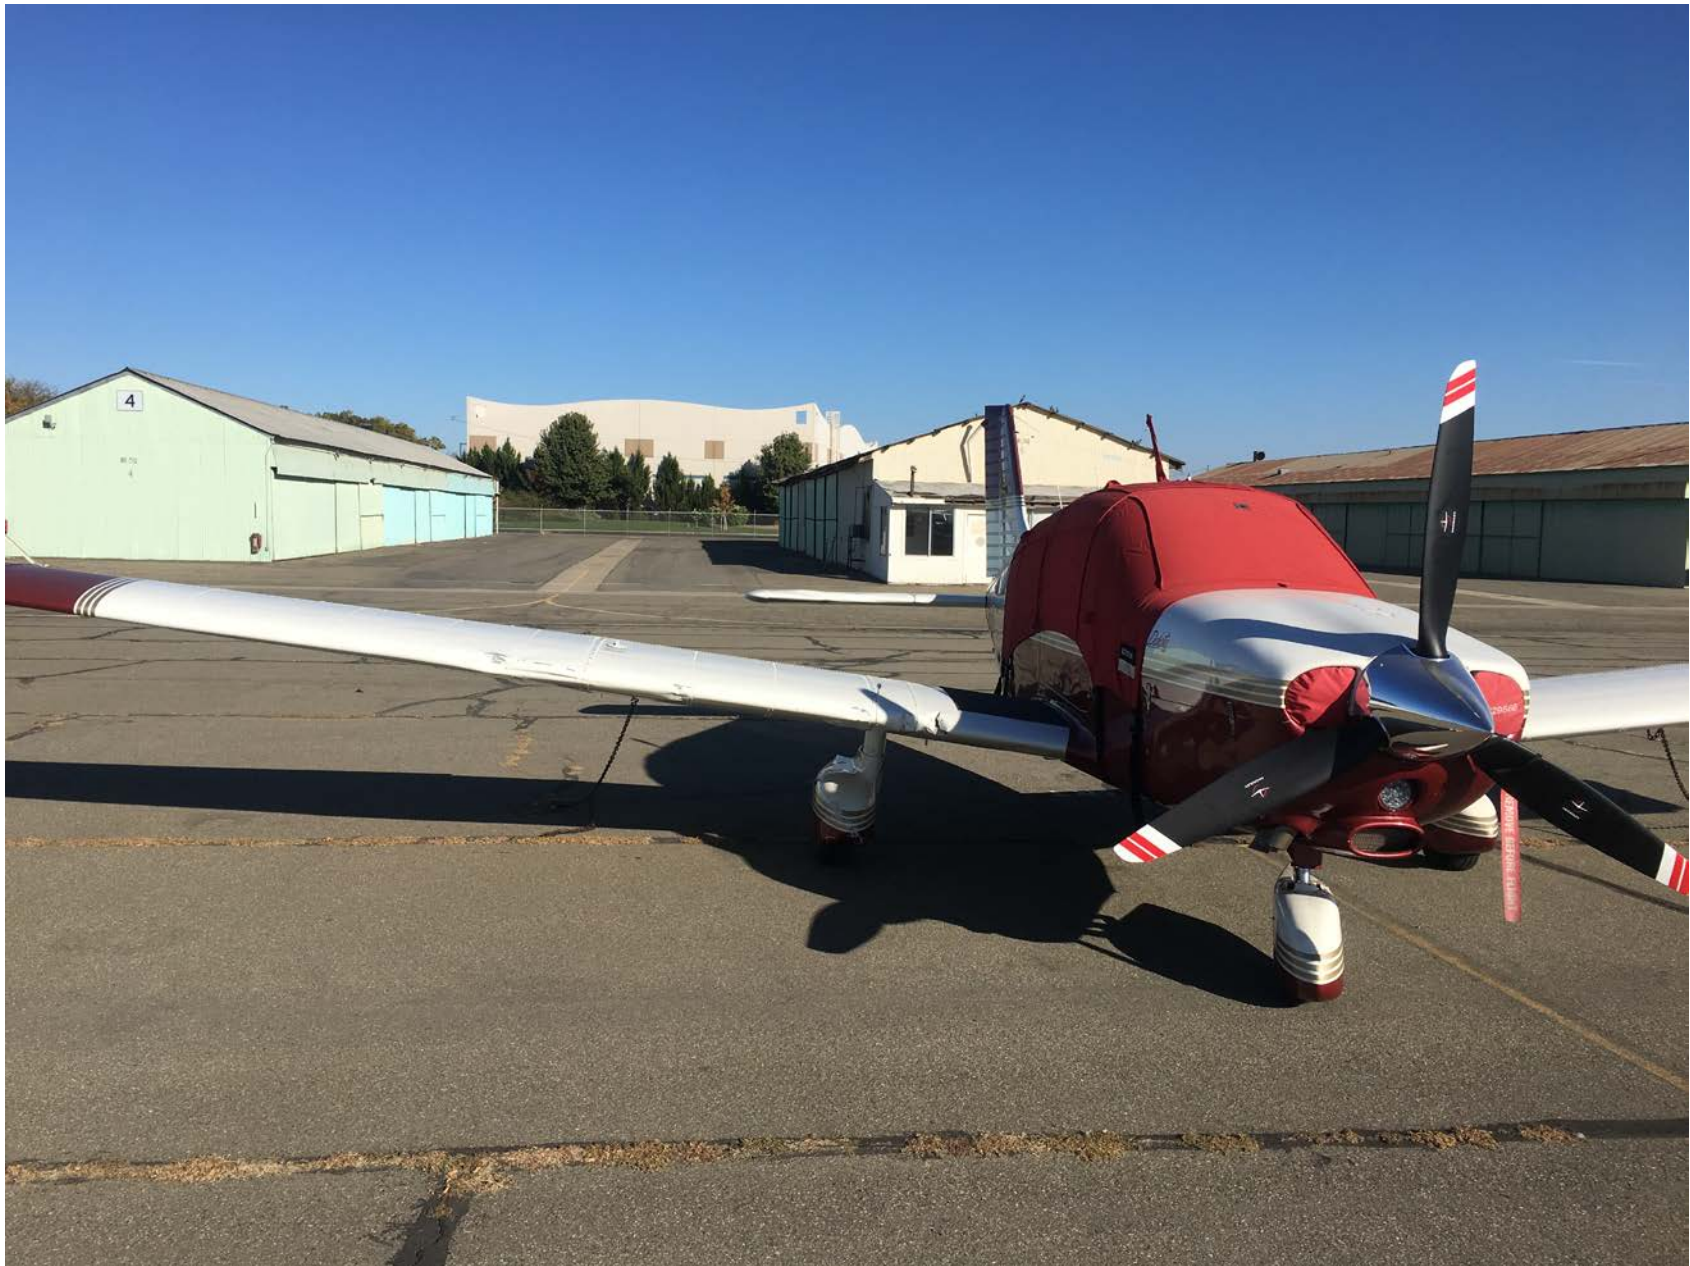
**Photo 1 – View of damage to the right wing (Courtesy of FAA)**

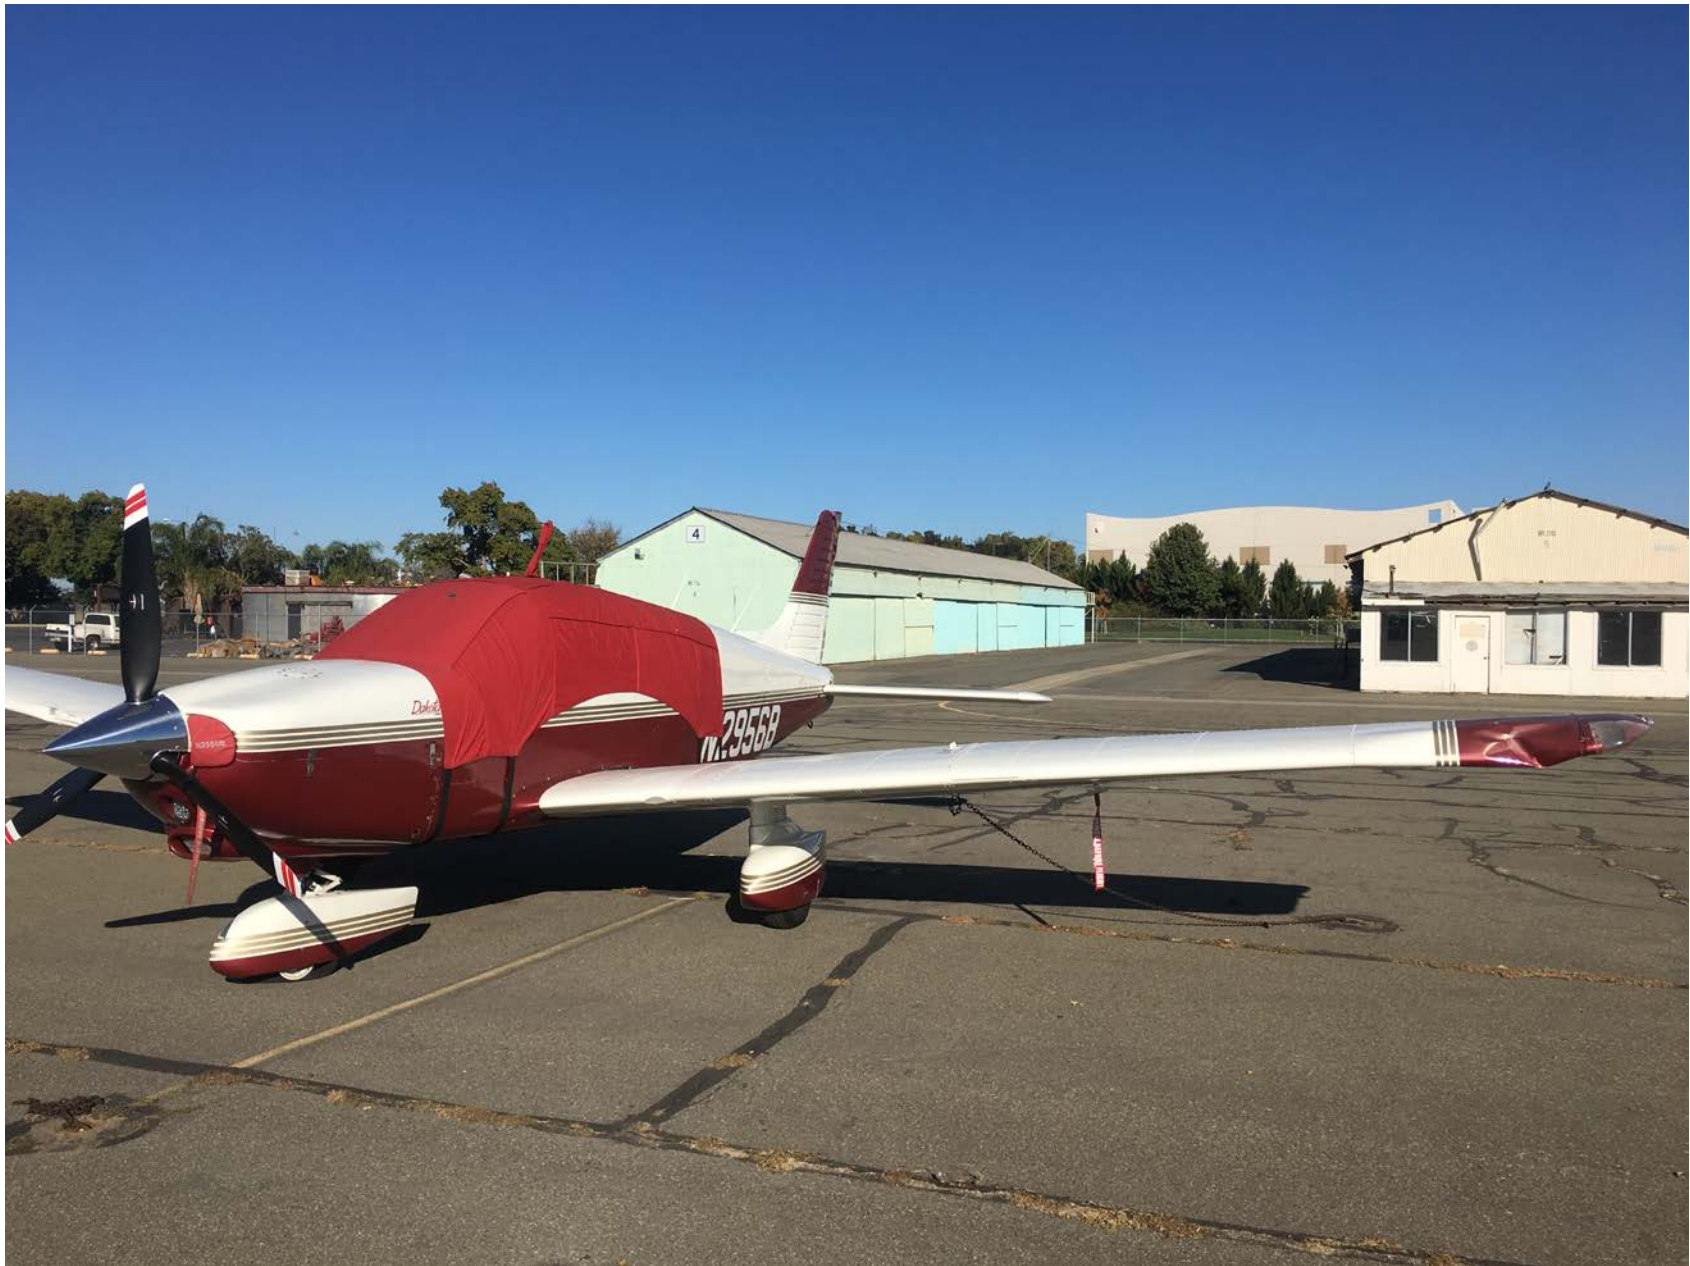
**Photo 2 – View of damage to the left wing (Courtesy of FAA)**

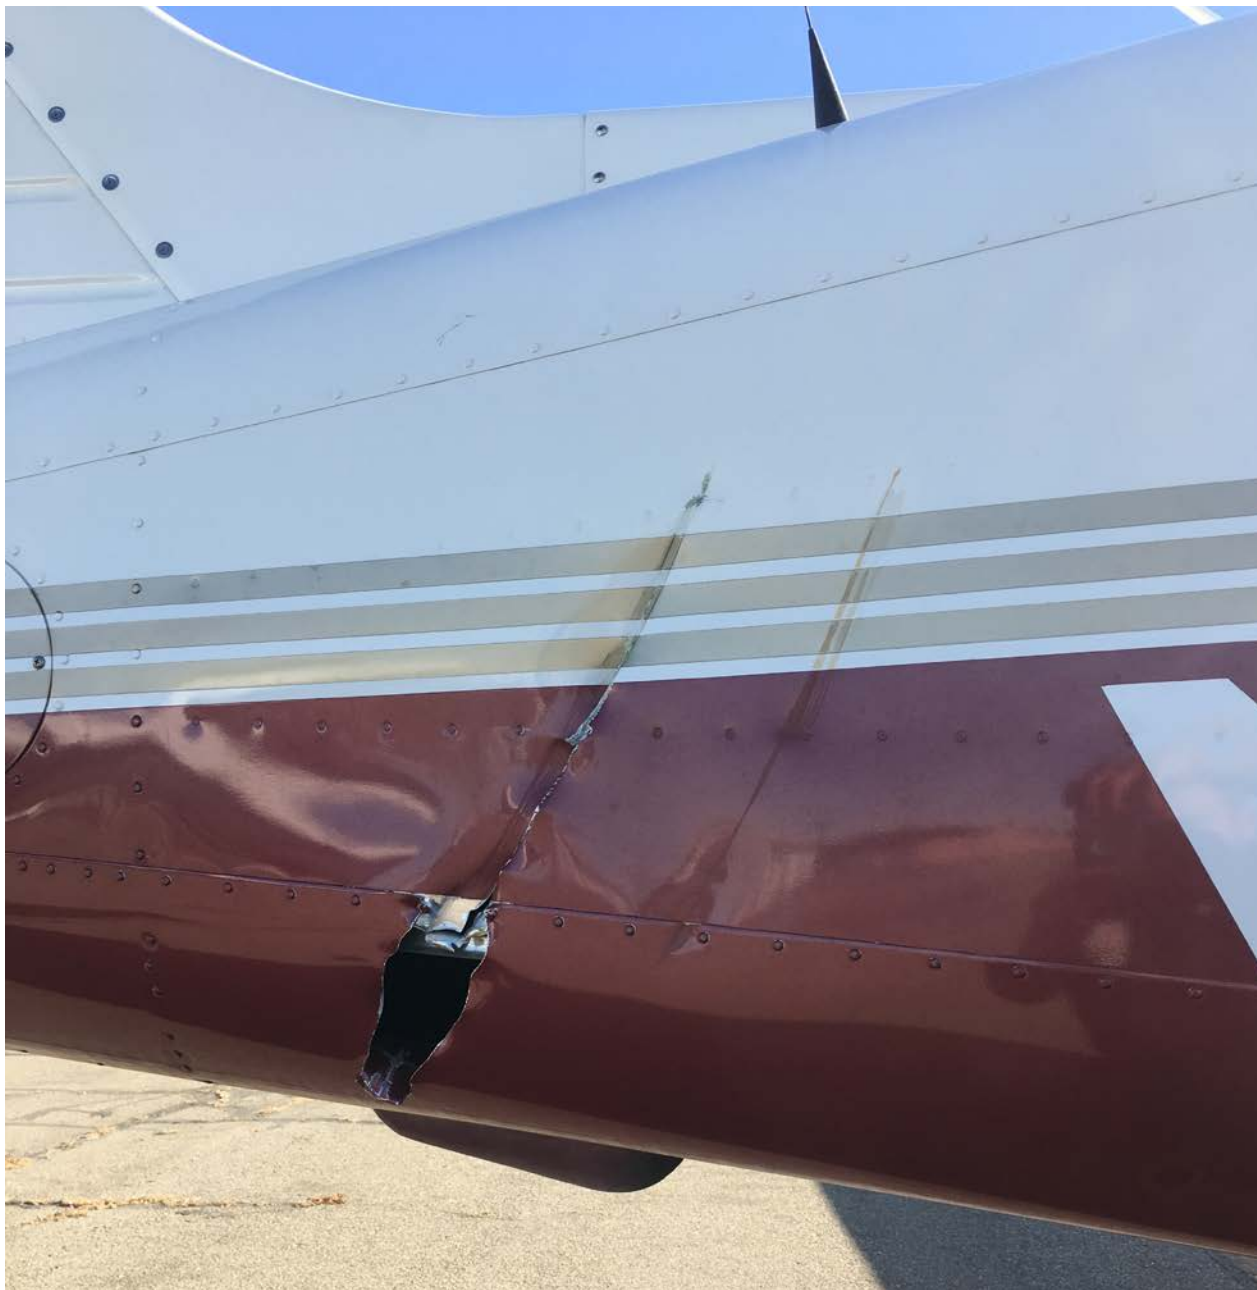
**Photo 3 – View of damage to the right side empennage longeron (Courtesy of FAA)**
