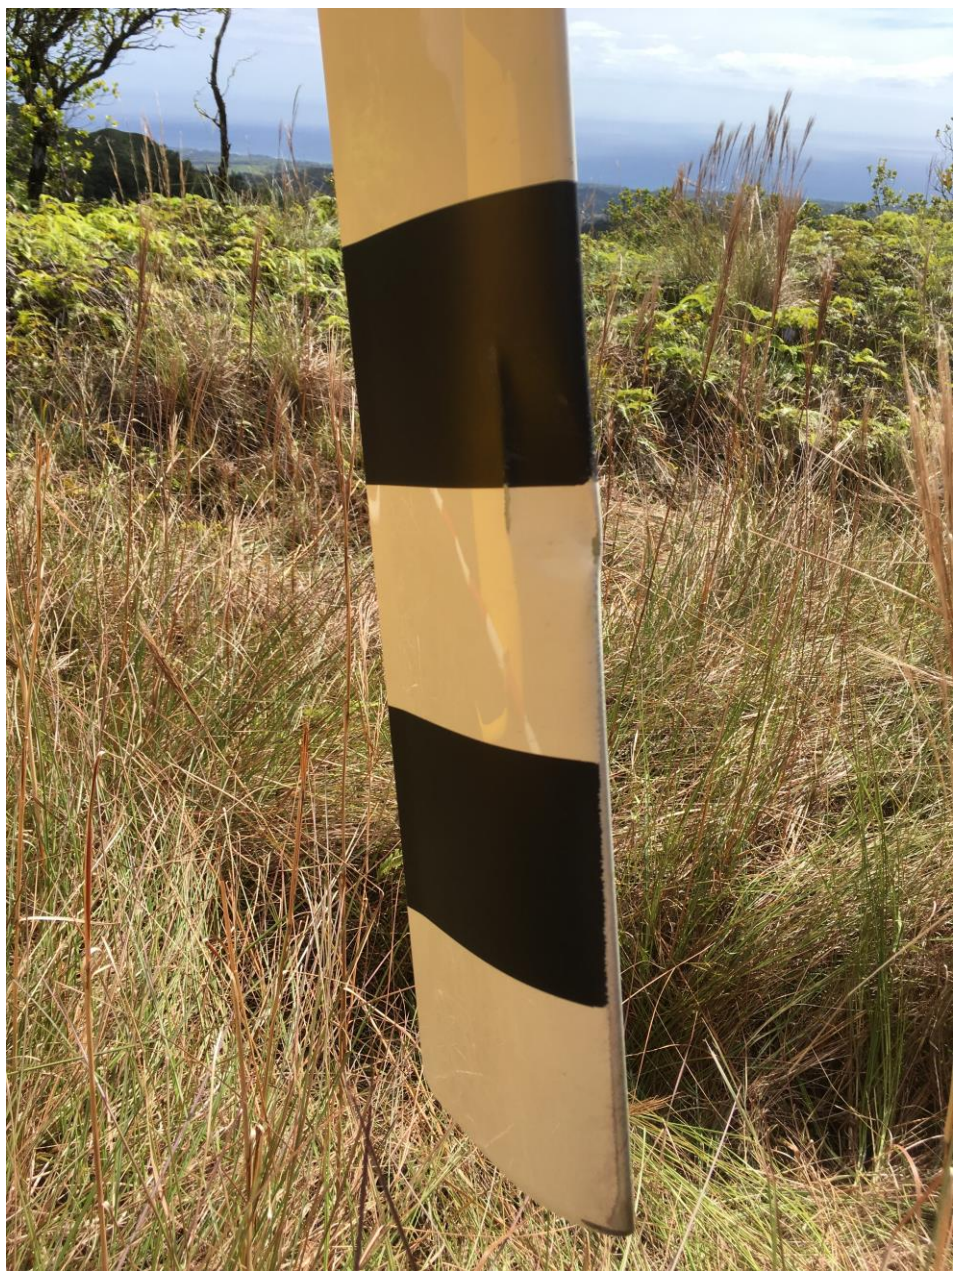
**Photo 1 – View of damaged tail rotor (Photo courtesy of the operator)**
