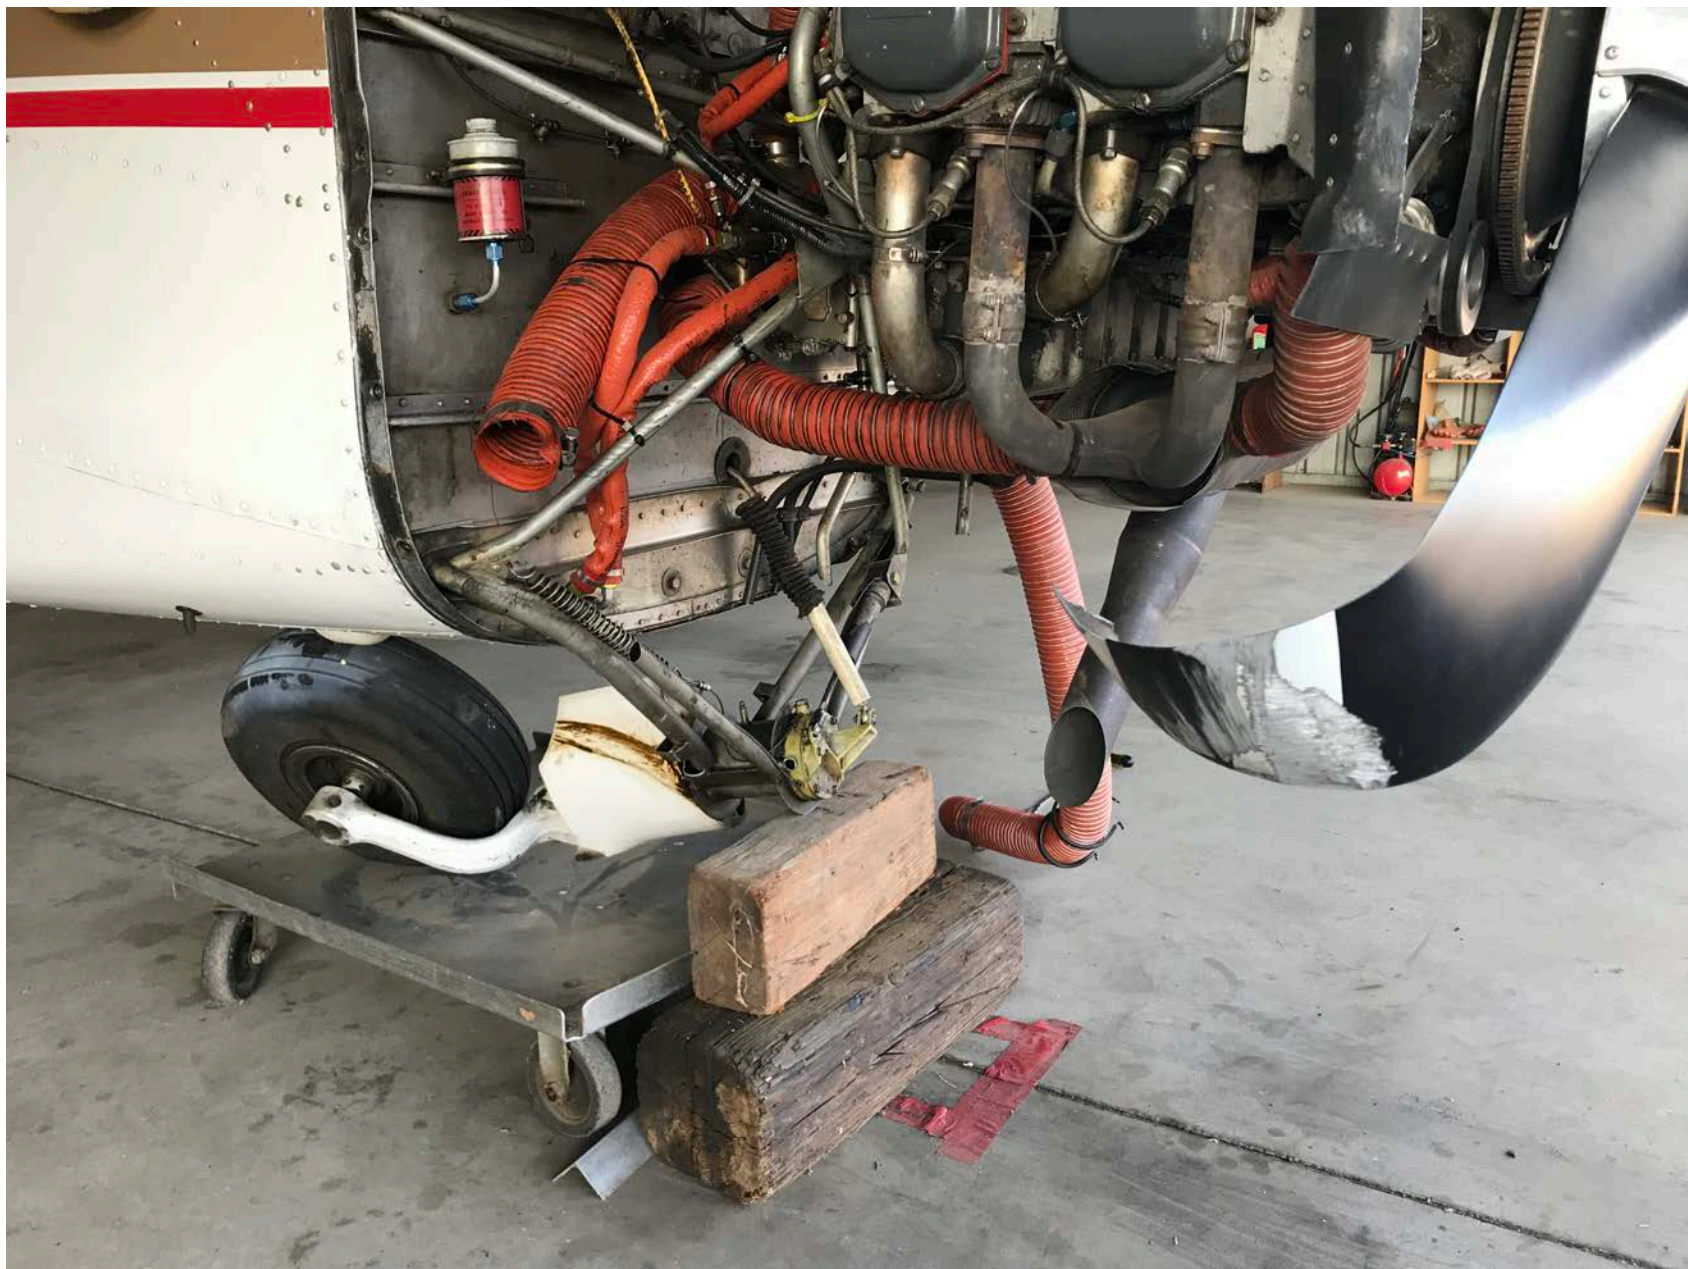
**Photo 1 – View of engine mount damage (photo courtesy of the FAA)**
