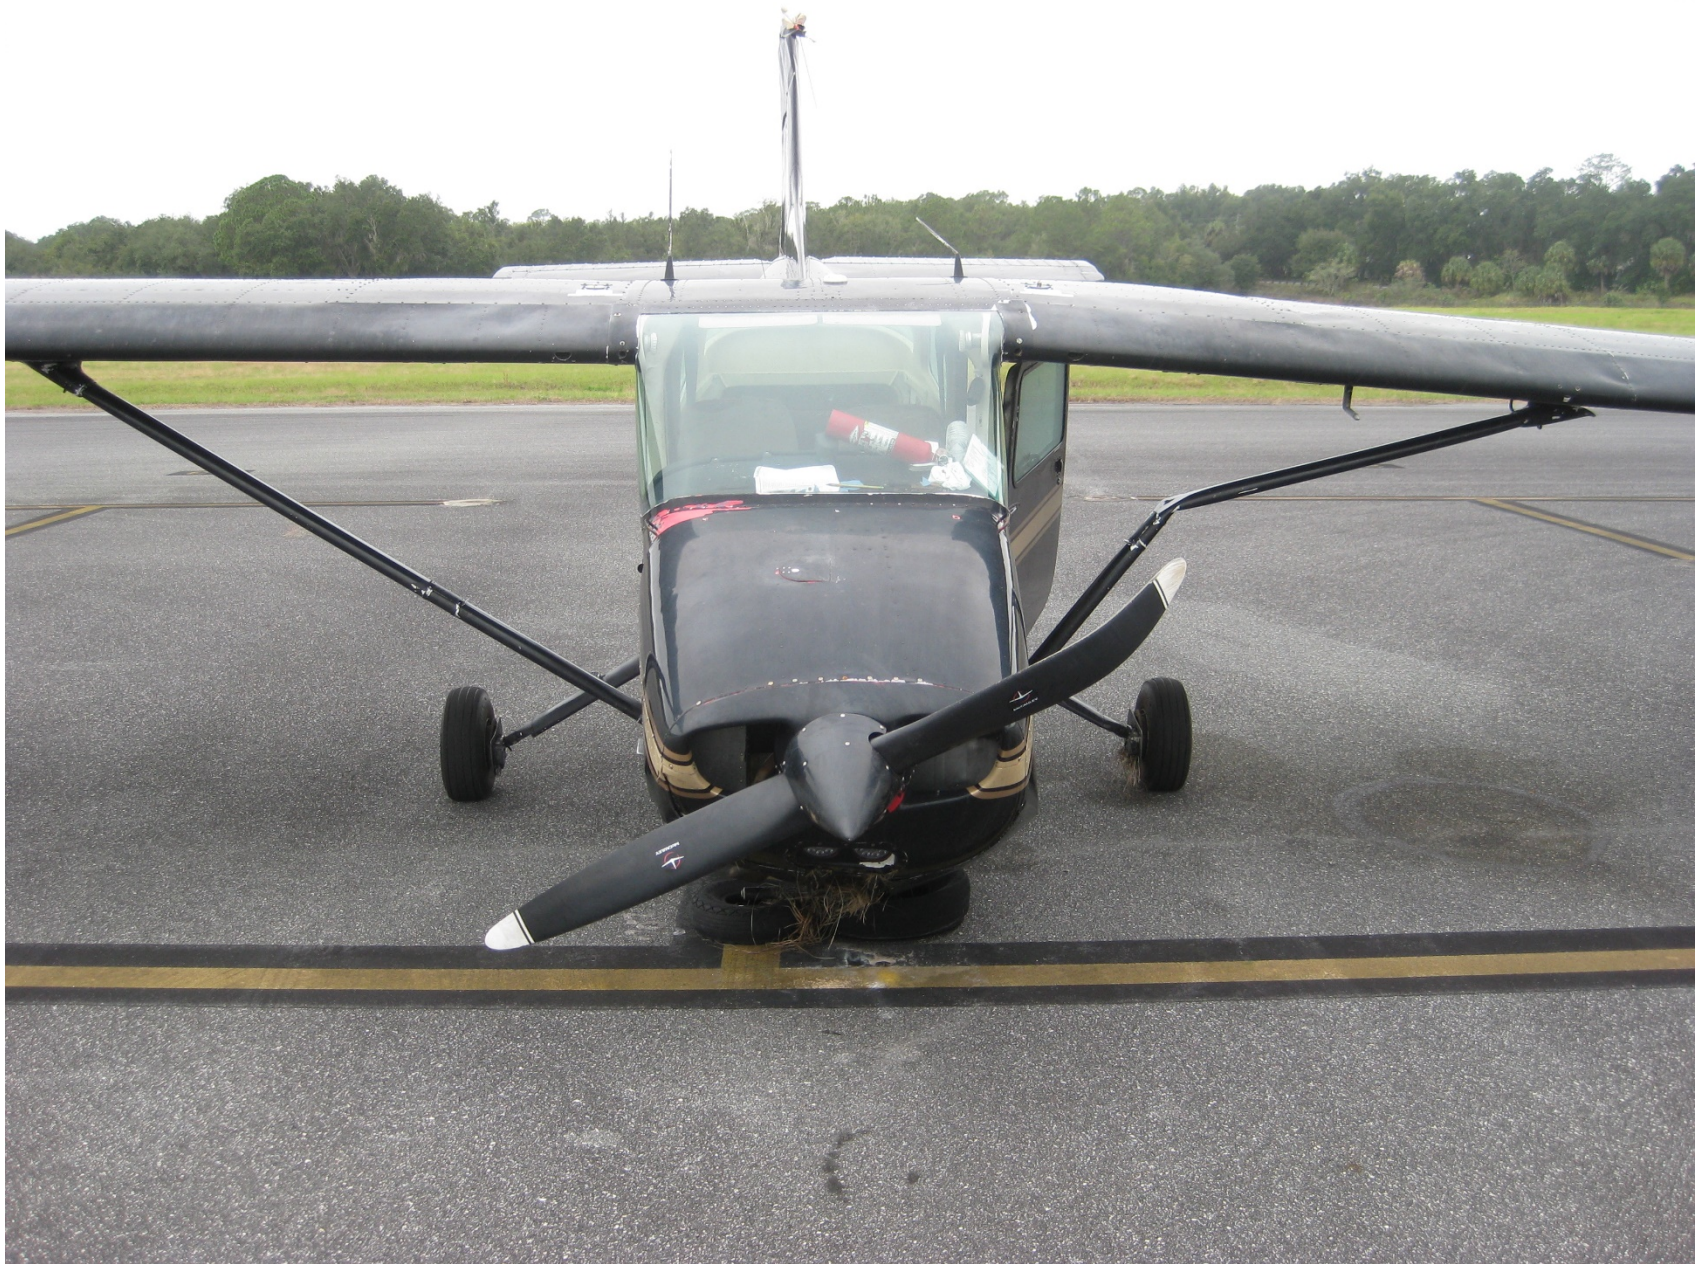
**Photo 1 – View of damaged left wing lift strut (Photo courtesy unknown)**
