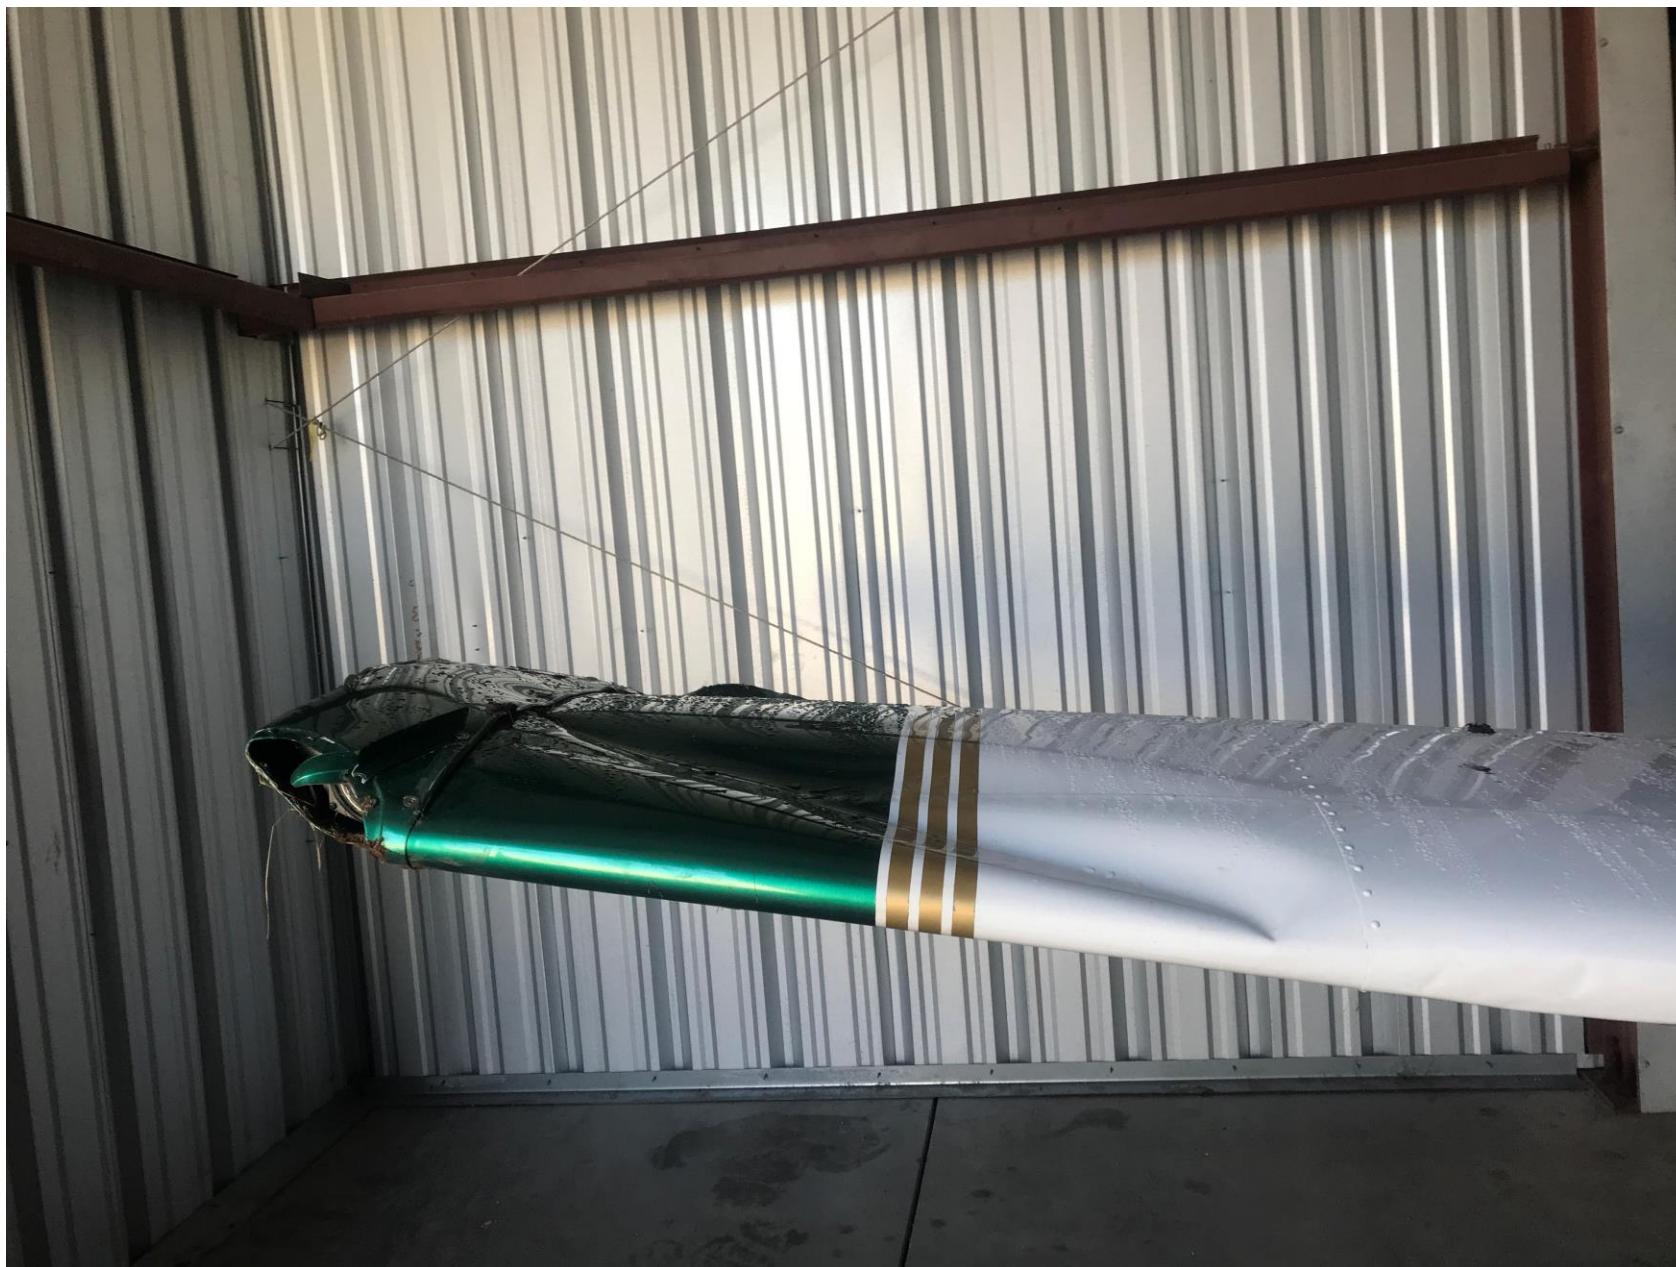
**Photo 1 – View of damaged right wing (Photo courtesy of the owner)**
