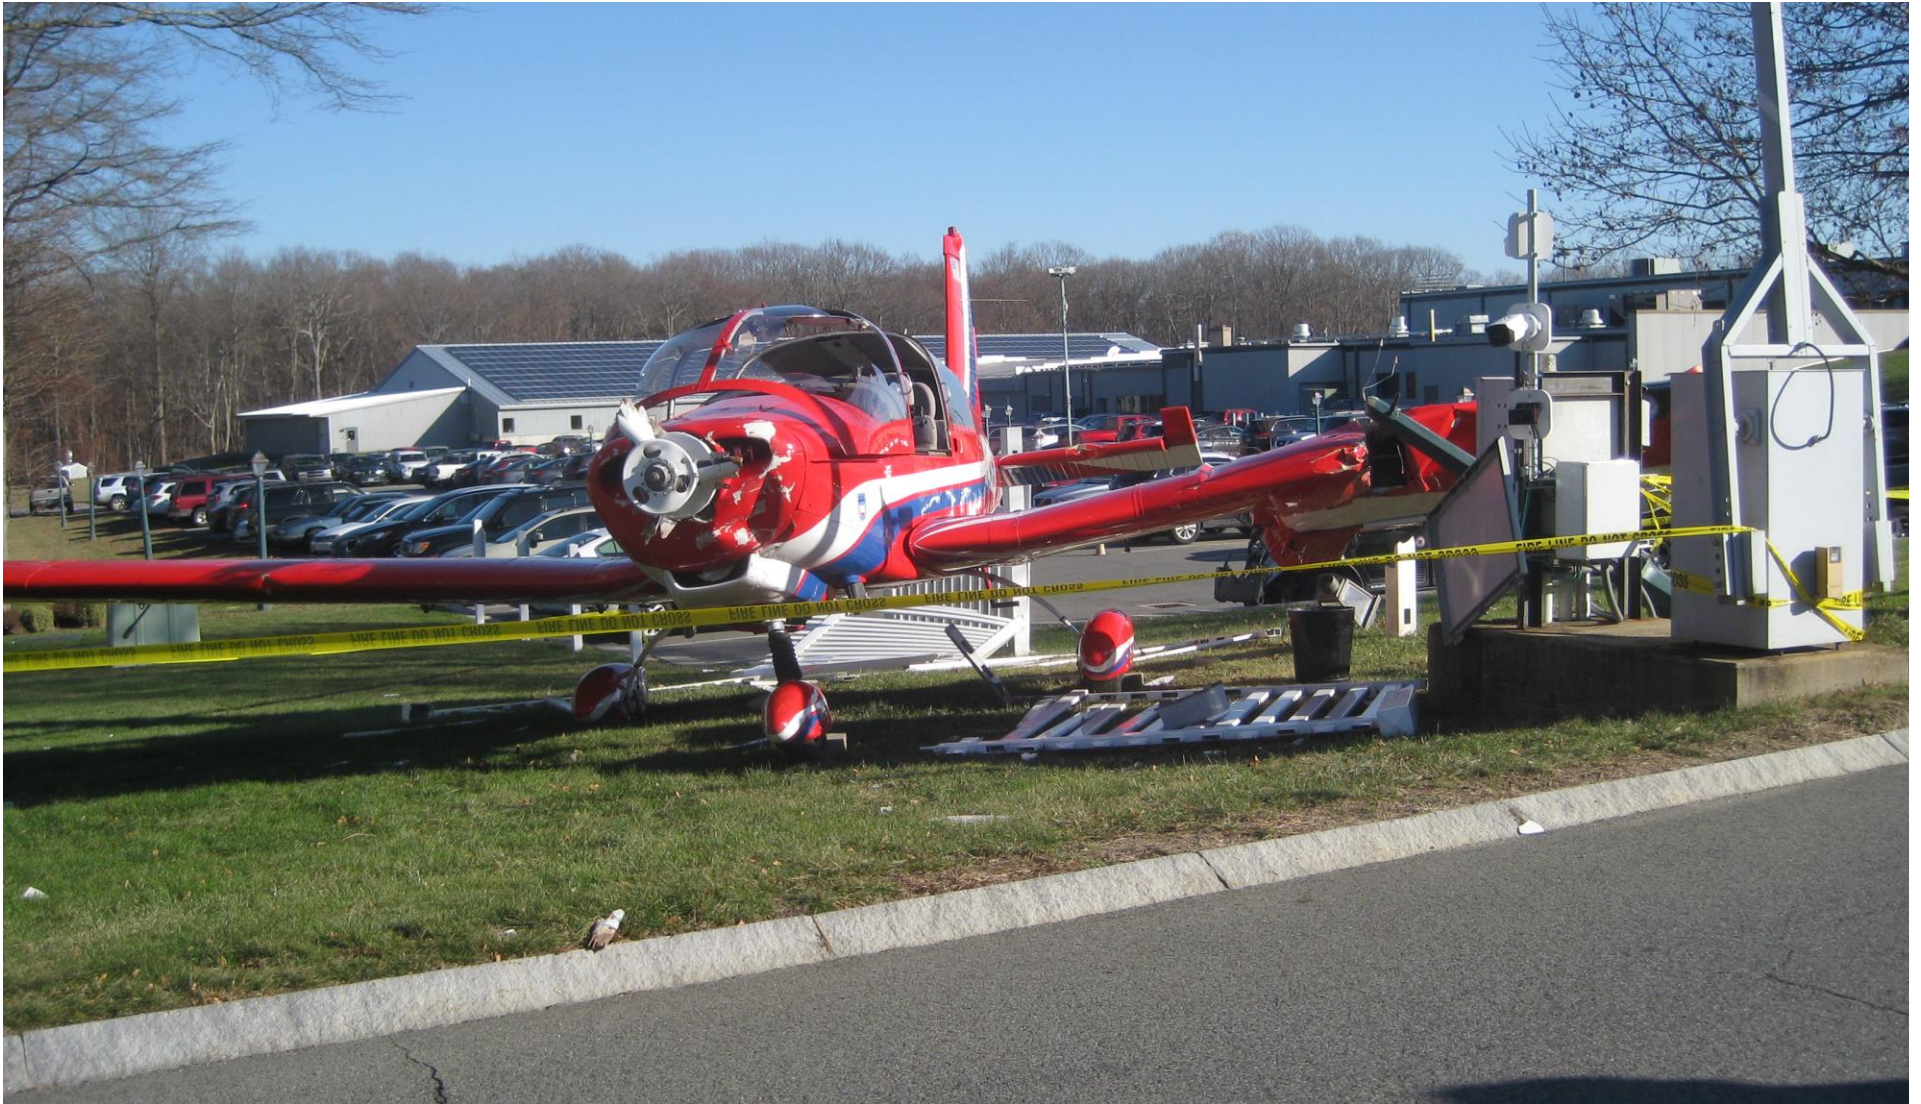
**Photo 1 – View of damaged left wing and empennage (Photo courtesy of the FAA)**
