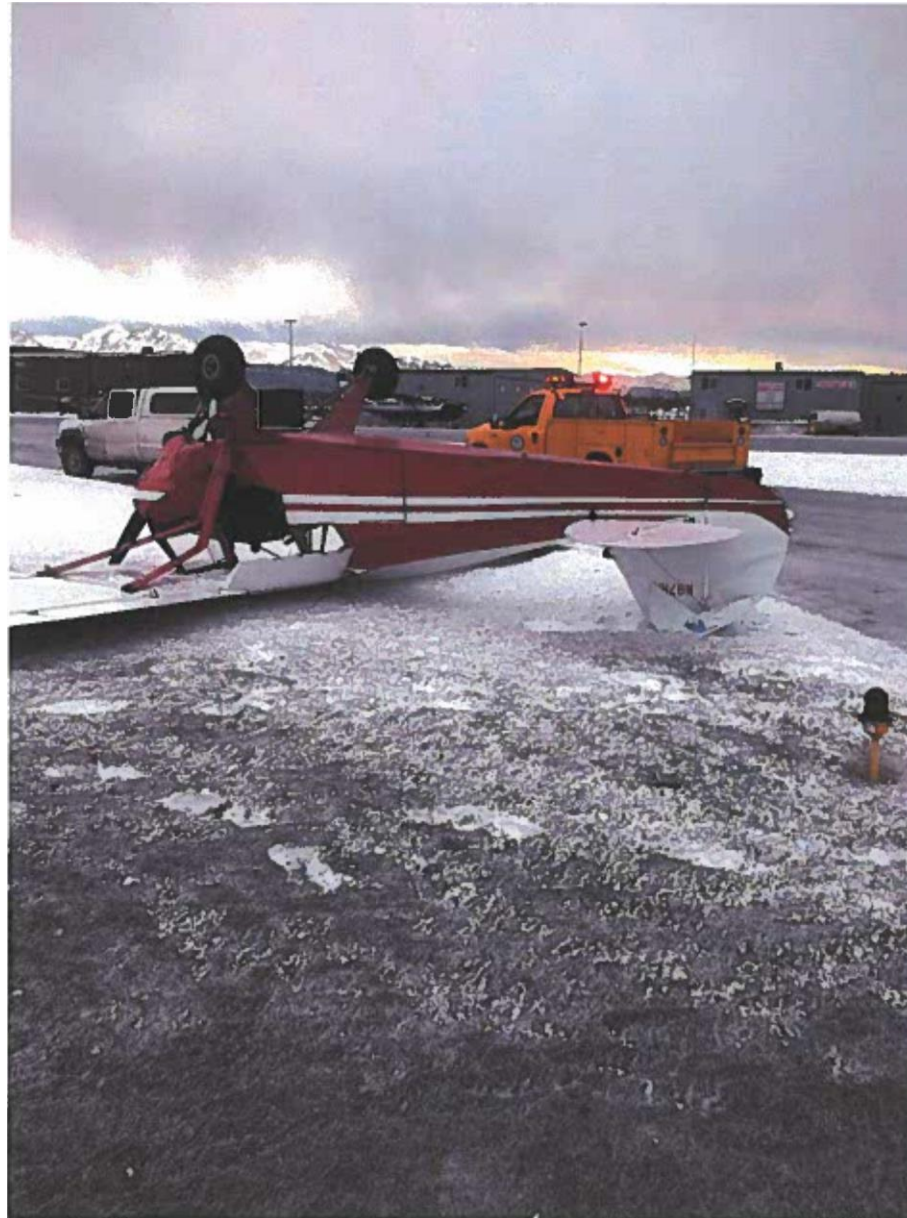
Photo 1 - View of airplane inverted with damage to the right **wing** lift strut and empennage (Photo courtesy of unknown)
