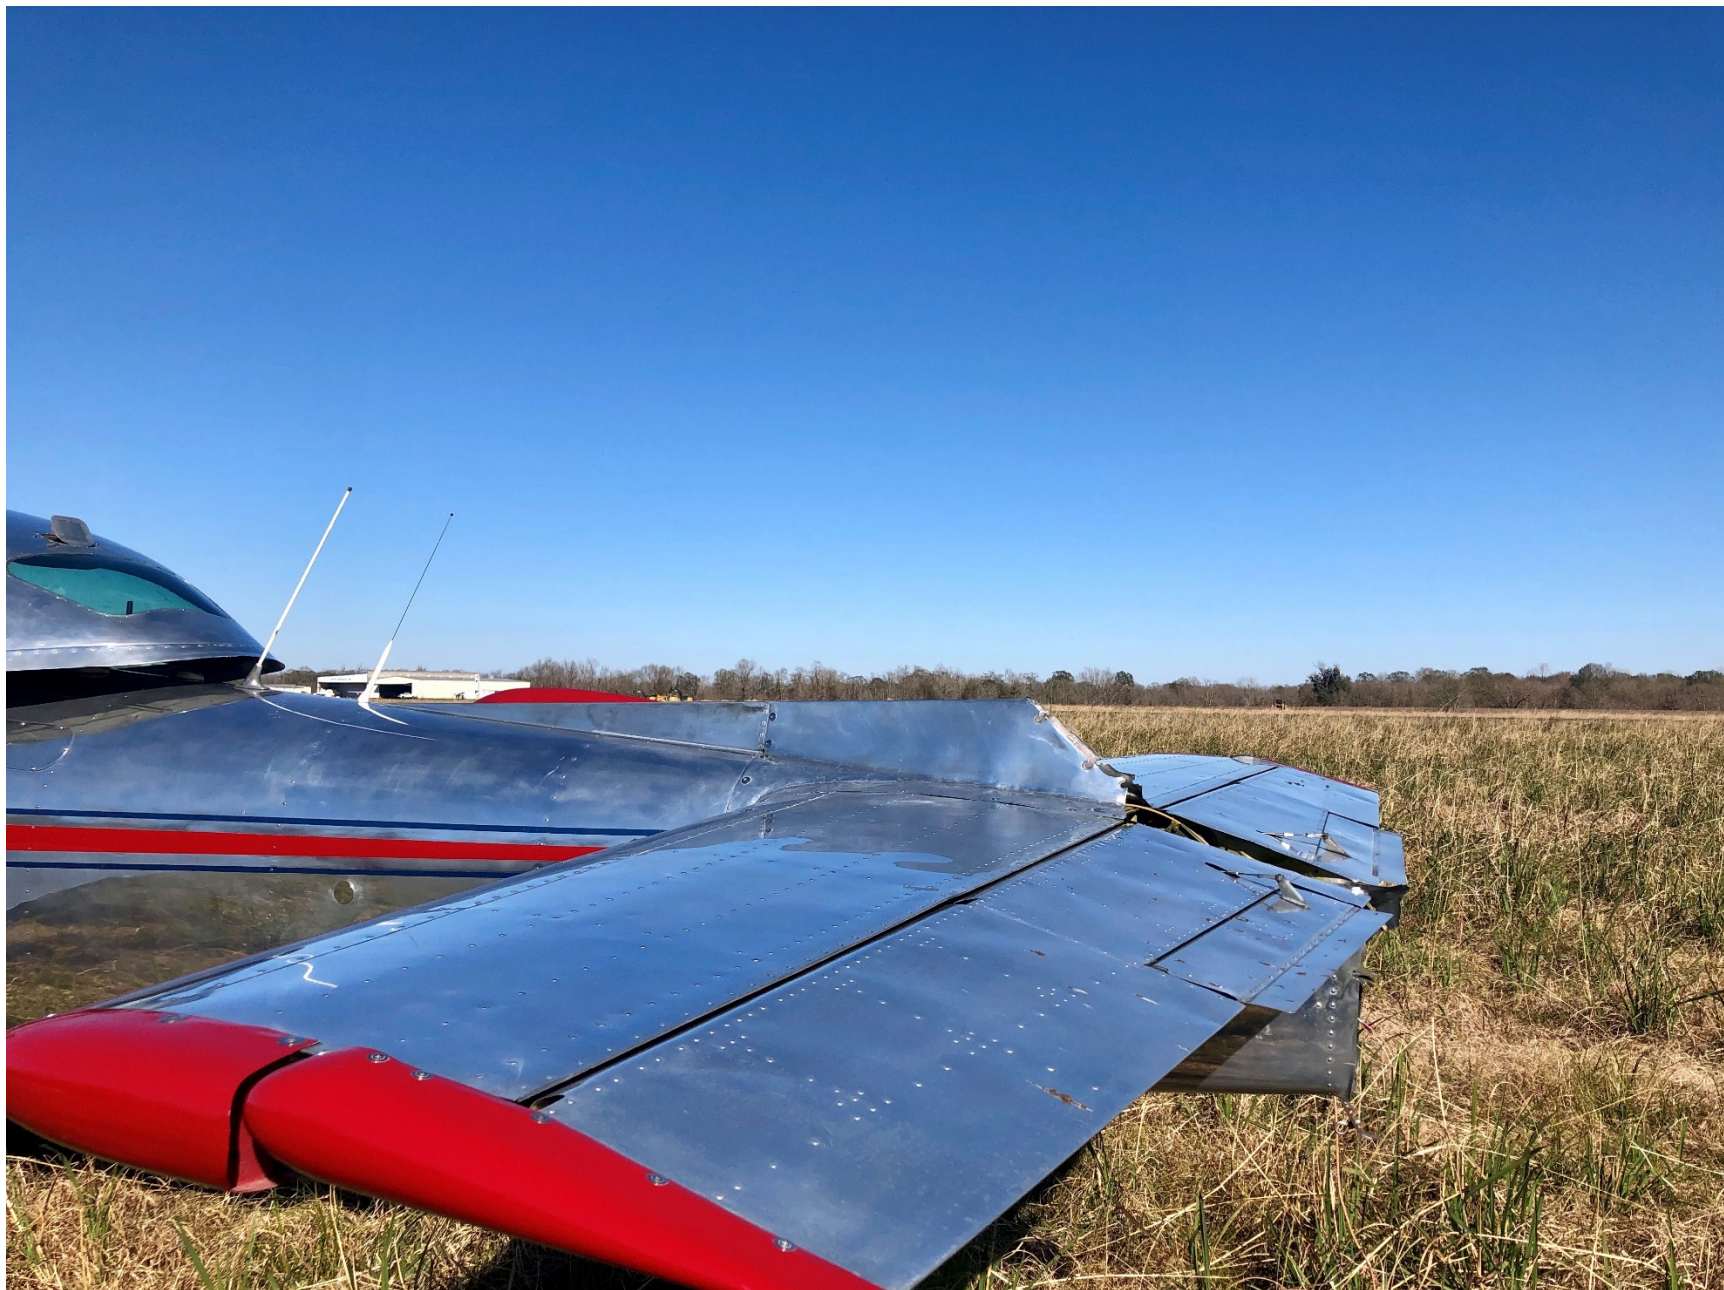
**Photo 1 – View of damaged empennage without vertical stabilizer and rudder (Photo courtesy of the pilot)**

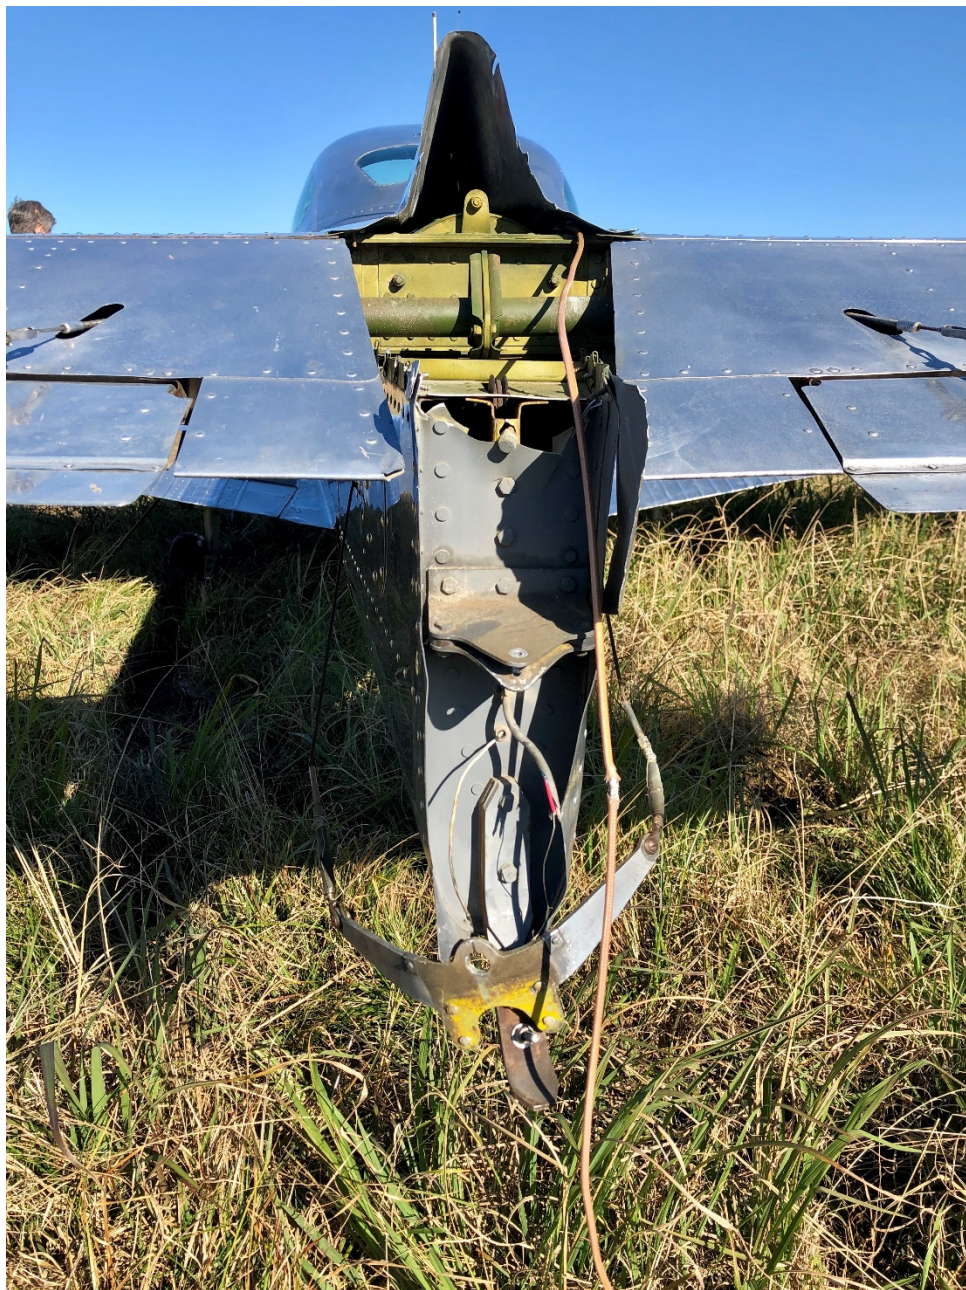
**Photo 2 – View of damaged empennage from rear (Photo courtesy of the pilot)**

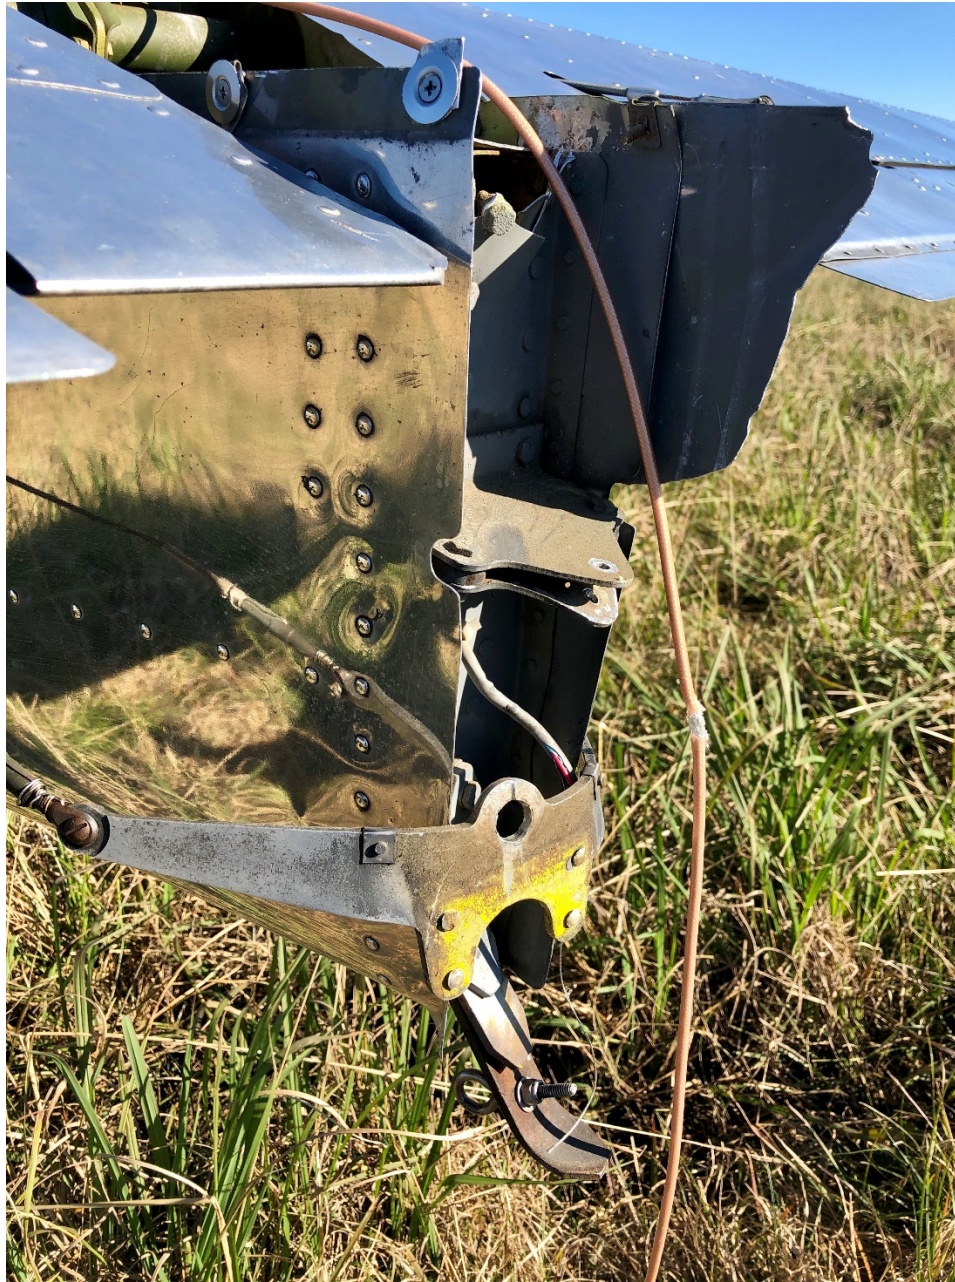
**Photo 3 – View of damaged empennage (Photo courtesy of the pilot)**
