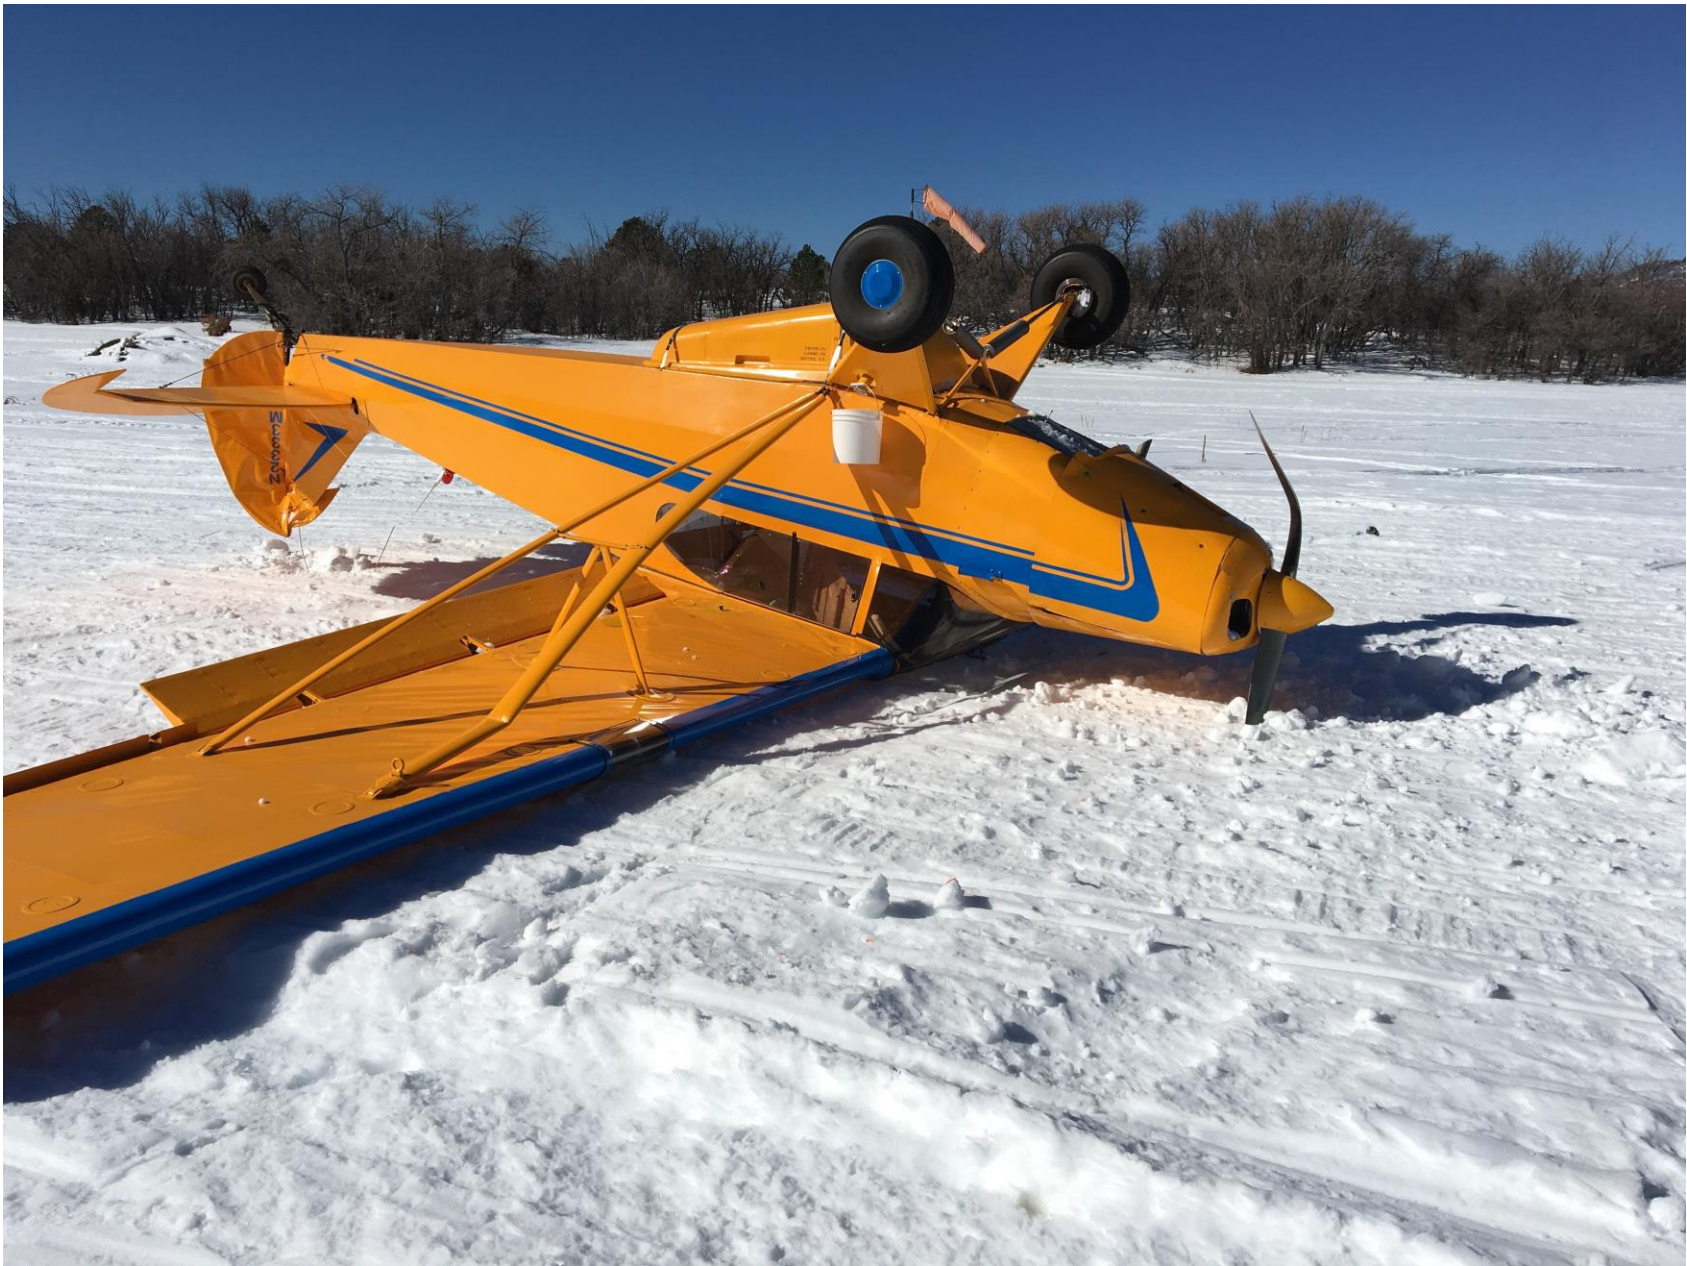
**Photo 1 – View of inverted airplane with damaged left wing lift strut and empennage (Photo courtesy of unknown)**
