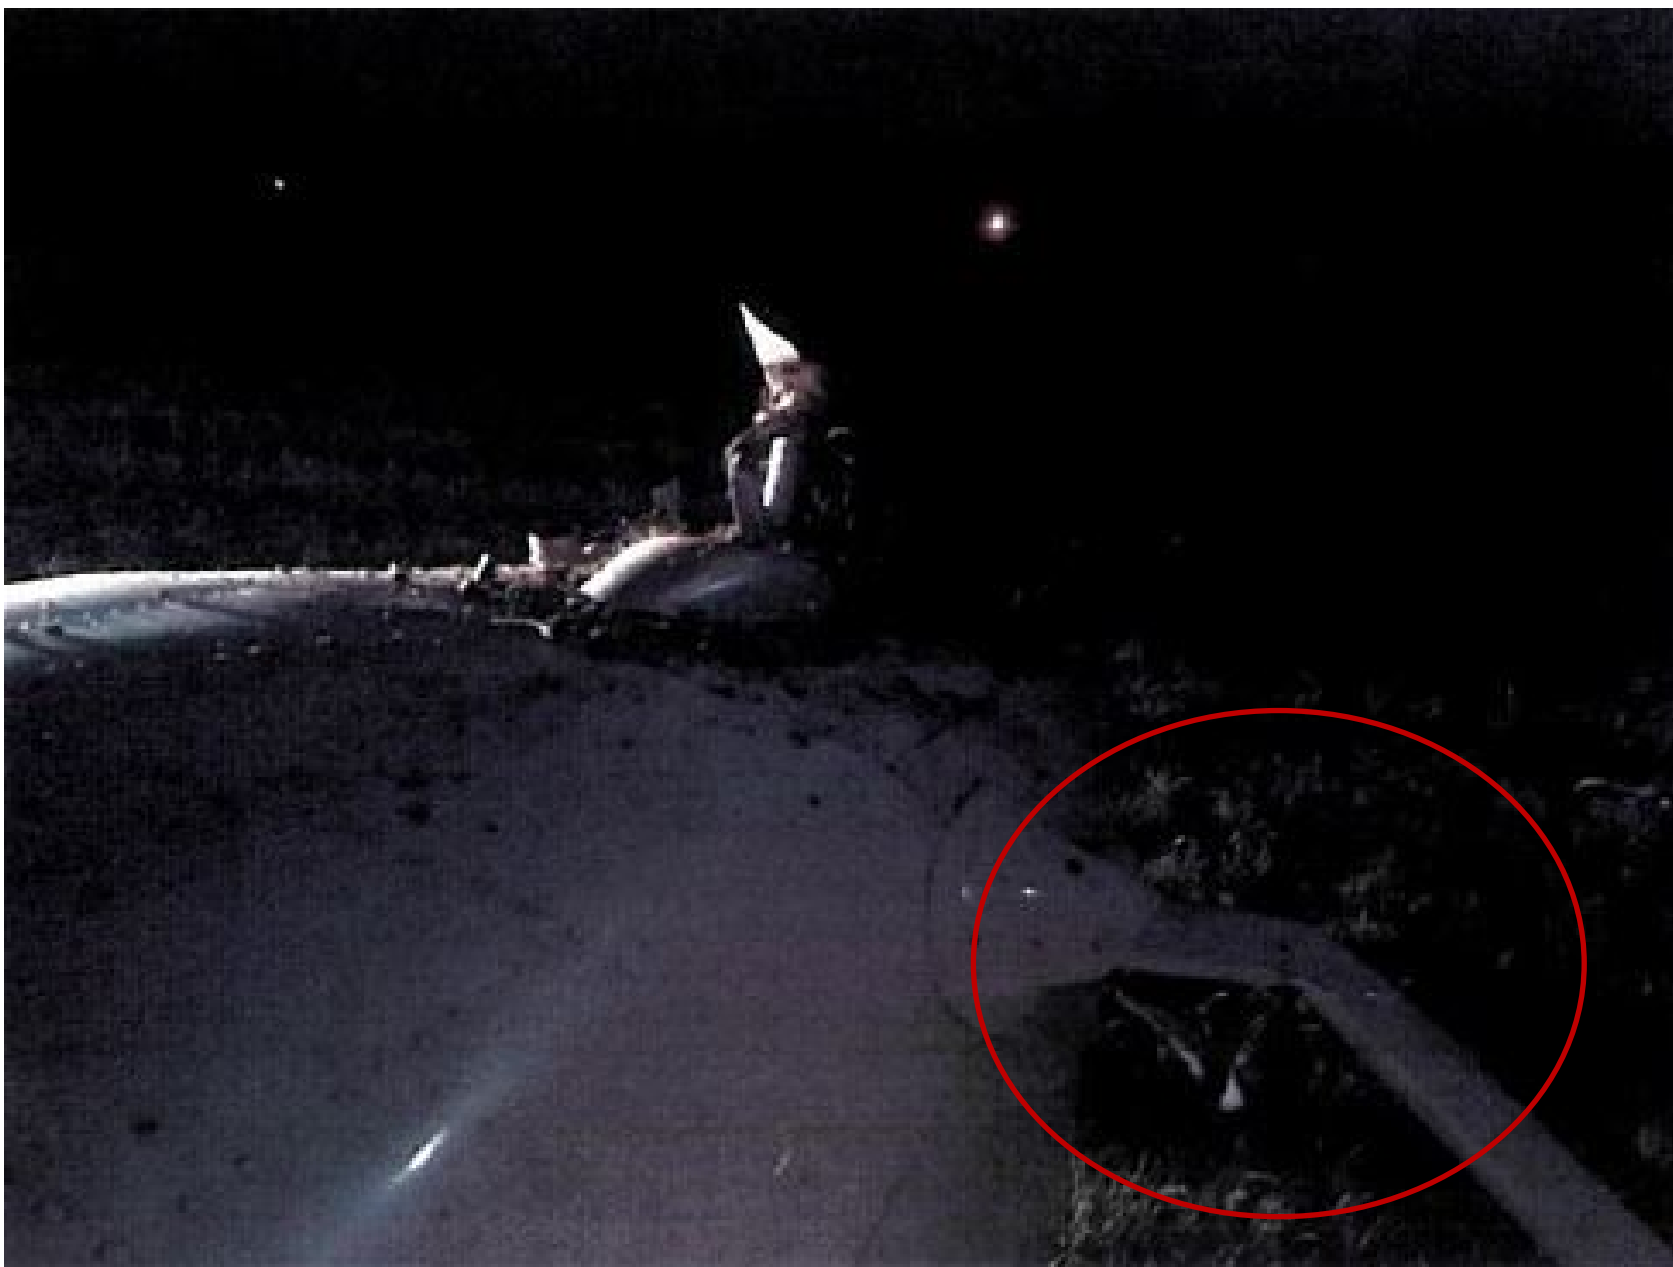
**Photo 1 – View of damage to lower left wing lift strut (courtesy of the FAA)**
