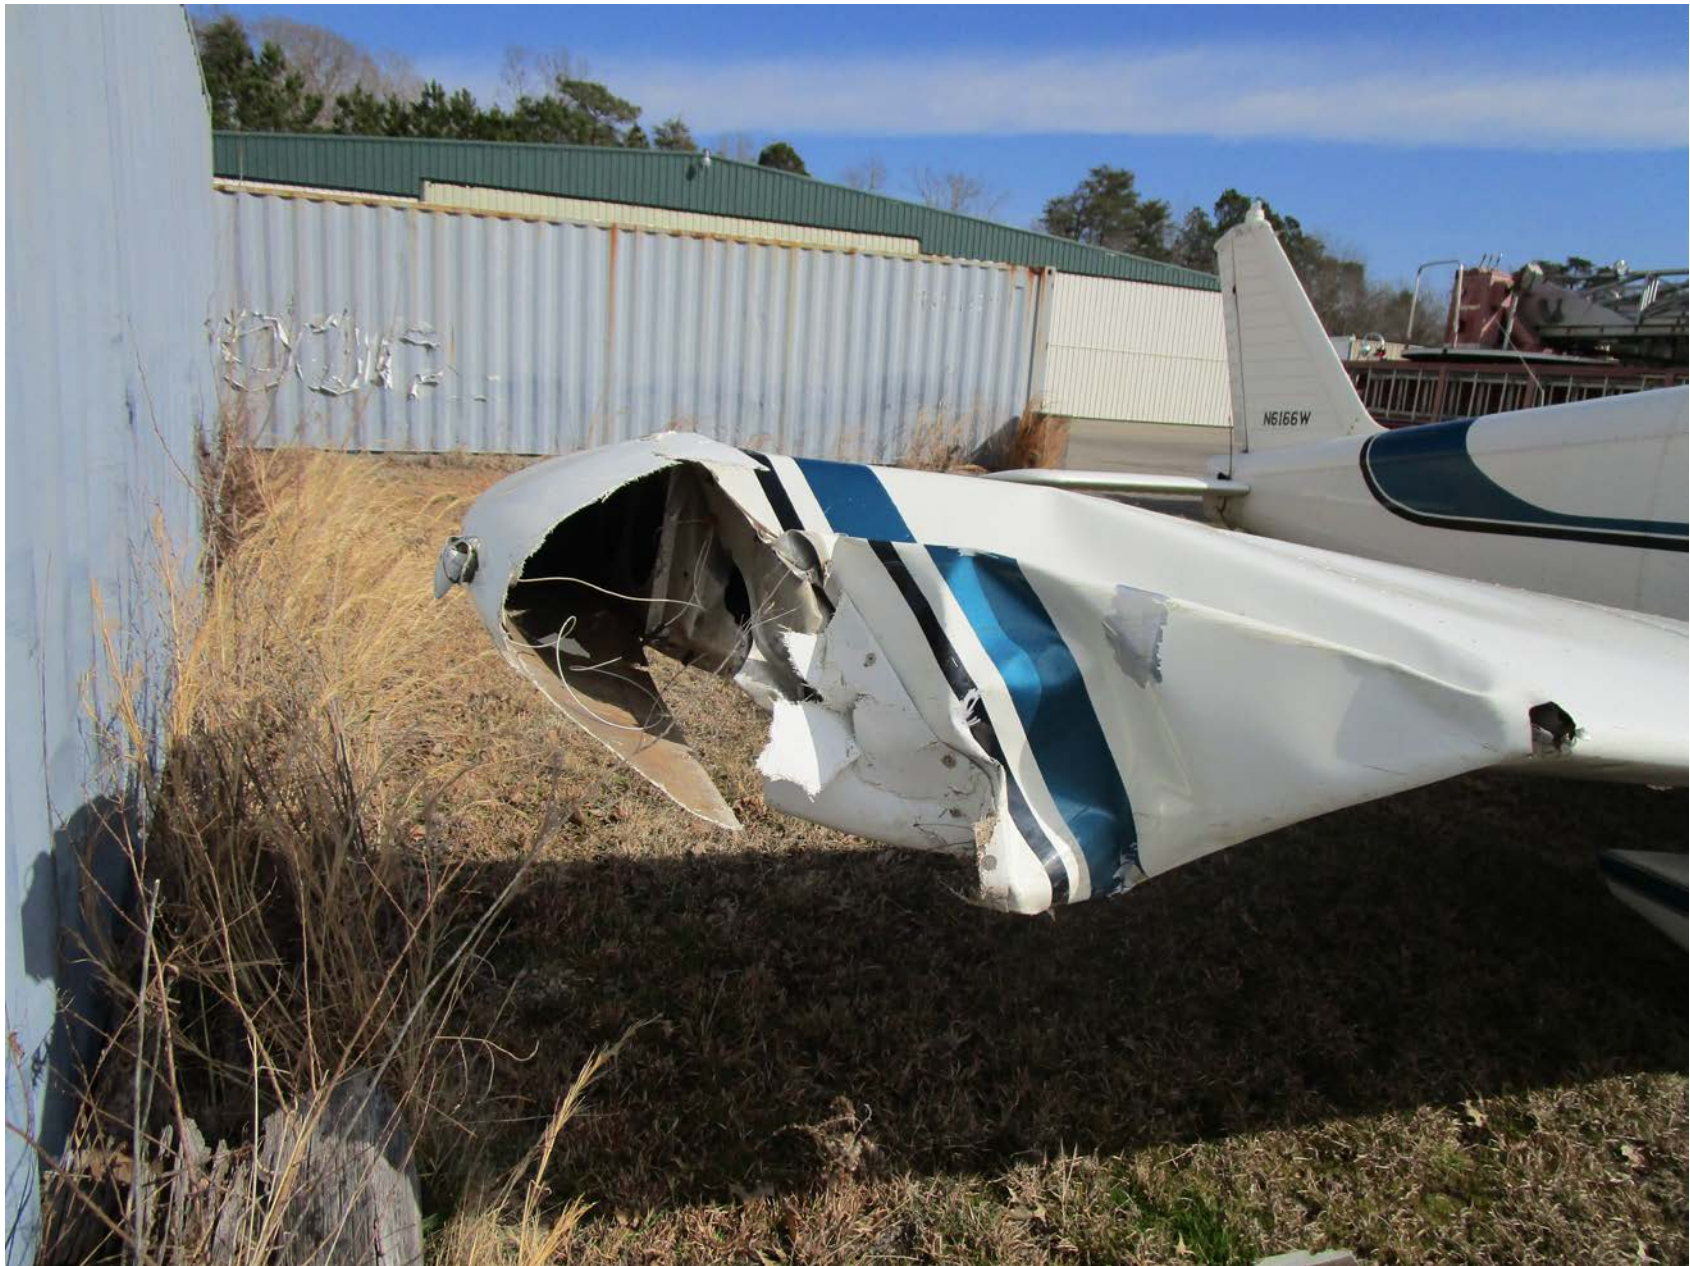
**Photo 1 – View of damage to the right wing (Courtesy of FAA)**

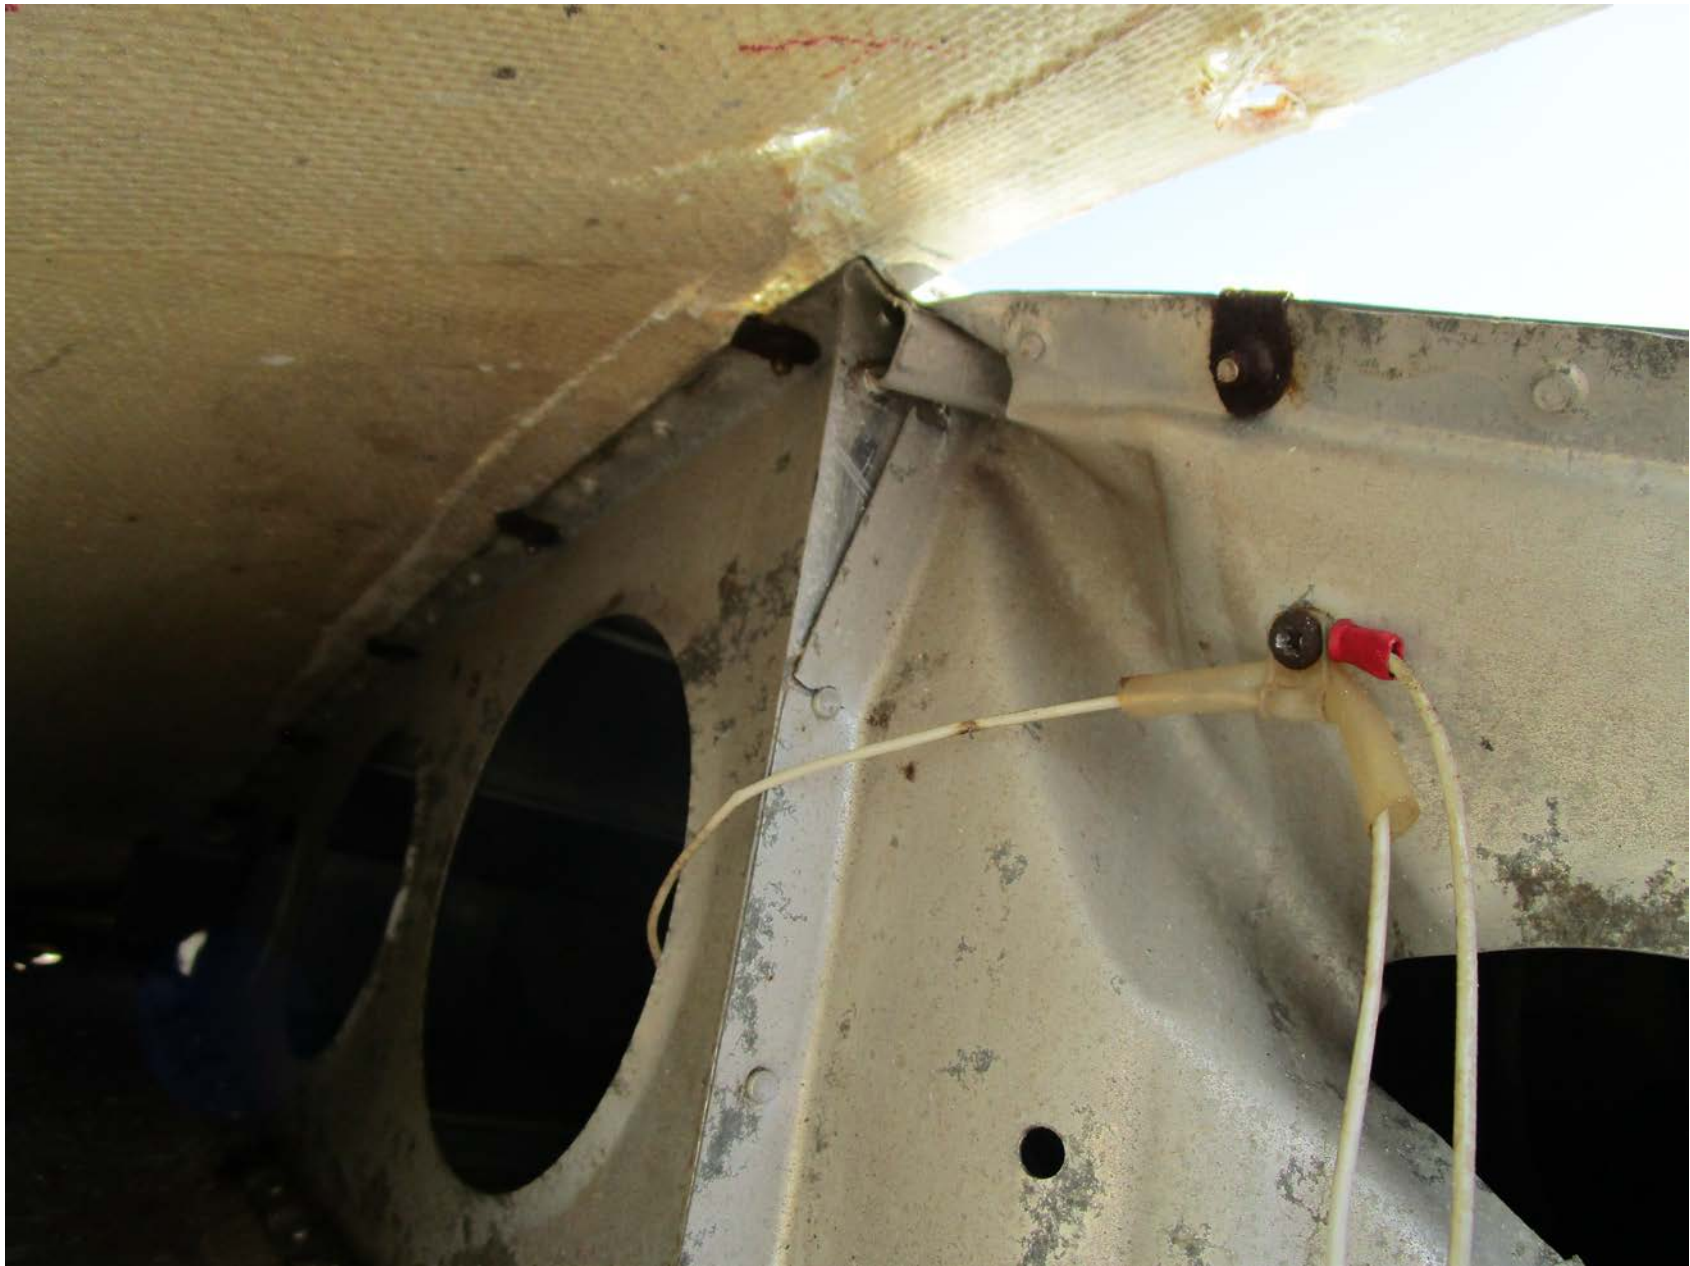
**Photo 2 – View of damage to the outboard right rib wing nose (Courtesy of FAA)**
