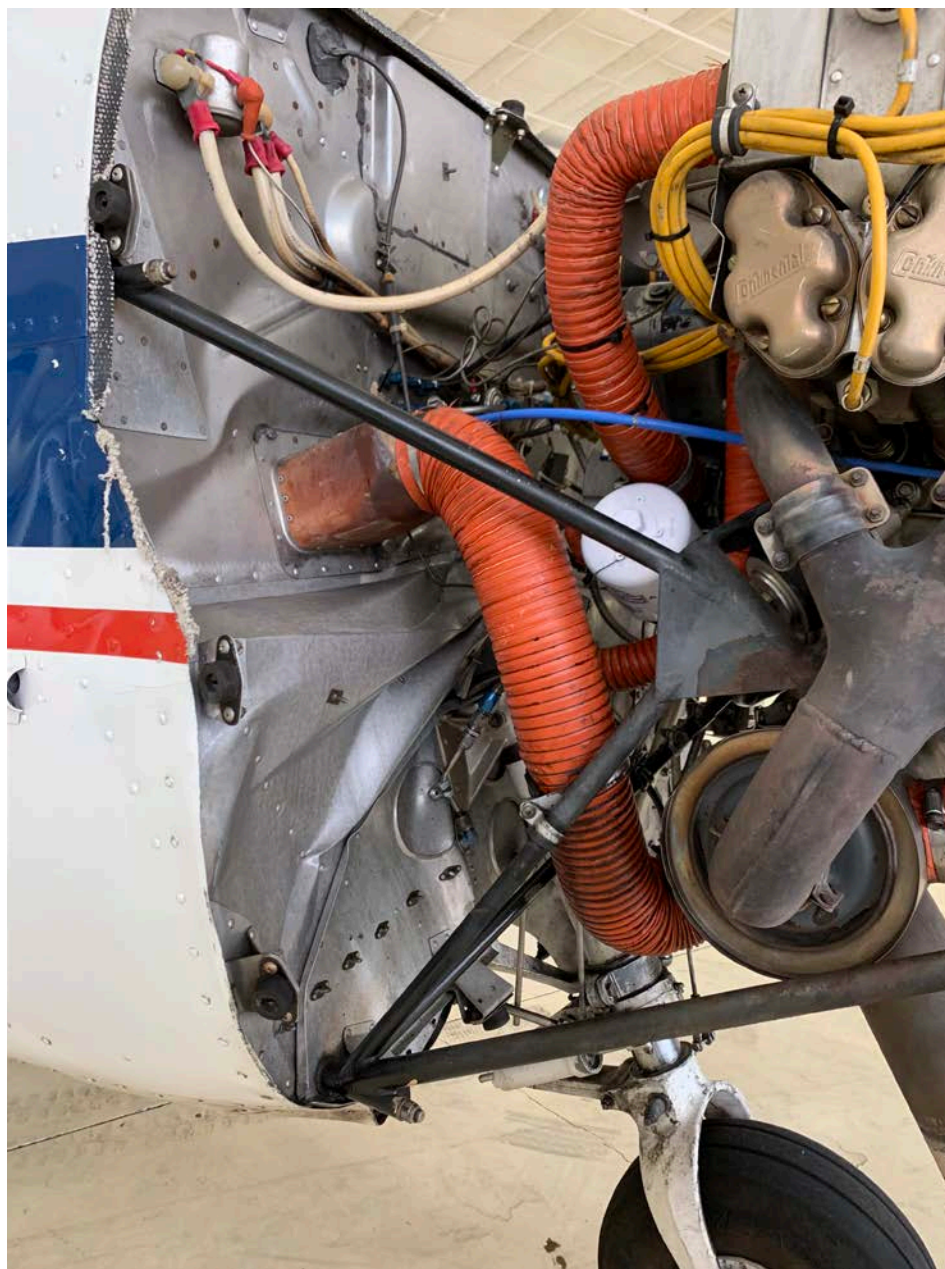
**Photo 1 – View of damaged firewall and engine mount frame (courtesy of the airframe and powerplant mechanic)**

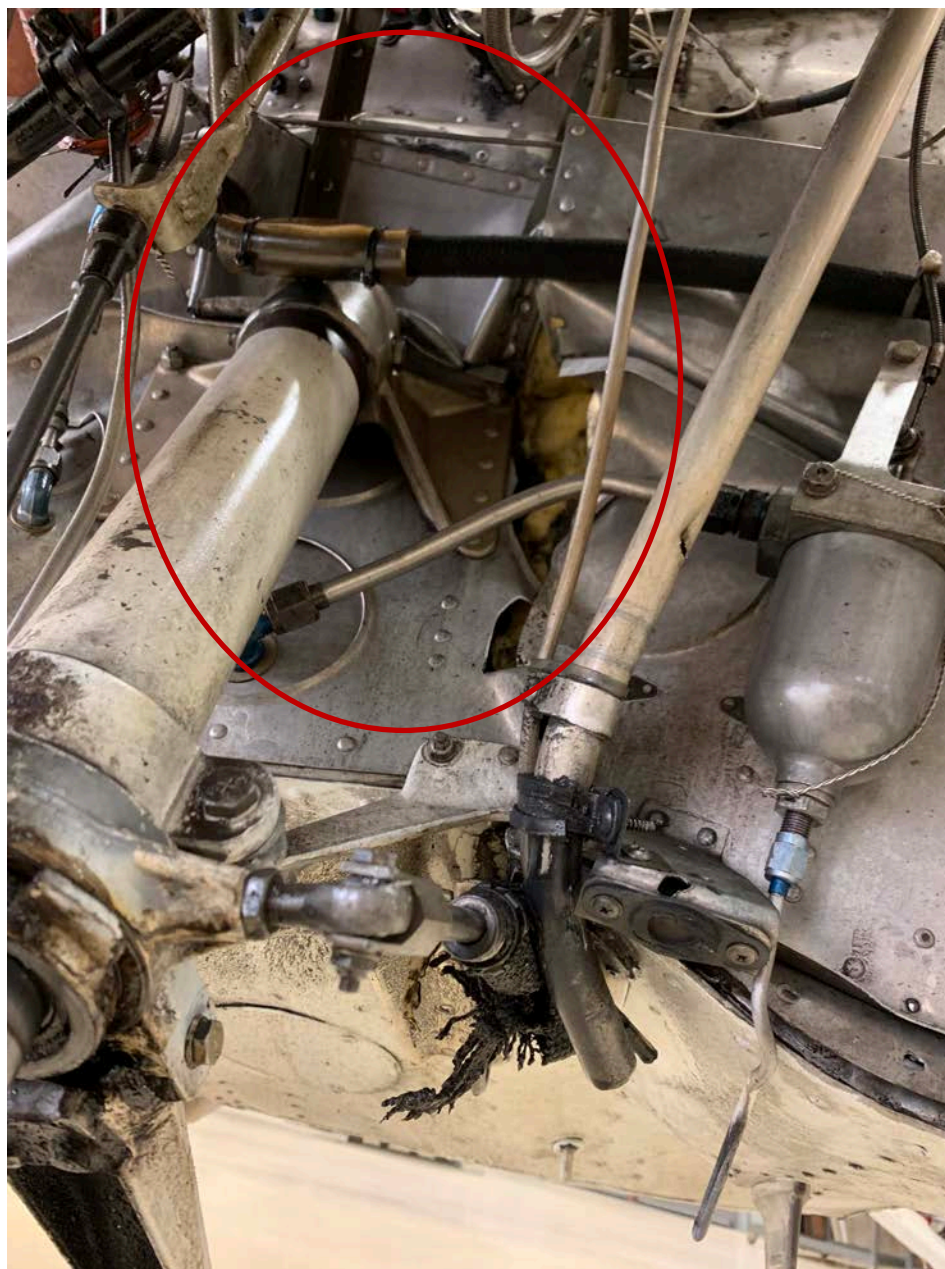
**Photo 2 – View of damage to firewall and nose landing gear tunnel (courtesy of the airframe and powerplant mechanic)**
