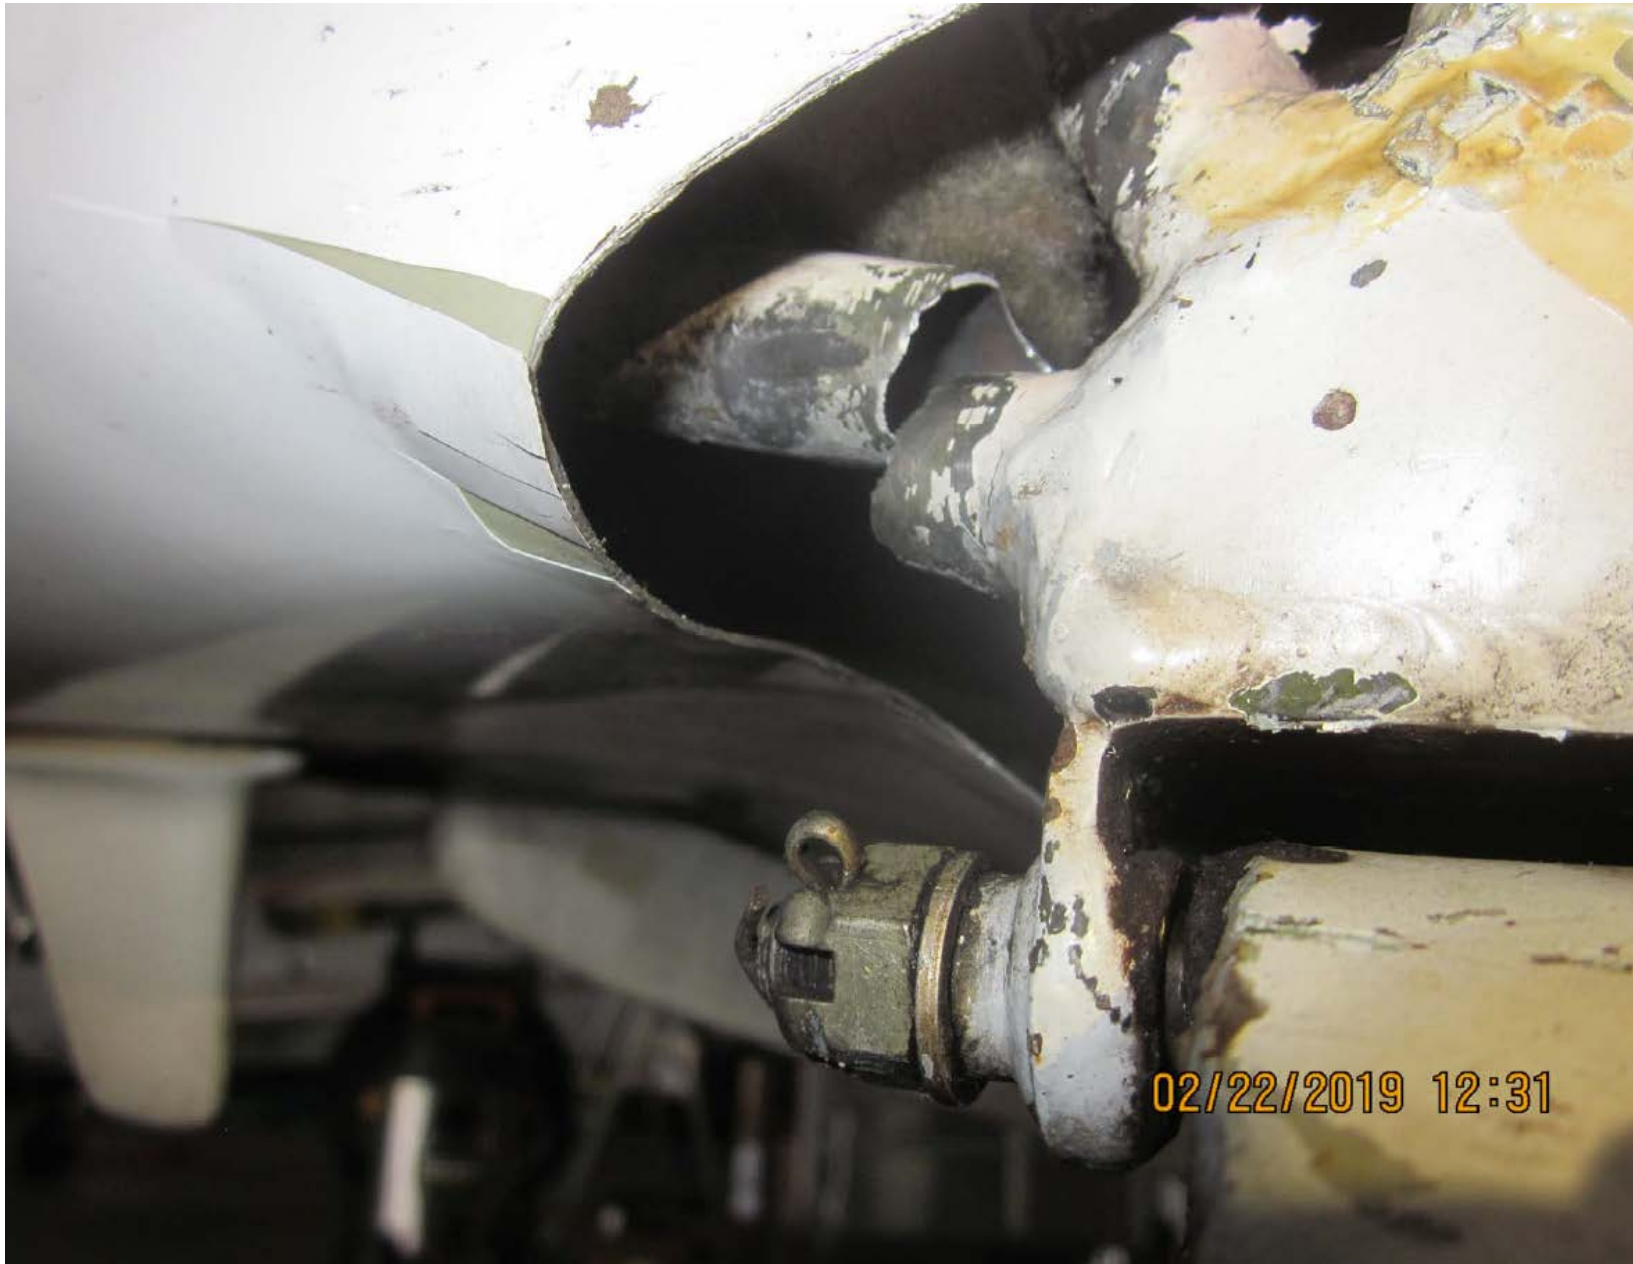
**Photo 1 – View of damage to the left main landing gear attachment point (Courtesy of FAA)**
