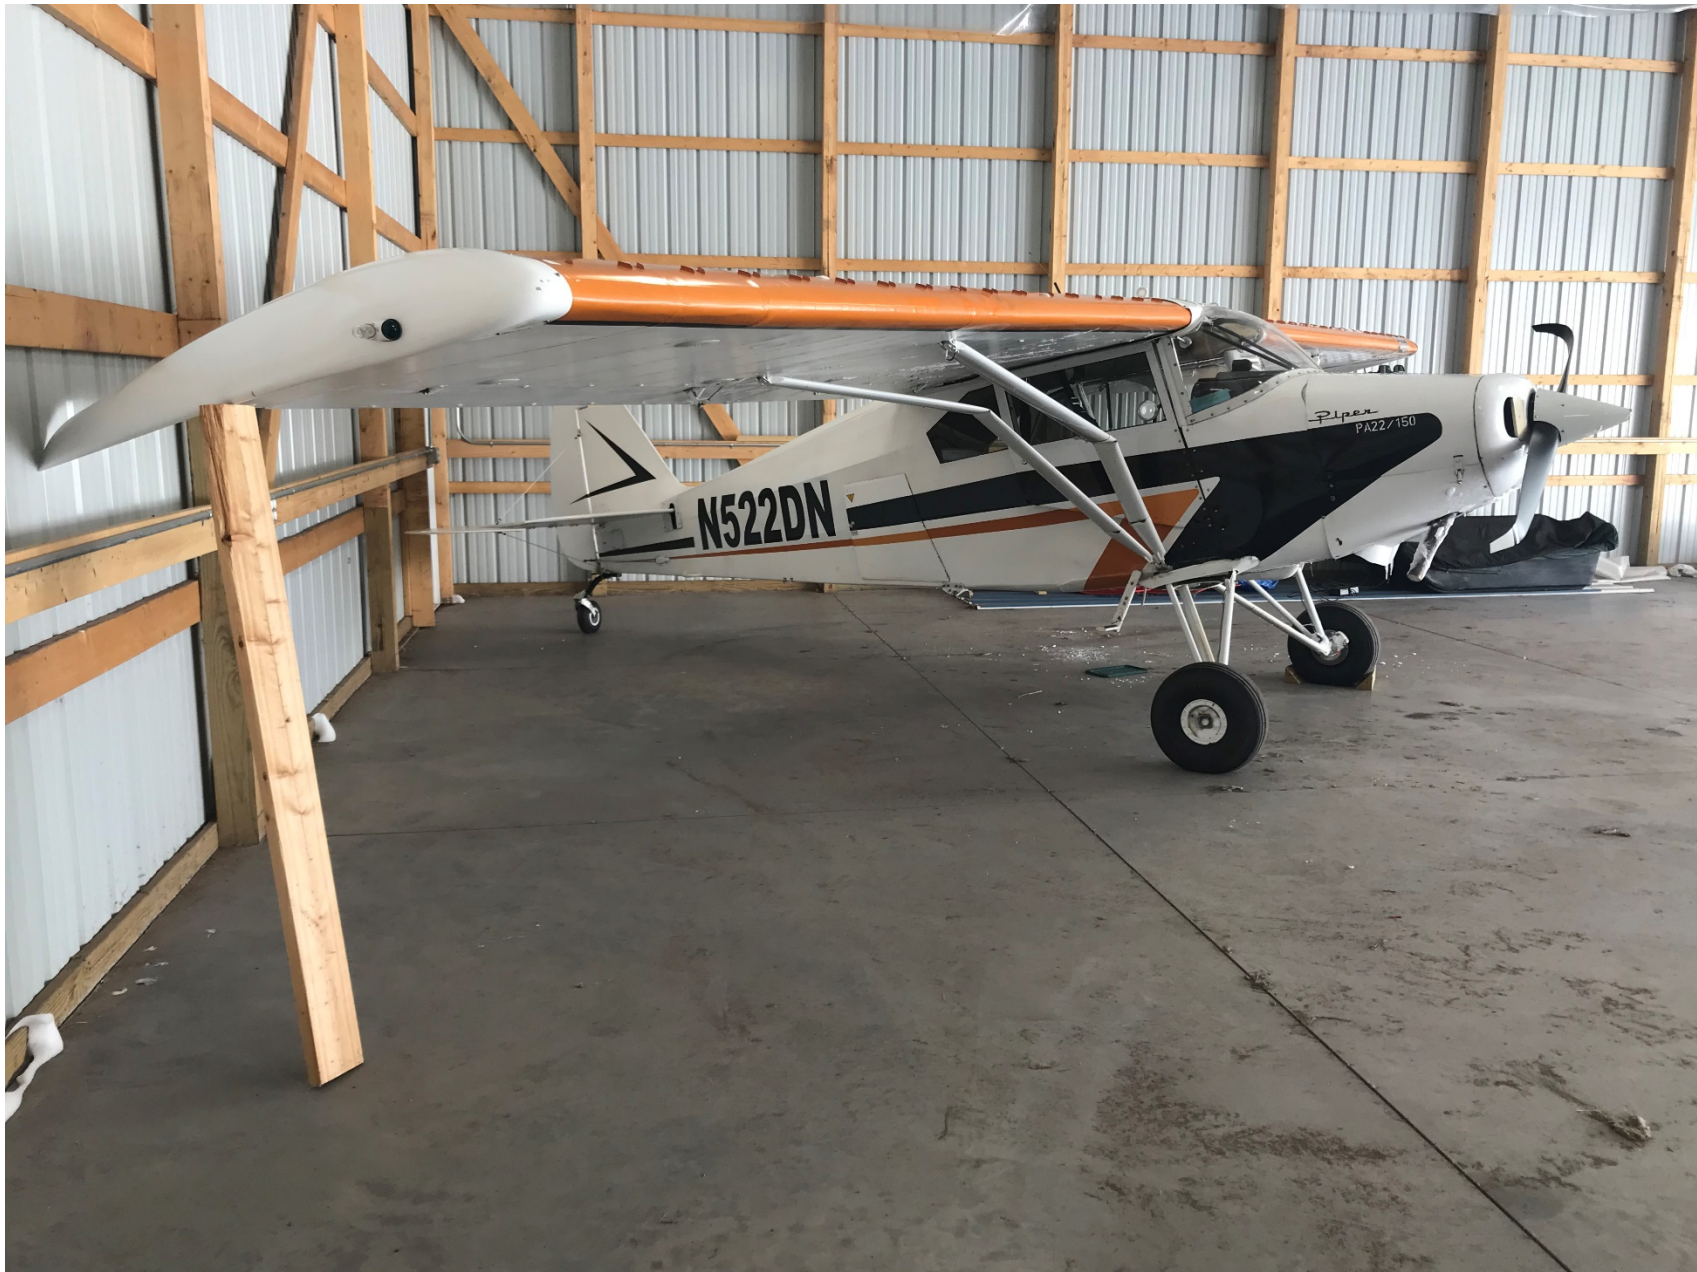
**Photo 1 – View of damaged right wing lift strut (Photo courtesy of the pilot)**
