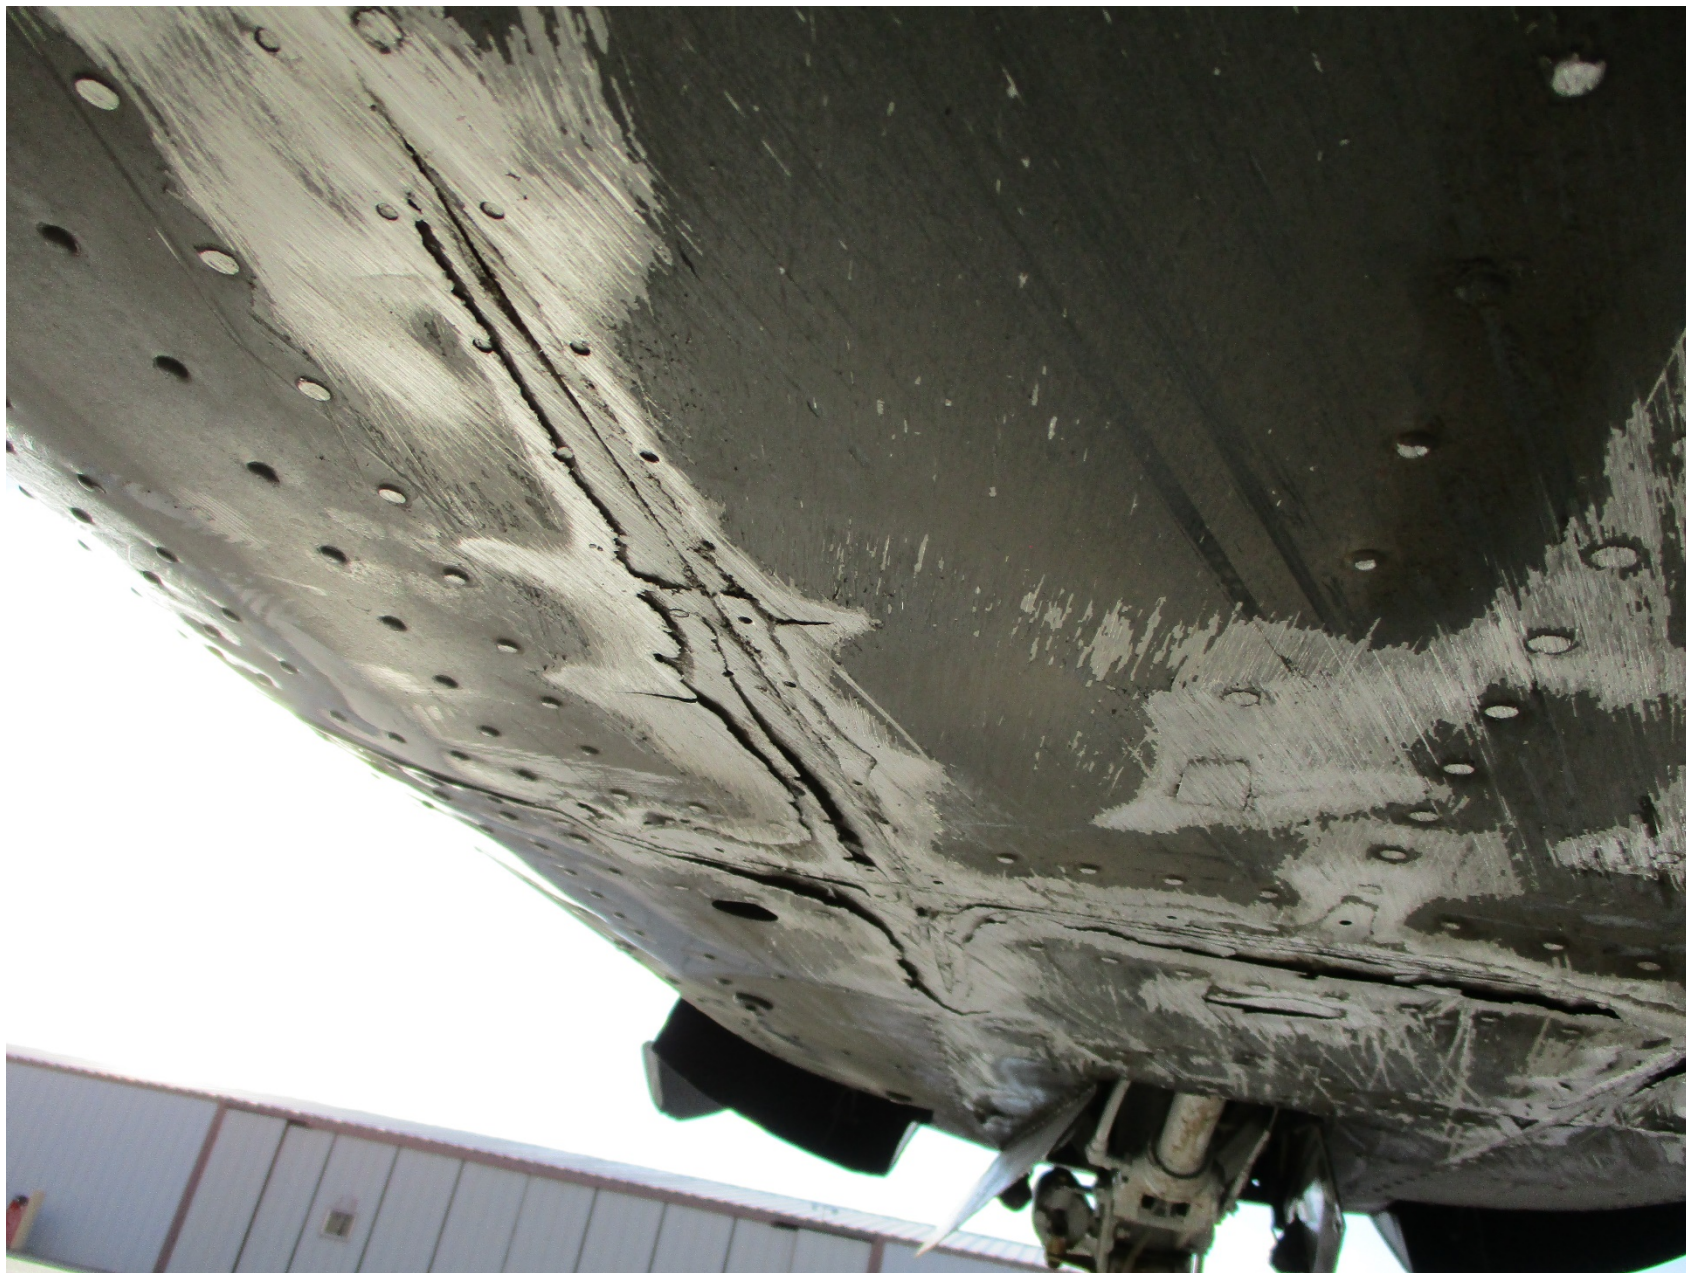
**Photo 1 – View of damaged fuselage from underneath (Photo courtesy of the FAA)**

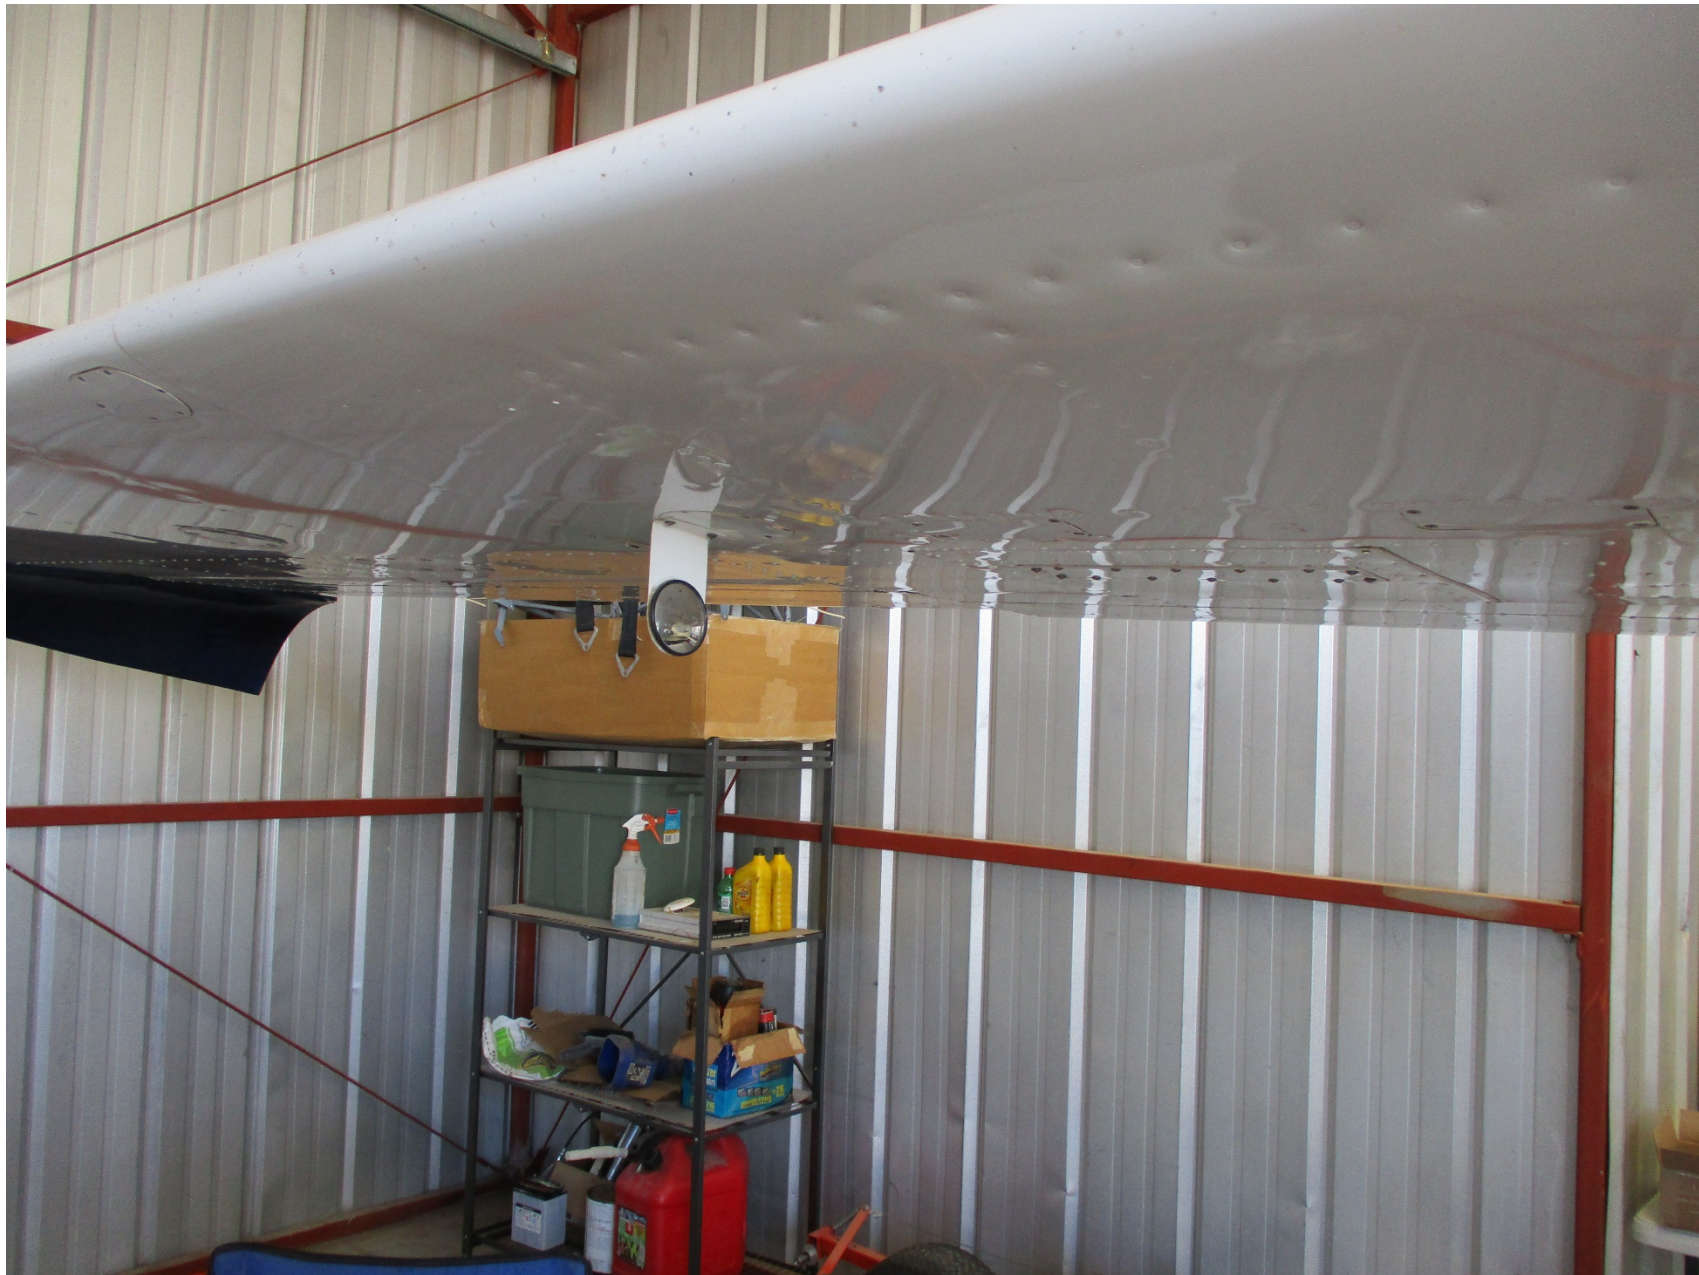
**Photo 2 – View of landing gear position observation mirror on right wing (Photo courtesy of the FAA)**

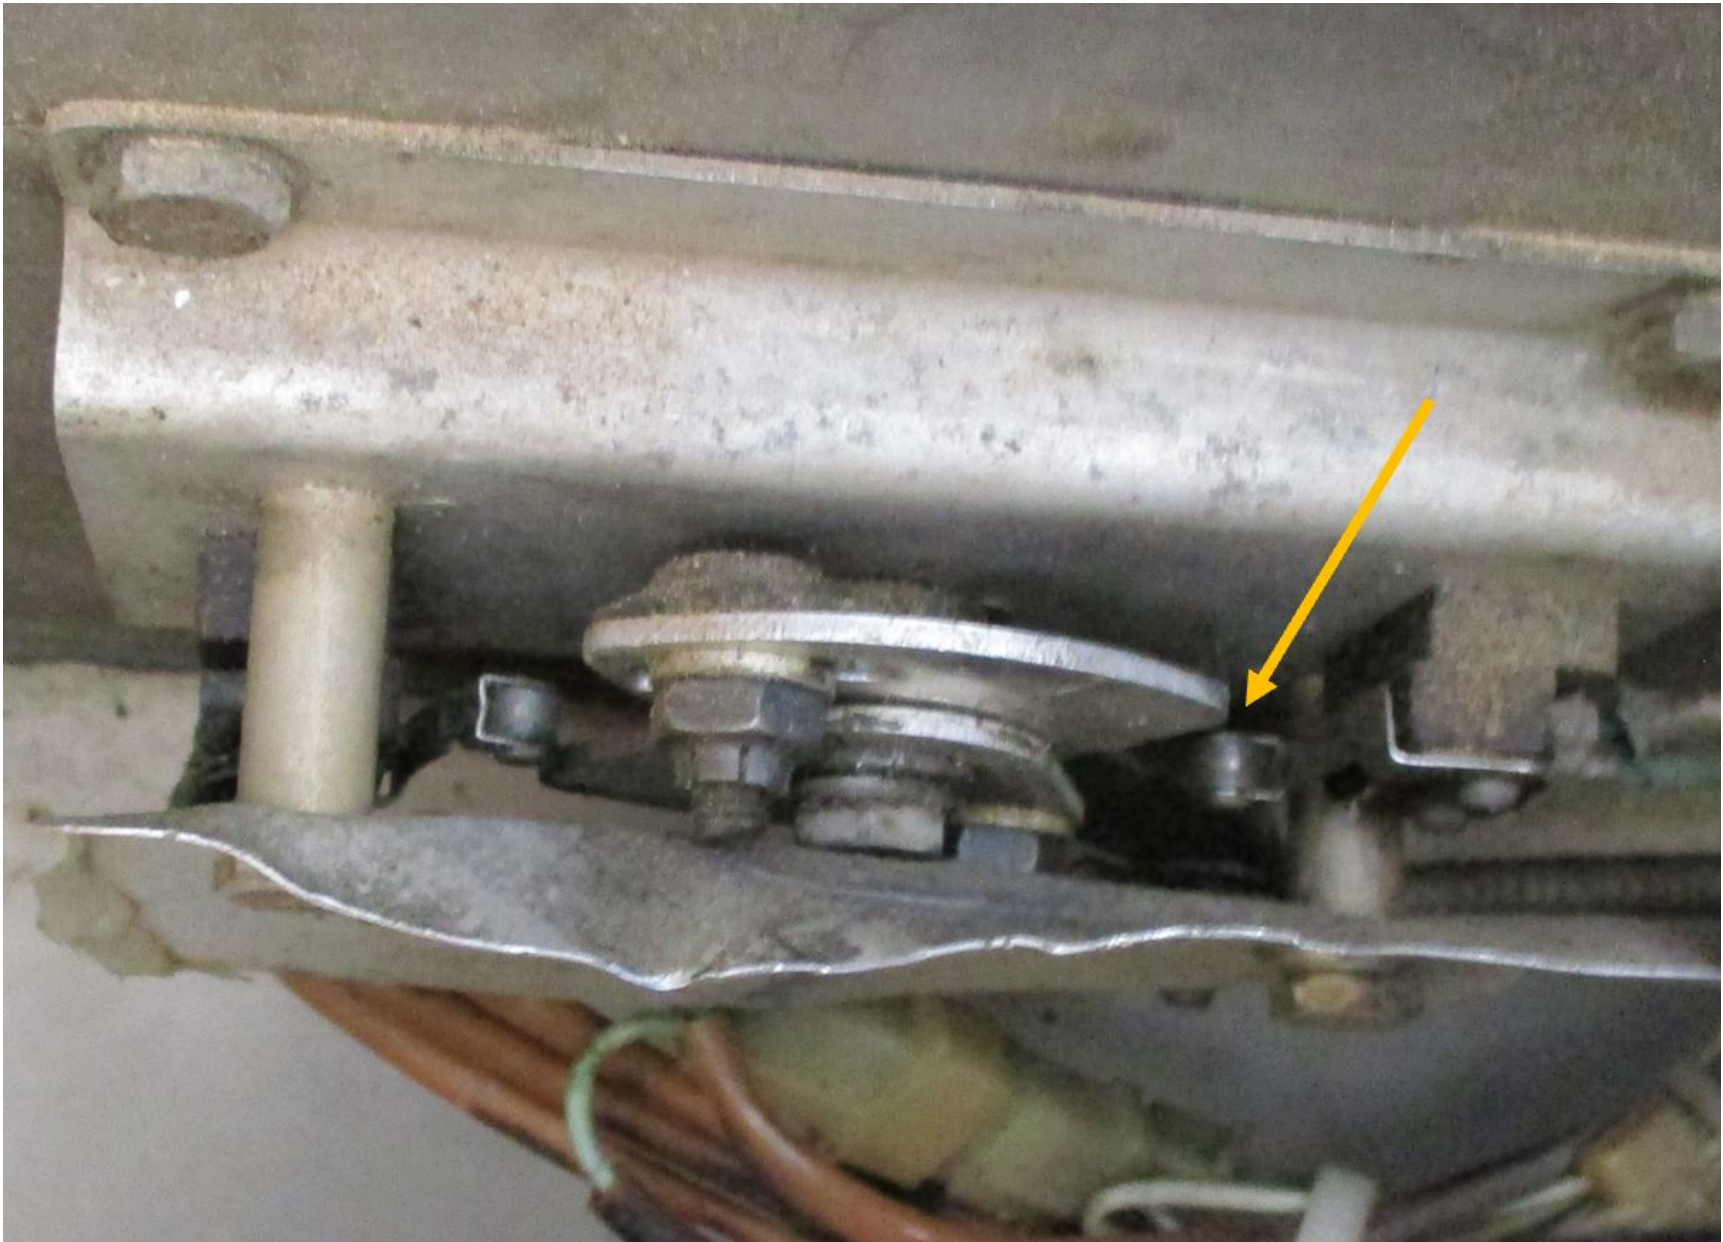
**Photo 3 – View of gear warning microswitch at throttle idle position with visible gap (Photo courtesy of the FAA)**
