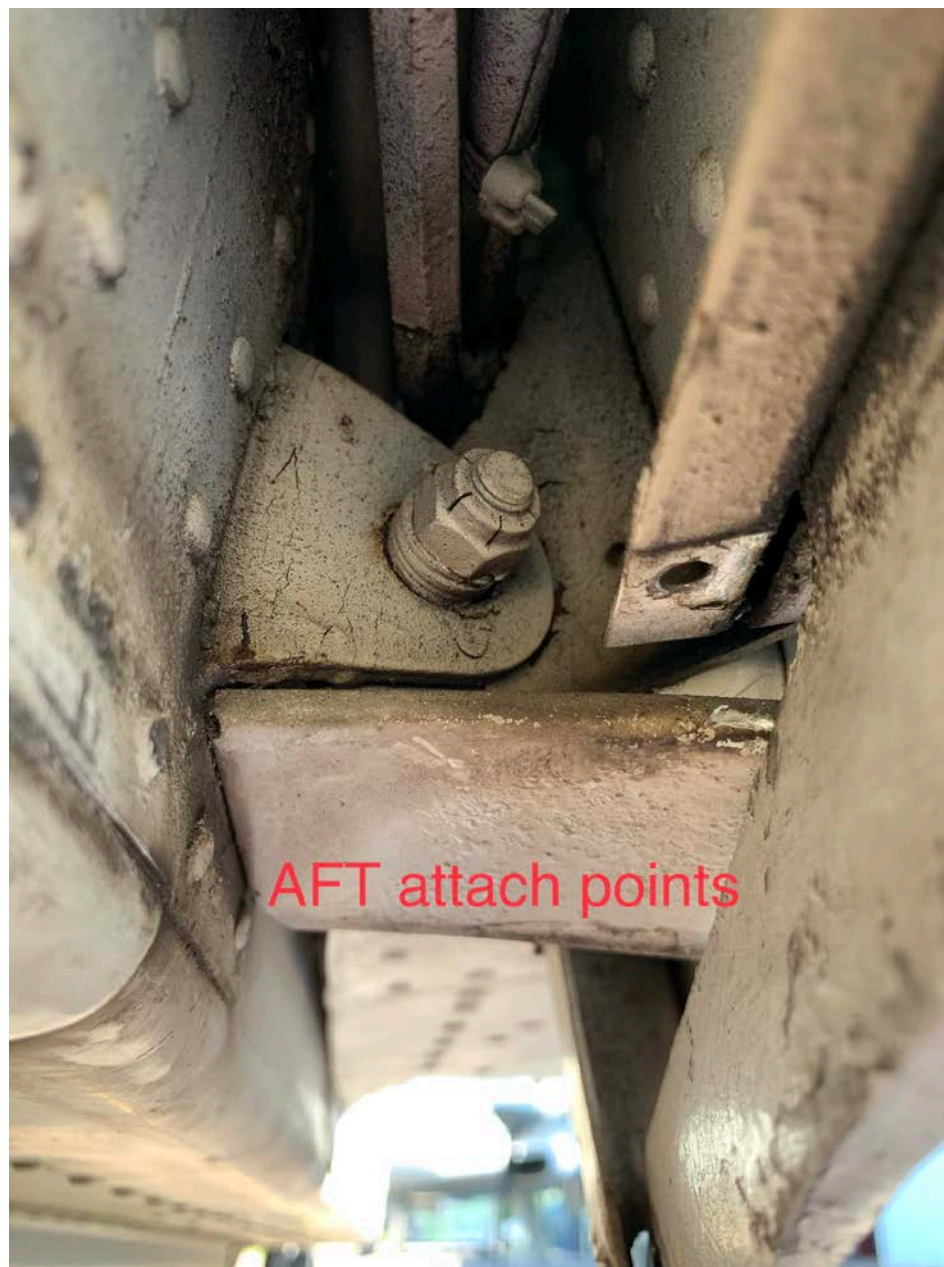
**Photo 1 – View facing toward the tail of damage to the aft left wing attachment points (Courtesy of FAA)**
