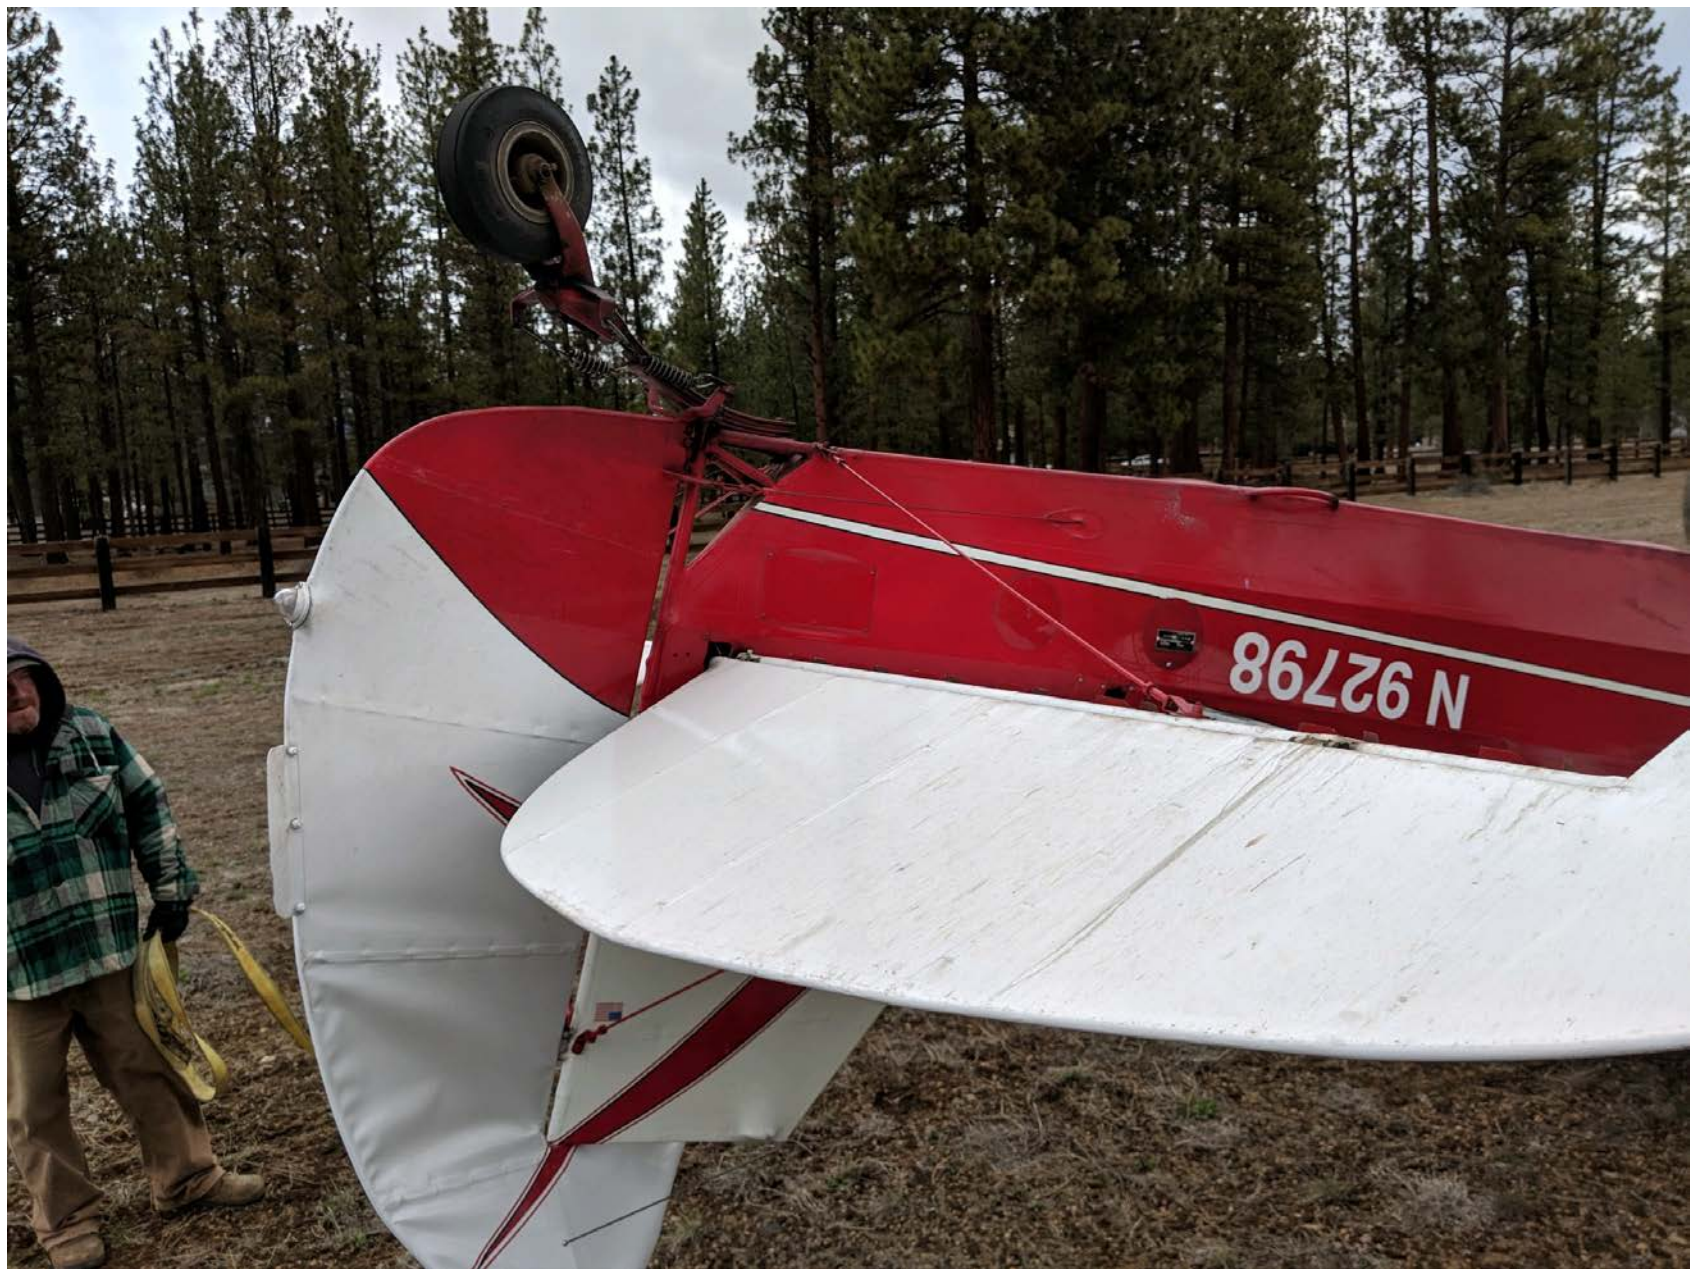
**Photo 1 – View of damage to the rudder (Courtesy of FAA)**

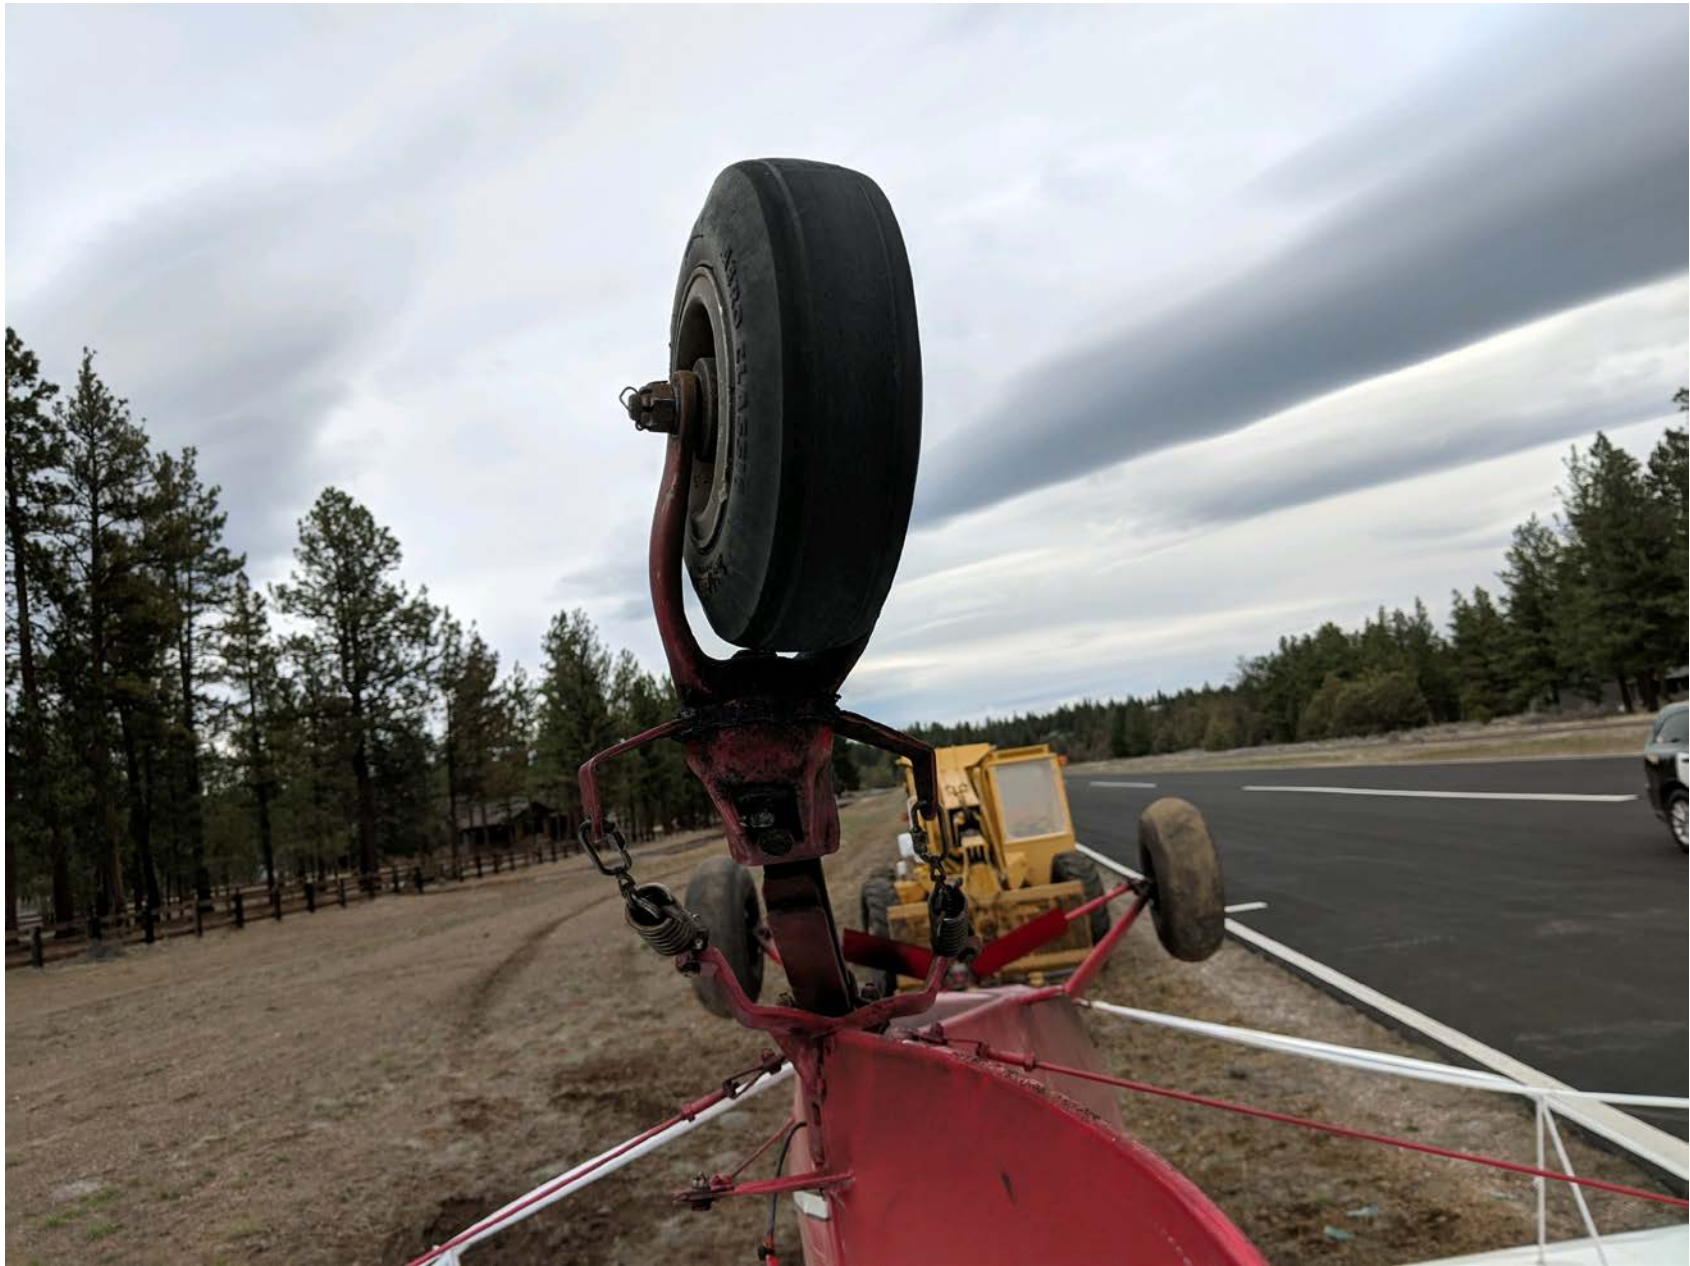
**Photo 2 – View of the rudder horns still attached while the airplane is inverted (Courtesy of FAA)**
