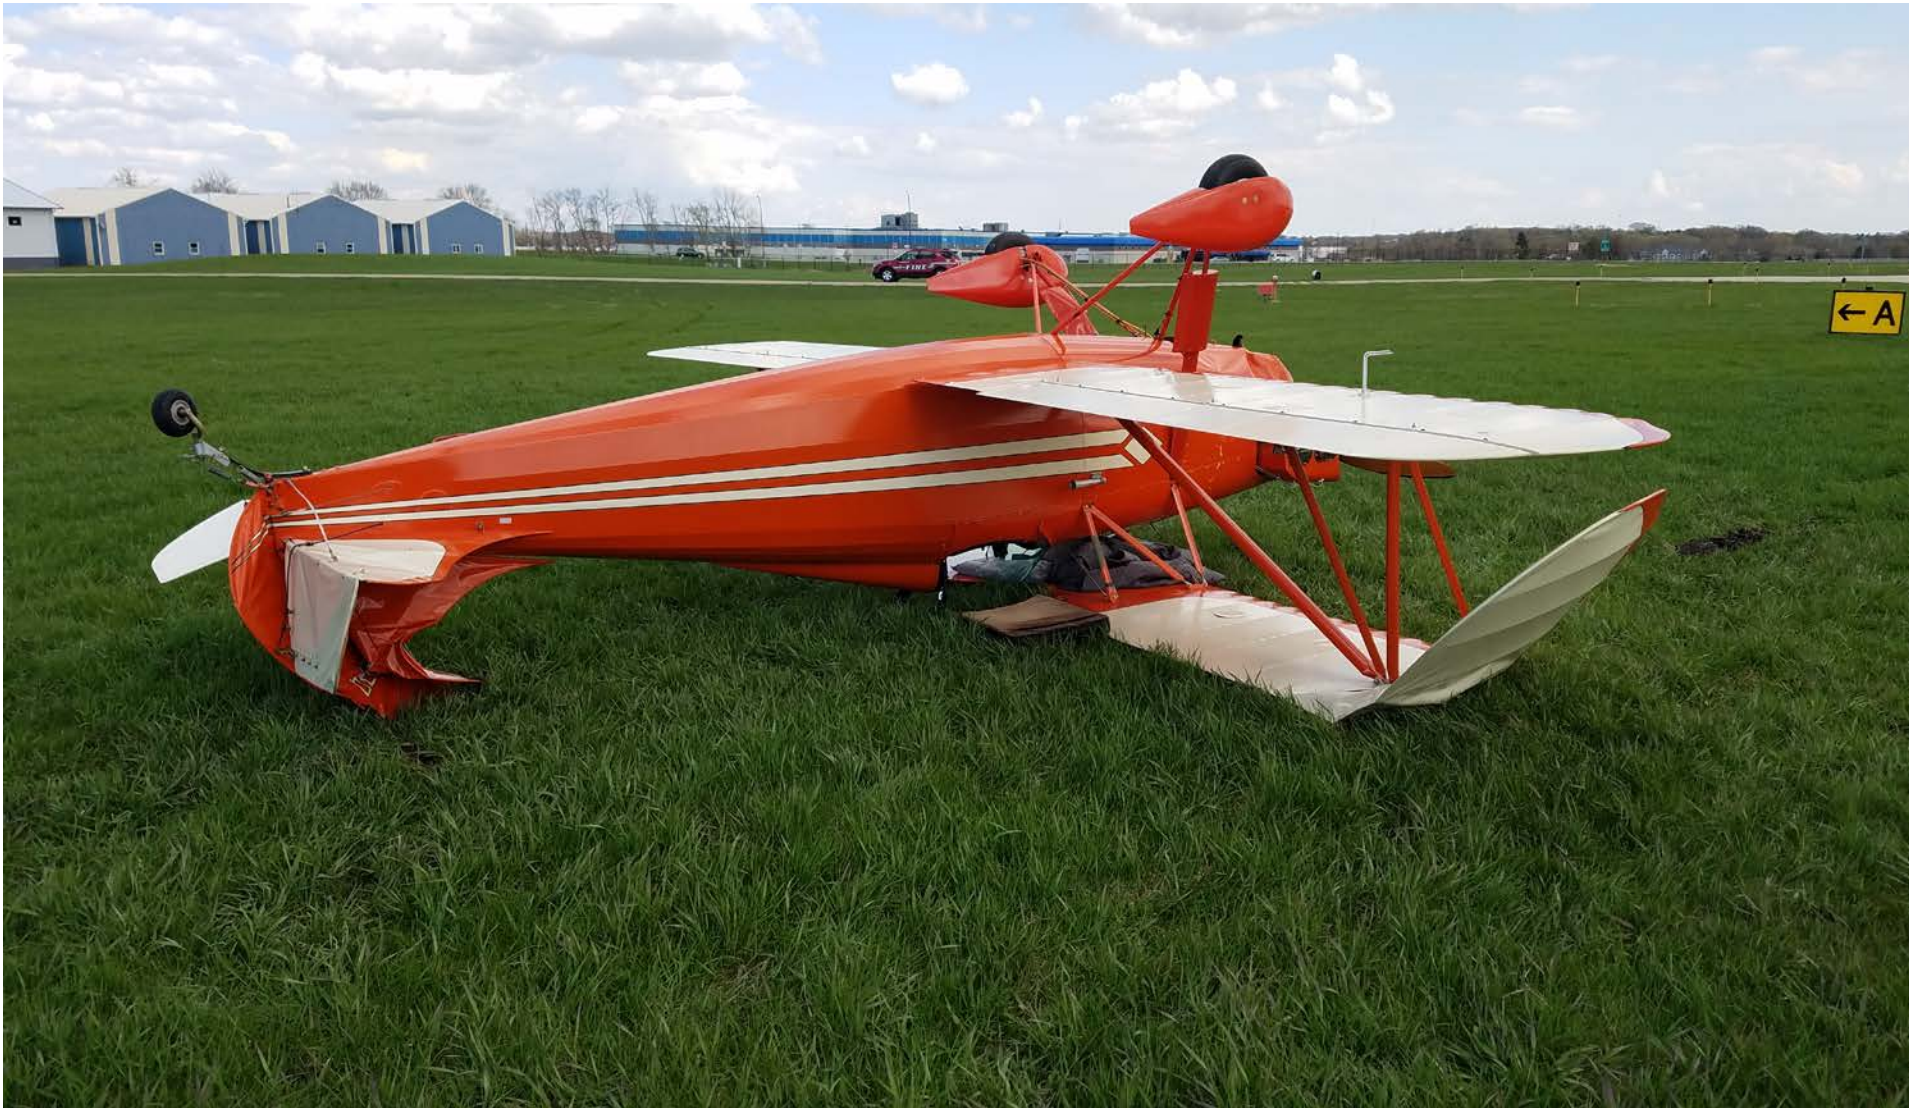
**Photo 1 – View of damaged left wing and empennage (courtesy of the pilot)**
