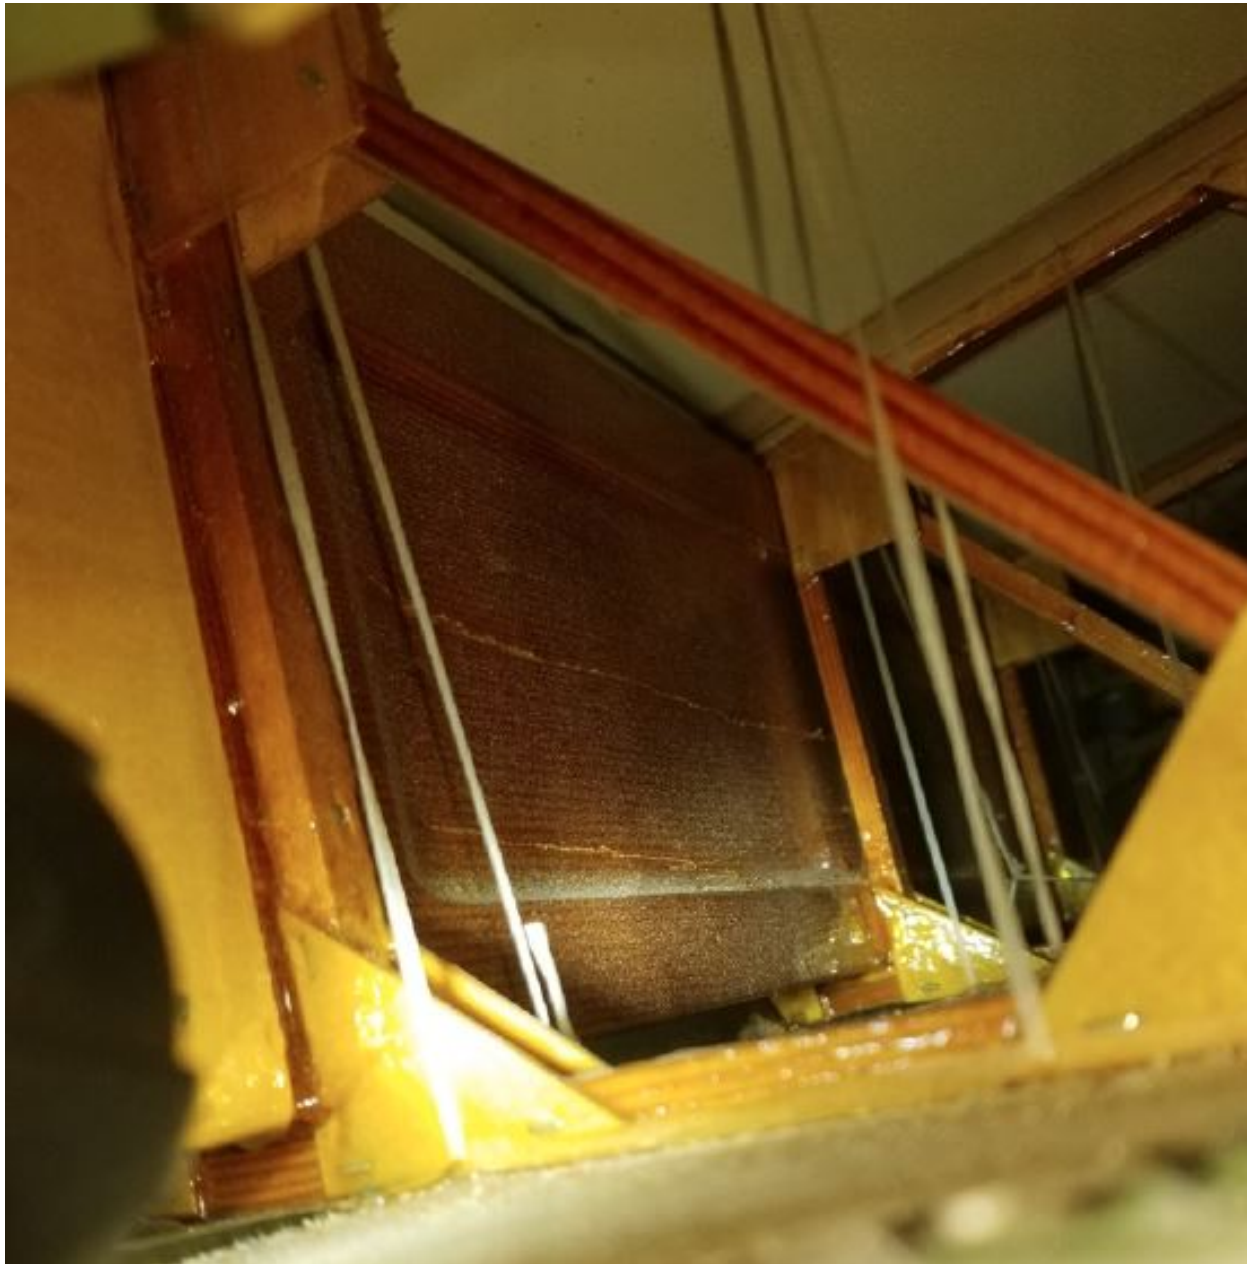
**Photo 1 – View of horizontal crack to left lower wing spar (courtesy of the FAA)**
