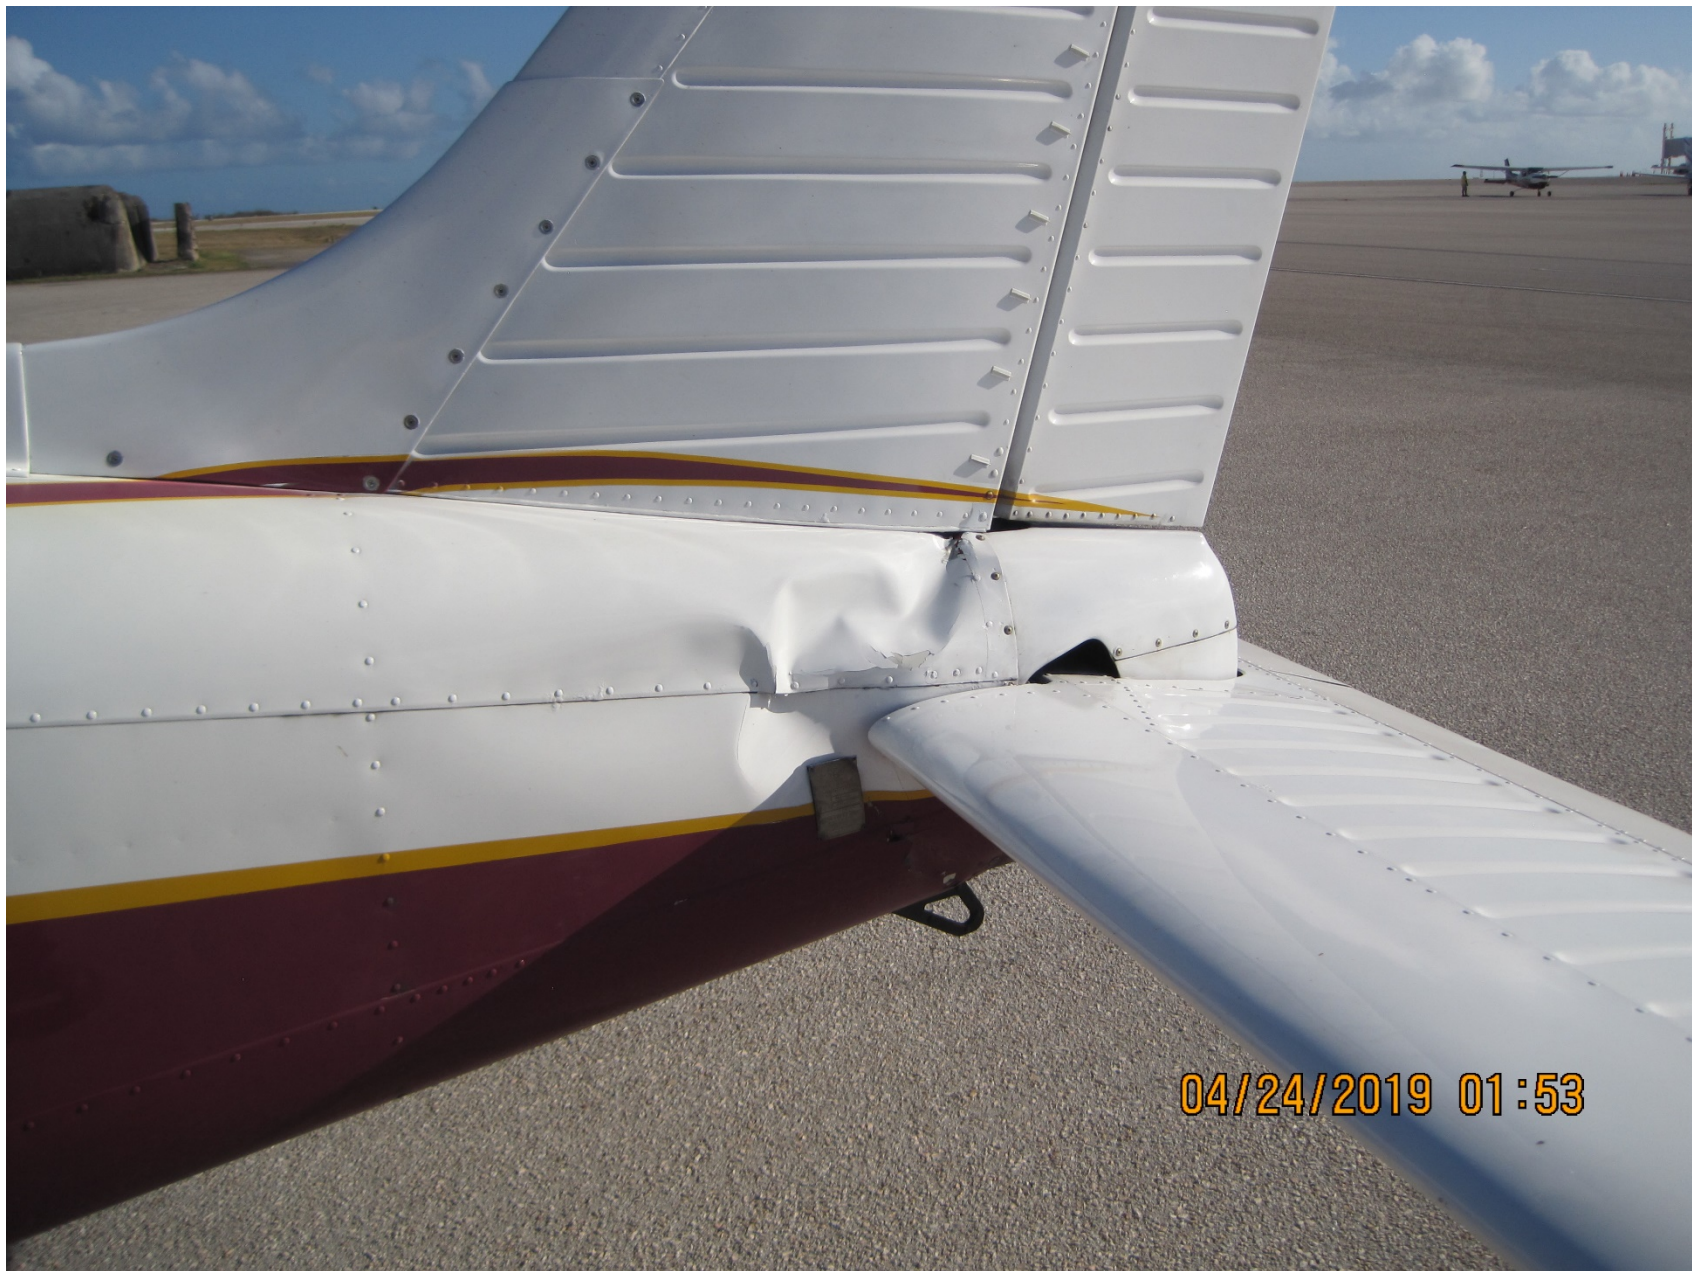
**Photo 1 – View of damaged empennage from left side (Photo courtesy of the FAA)**
