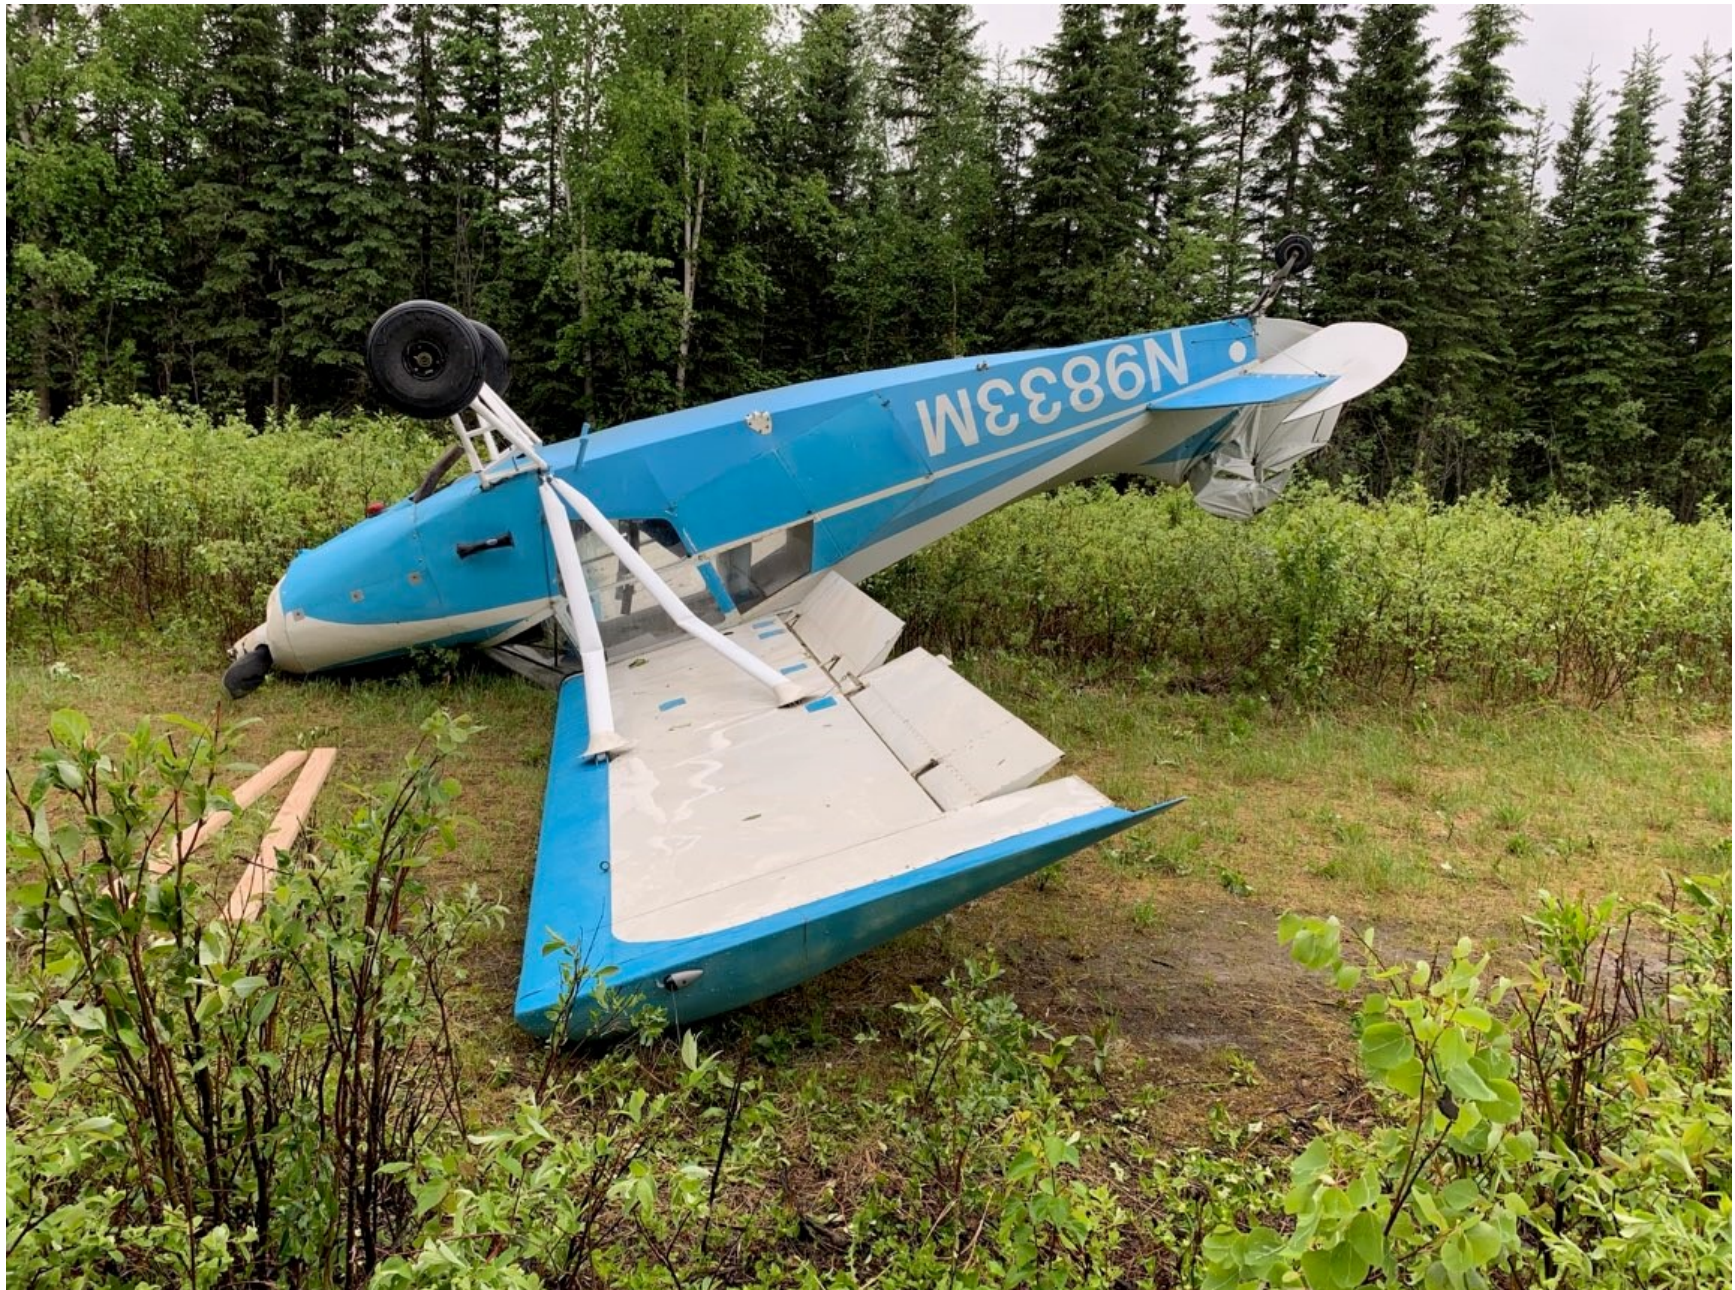
**Photo 1 – View of inverted airplane with damaged right wing lift strut and empennage (Photo courtesy unknown)**
