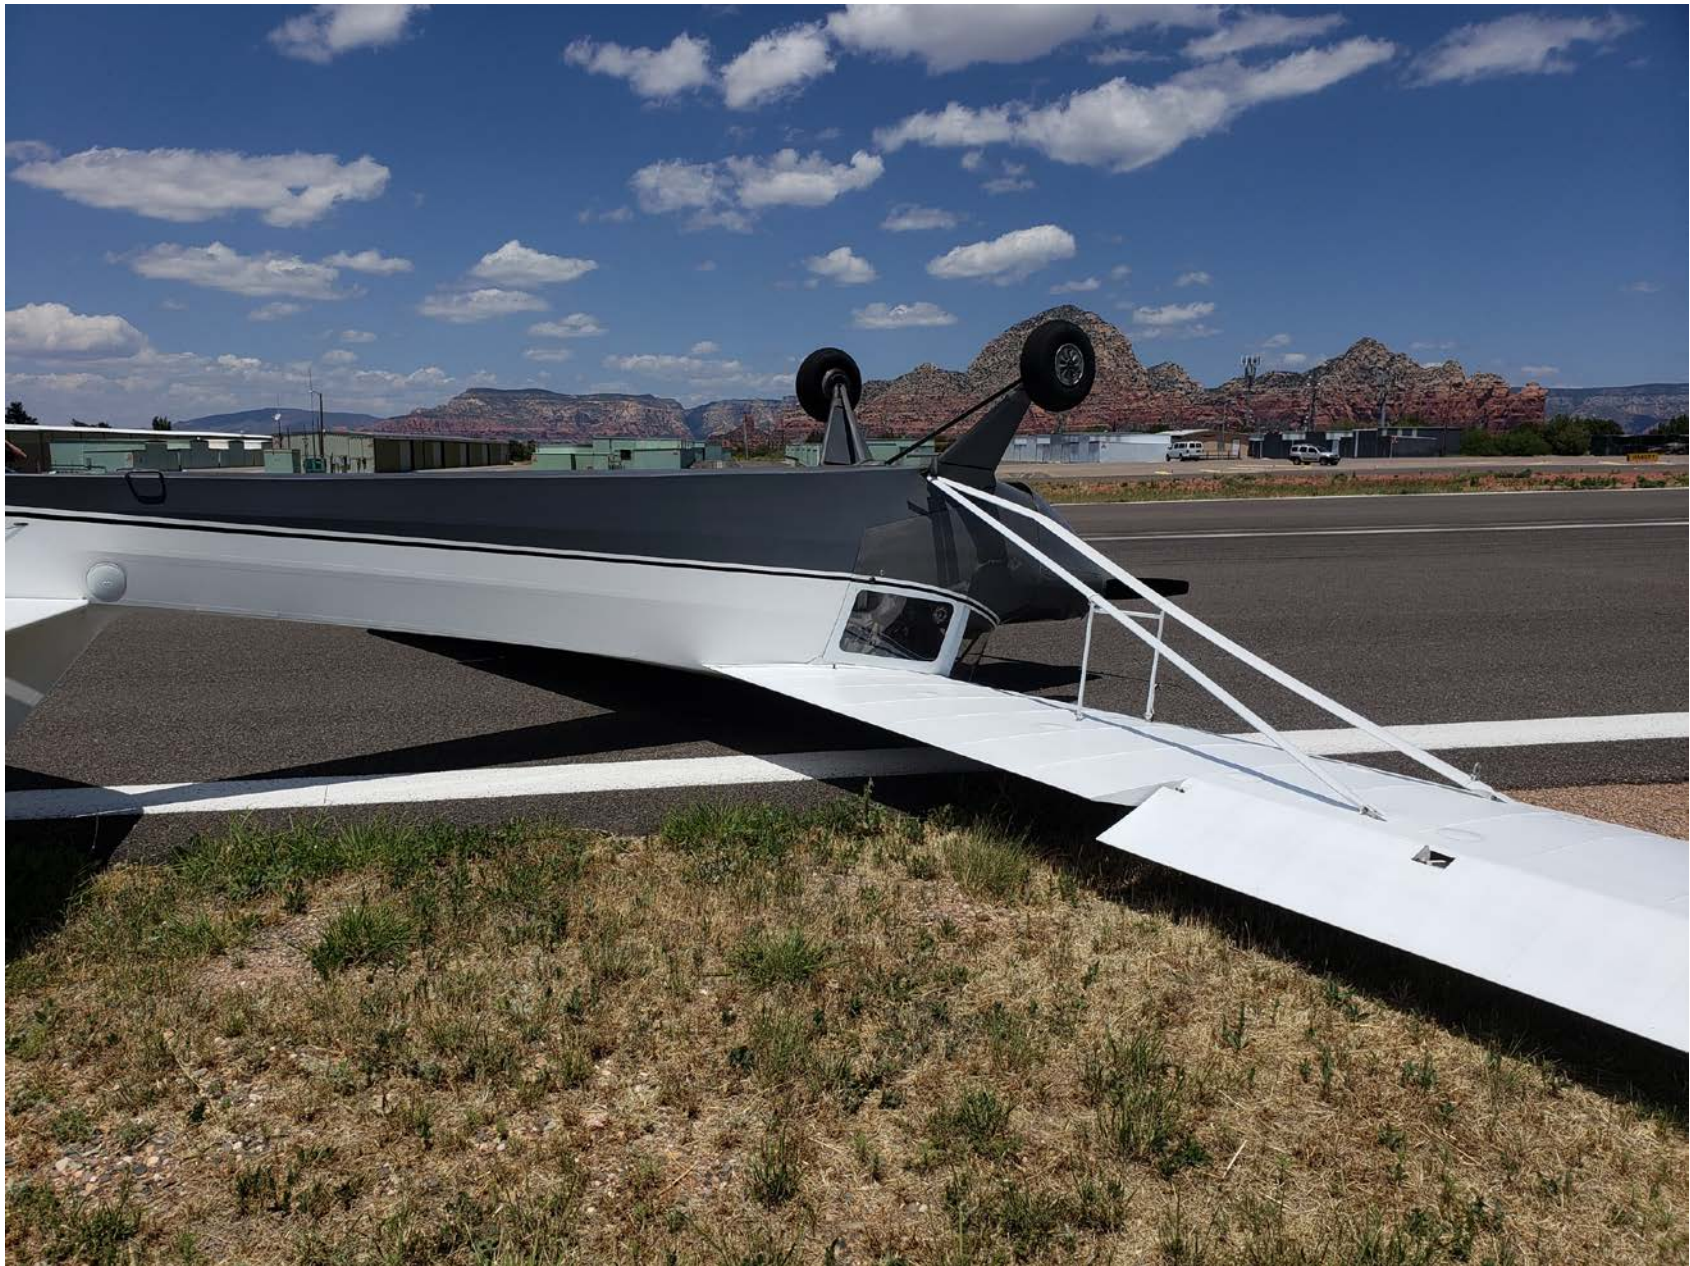
**Photo 1 – View of left wing lift strut damage (photo courtesy of the pilot)**
