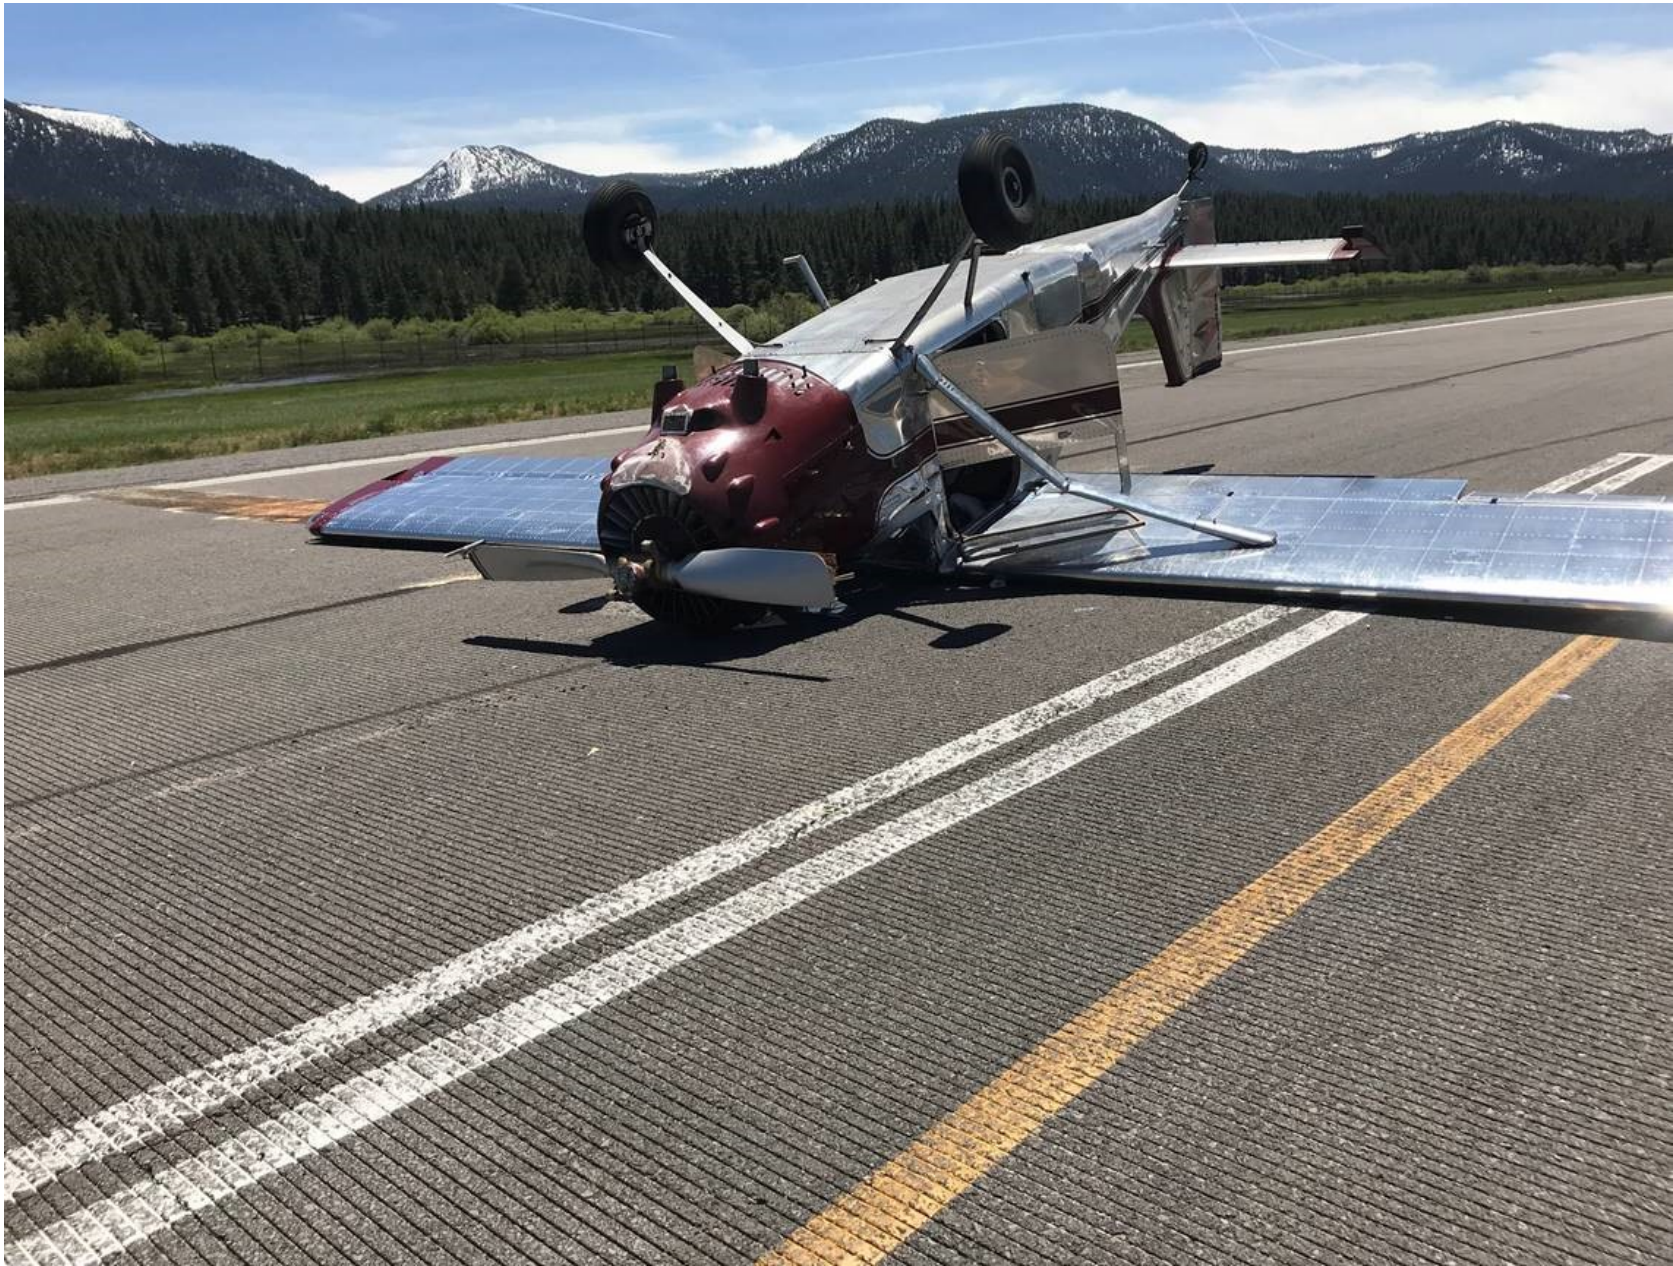
**Photo 1 – View of damage to the right wing lift strut and rudder (Courtesy of FAA)**
