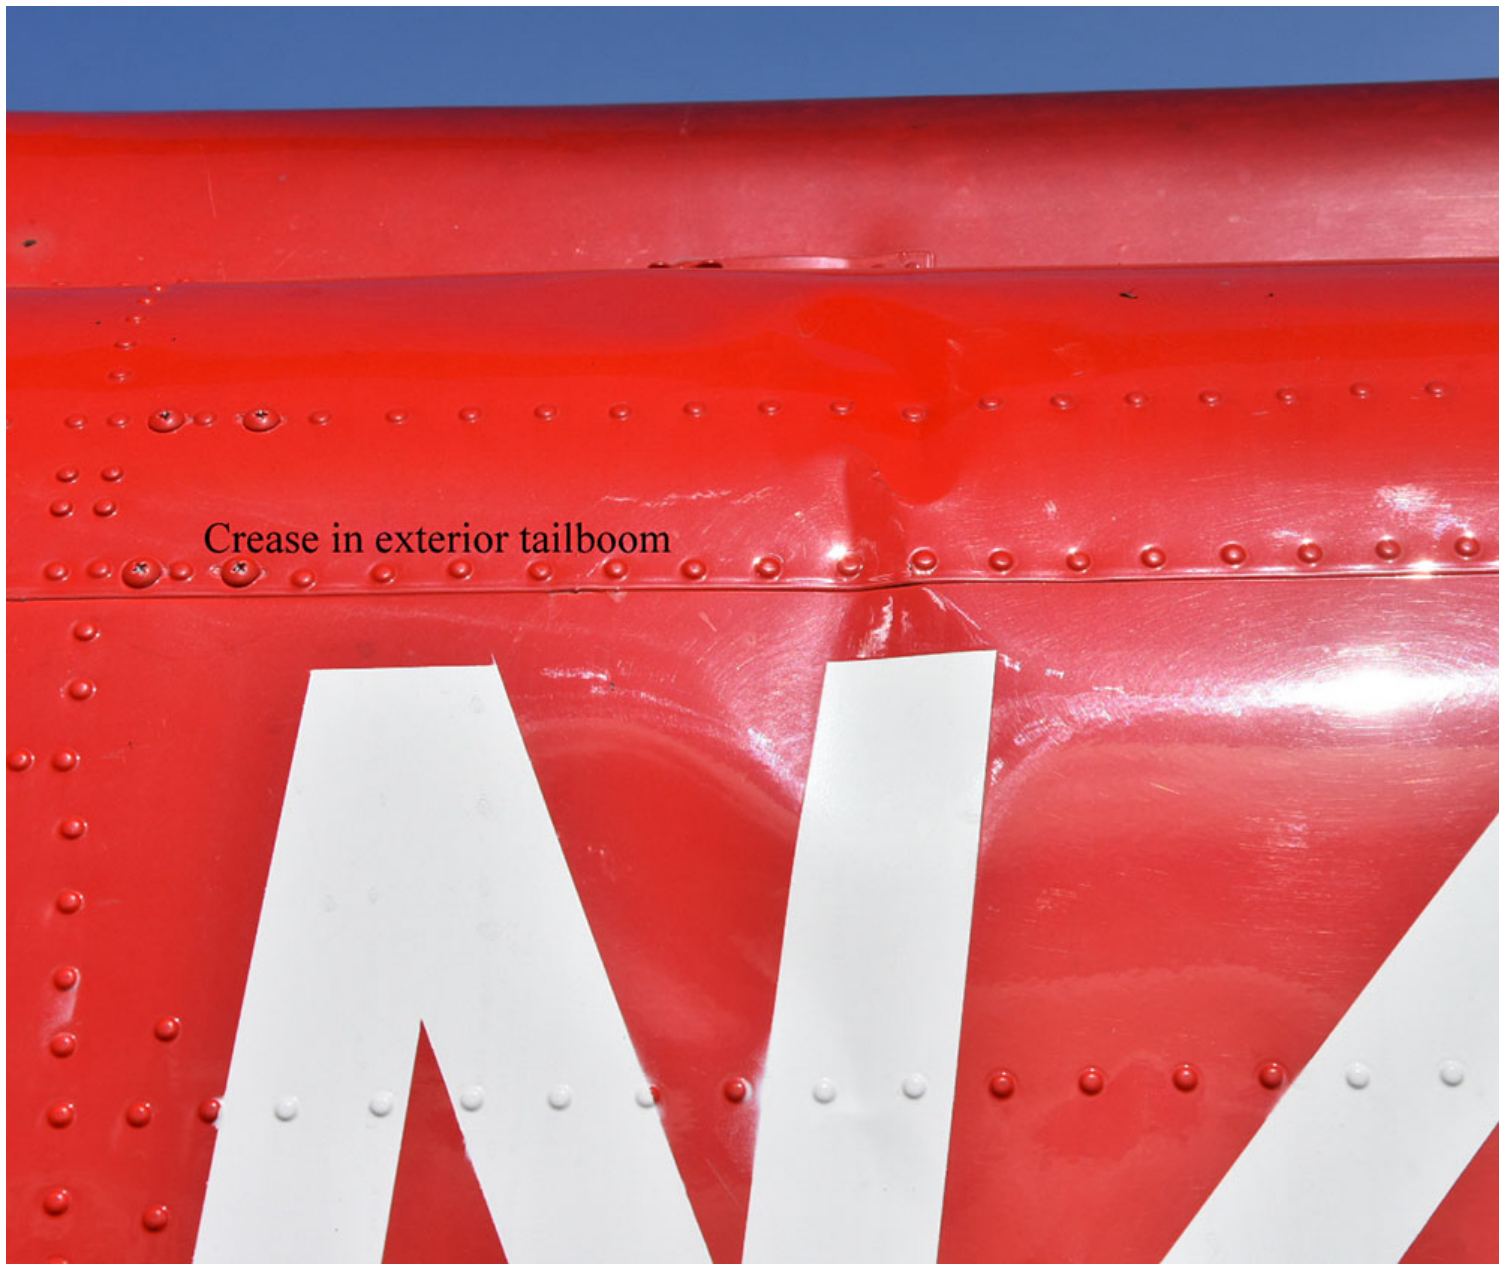
**Photo 1 – View of damaged tailboom (Photo courtesy of the FAA)**

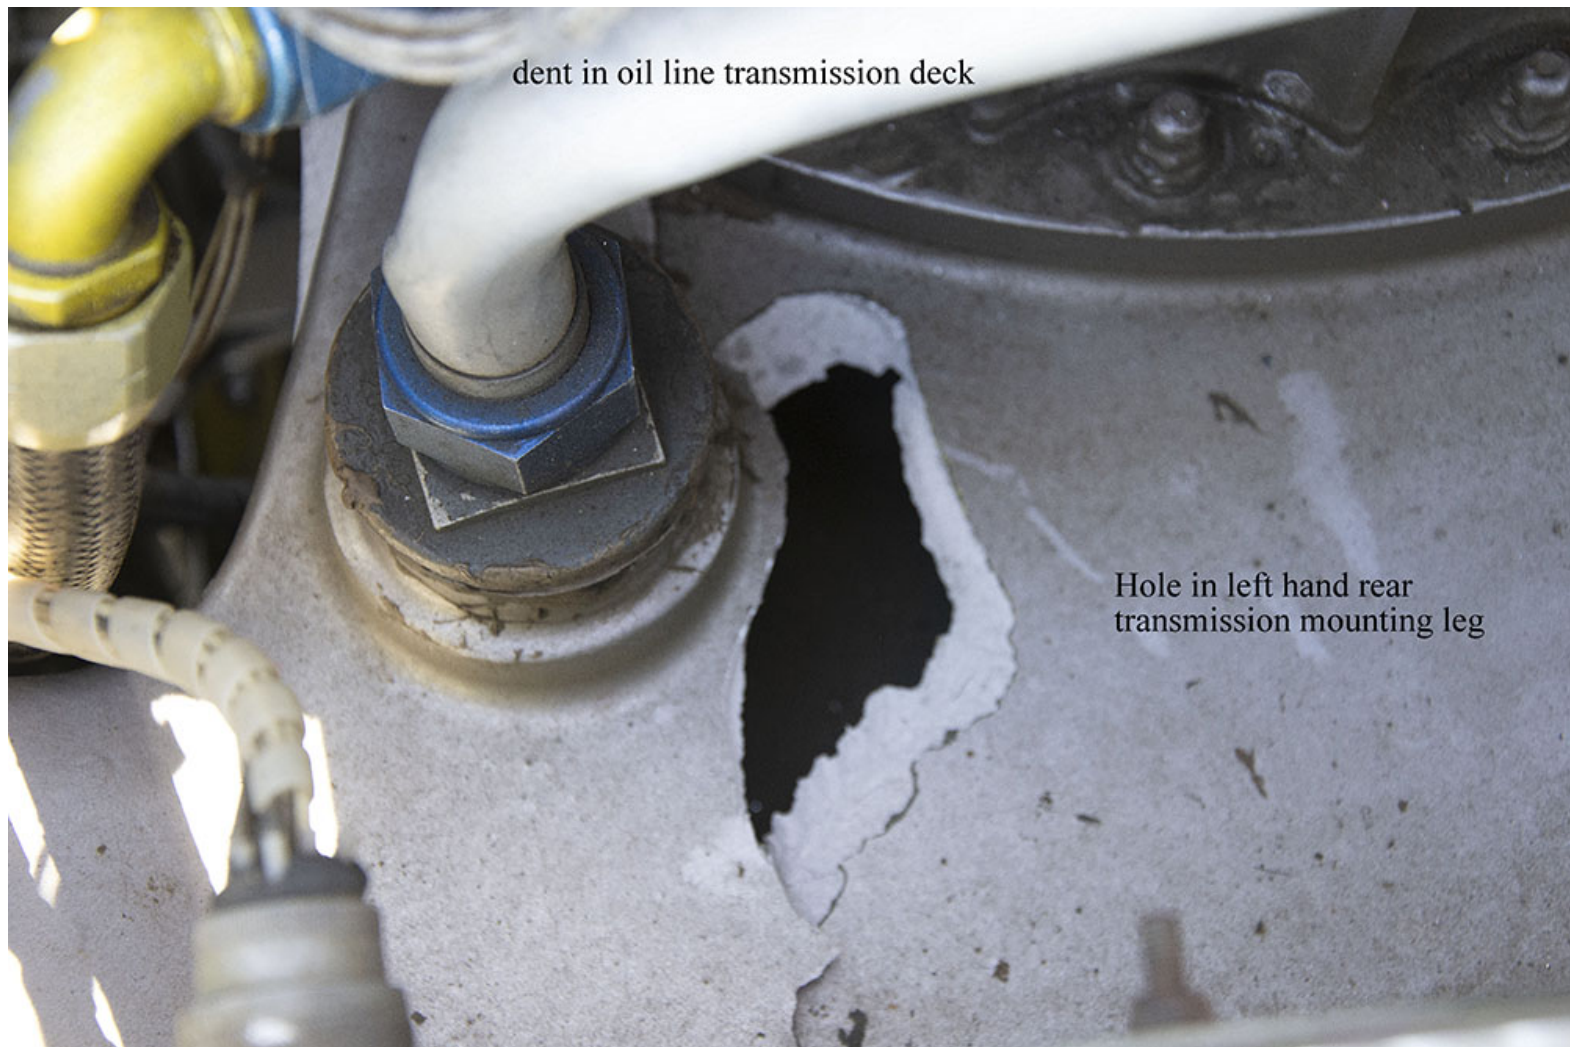
**Photo 2 – View of damaged transmission mounts (Photo courtesy of the FAA)**
