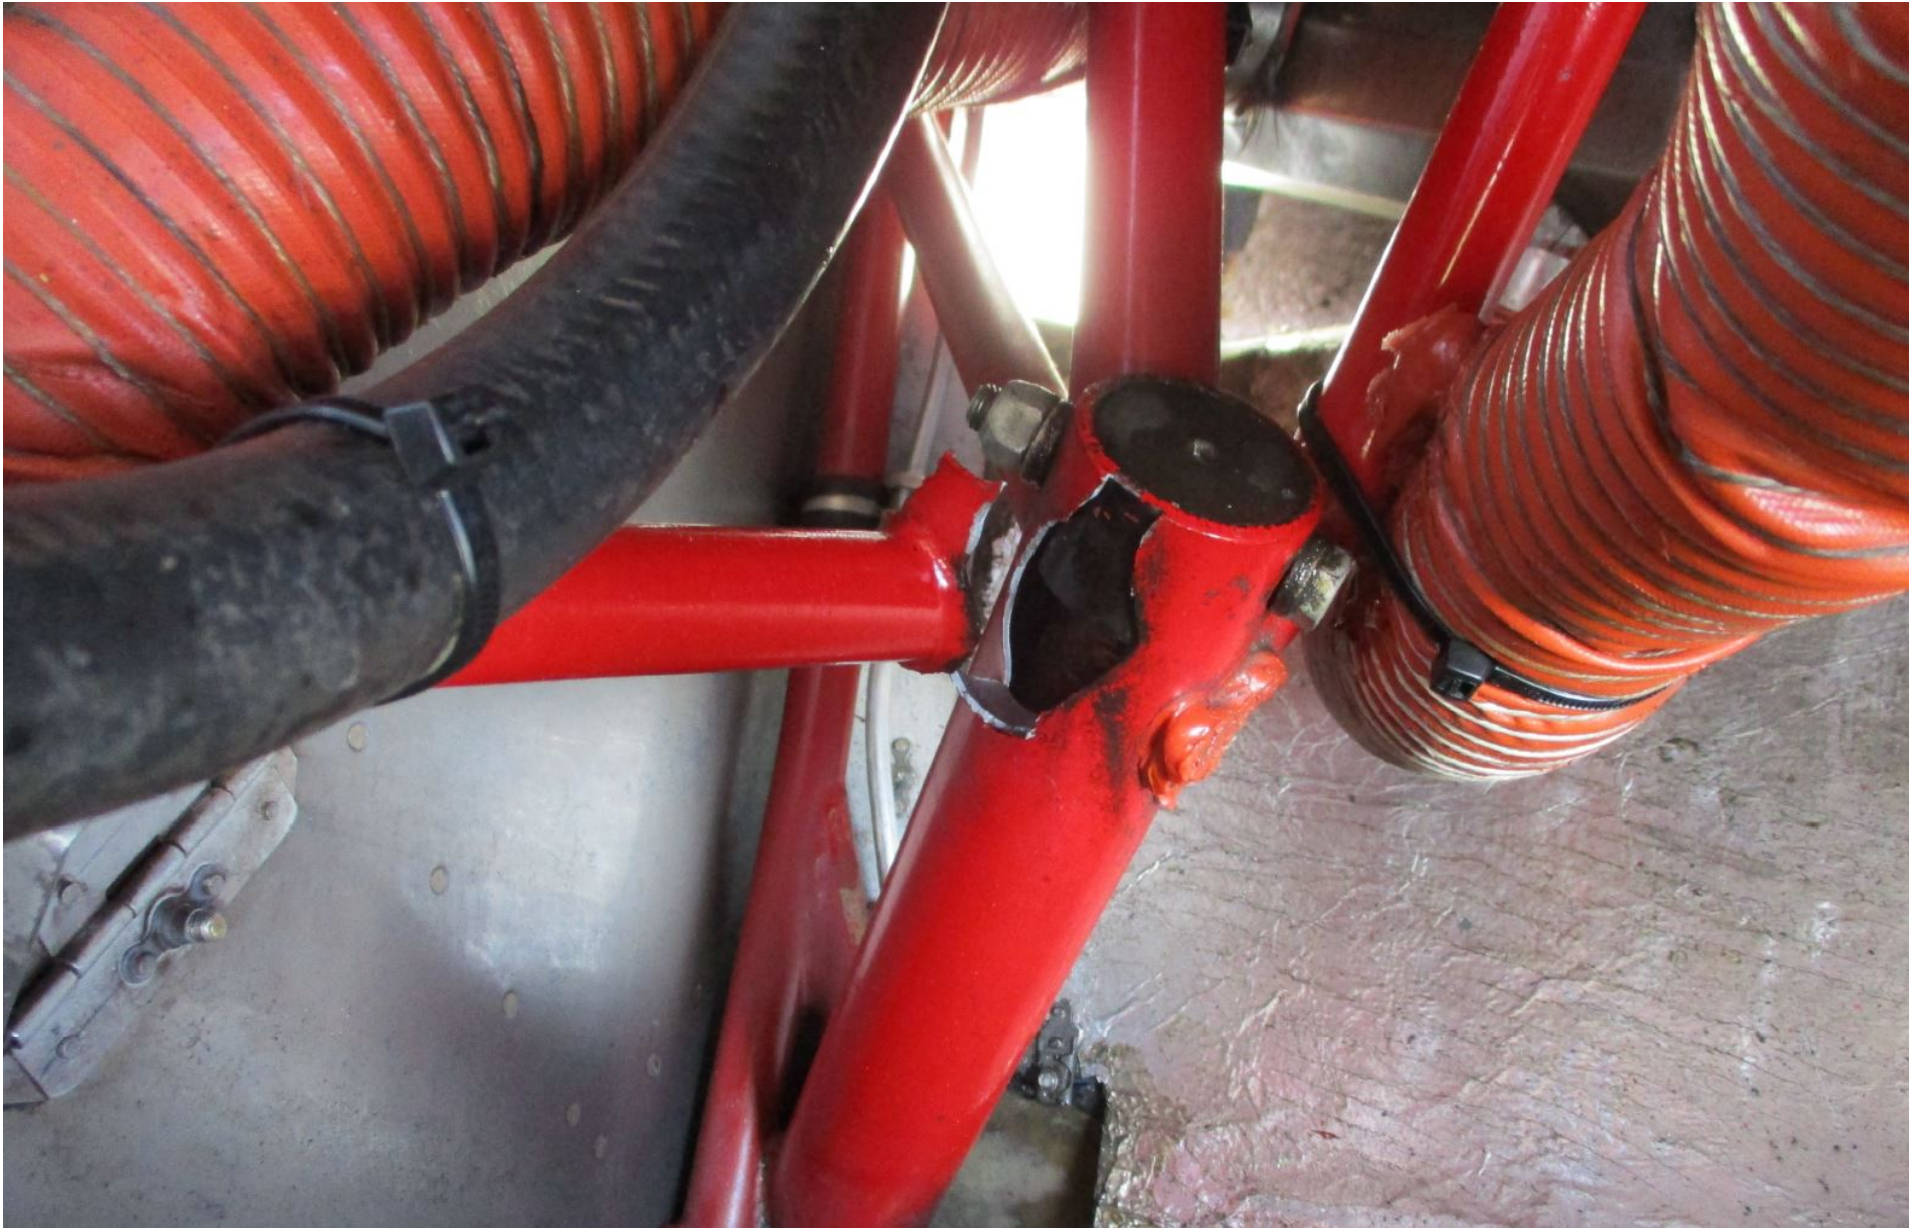
**Photo 1 – View of damaged engine mount (courtesy of the FAA)**
