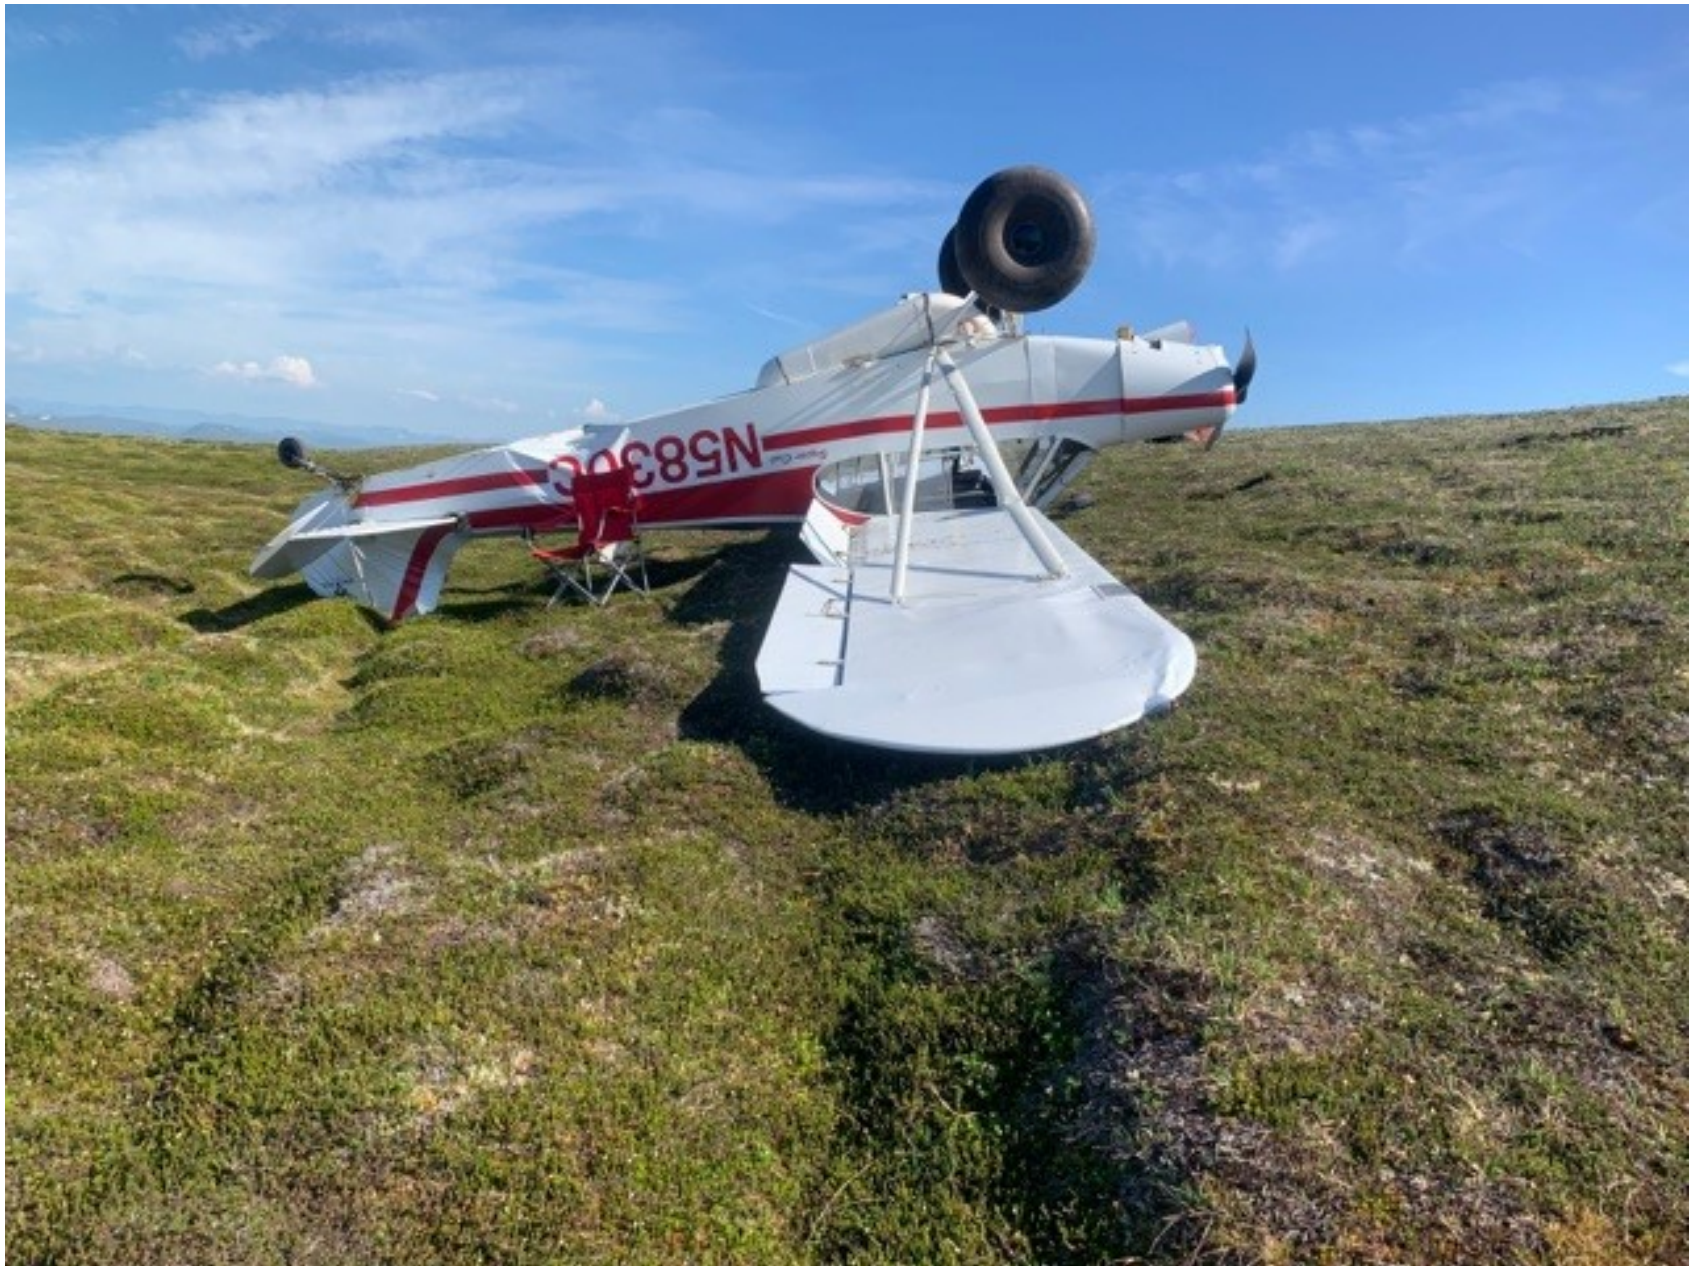
**Photo 1 – View of fuselage and wing lift strut damage (photo courtesy of the FAA)**
