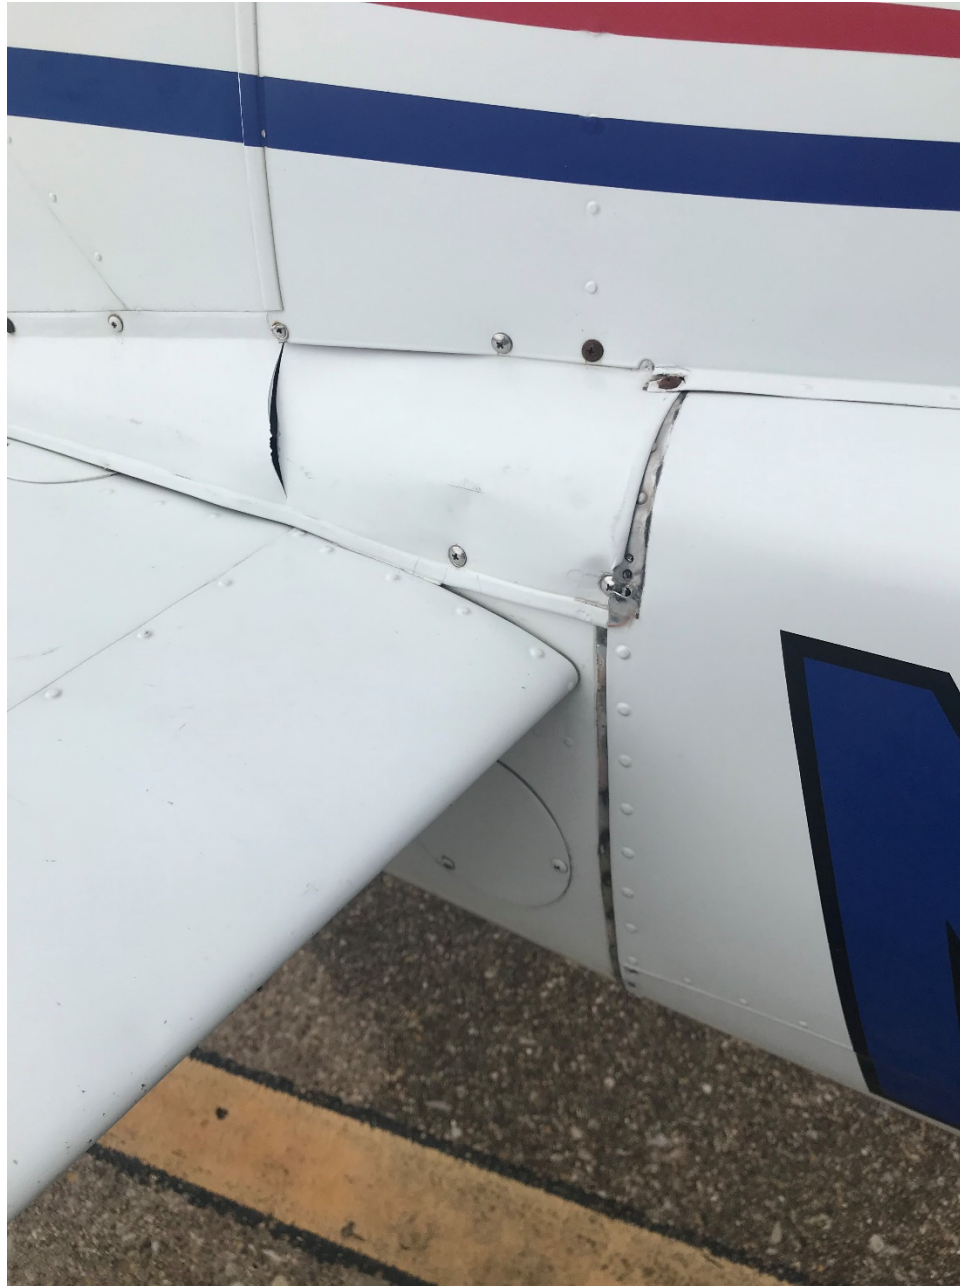
**Photo 1 – View of empennage damage (Photo courtesy of the FAA)**

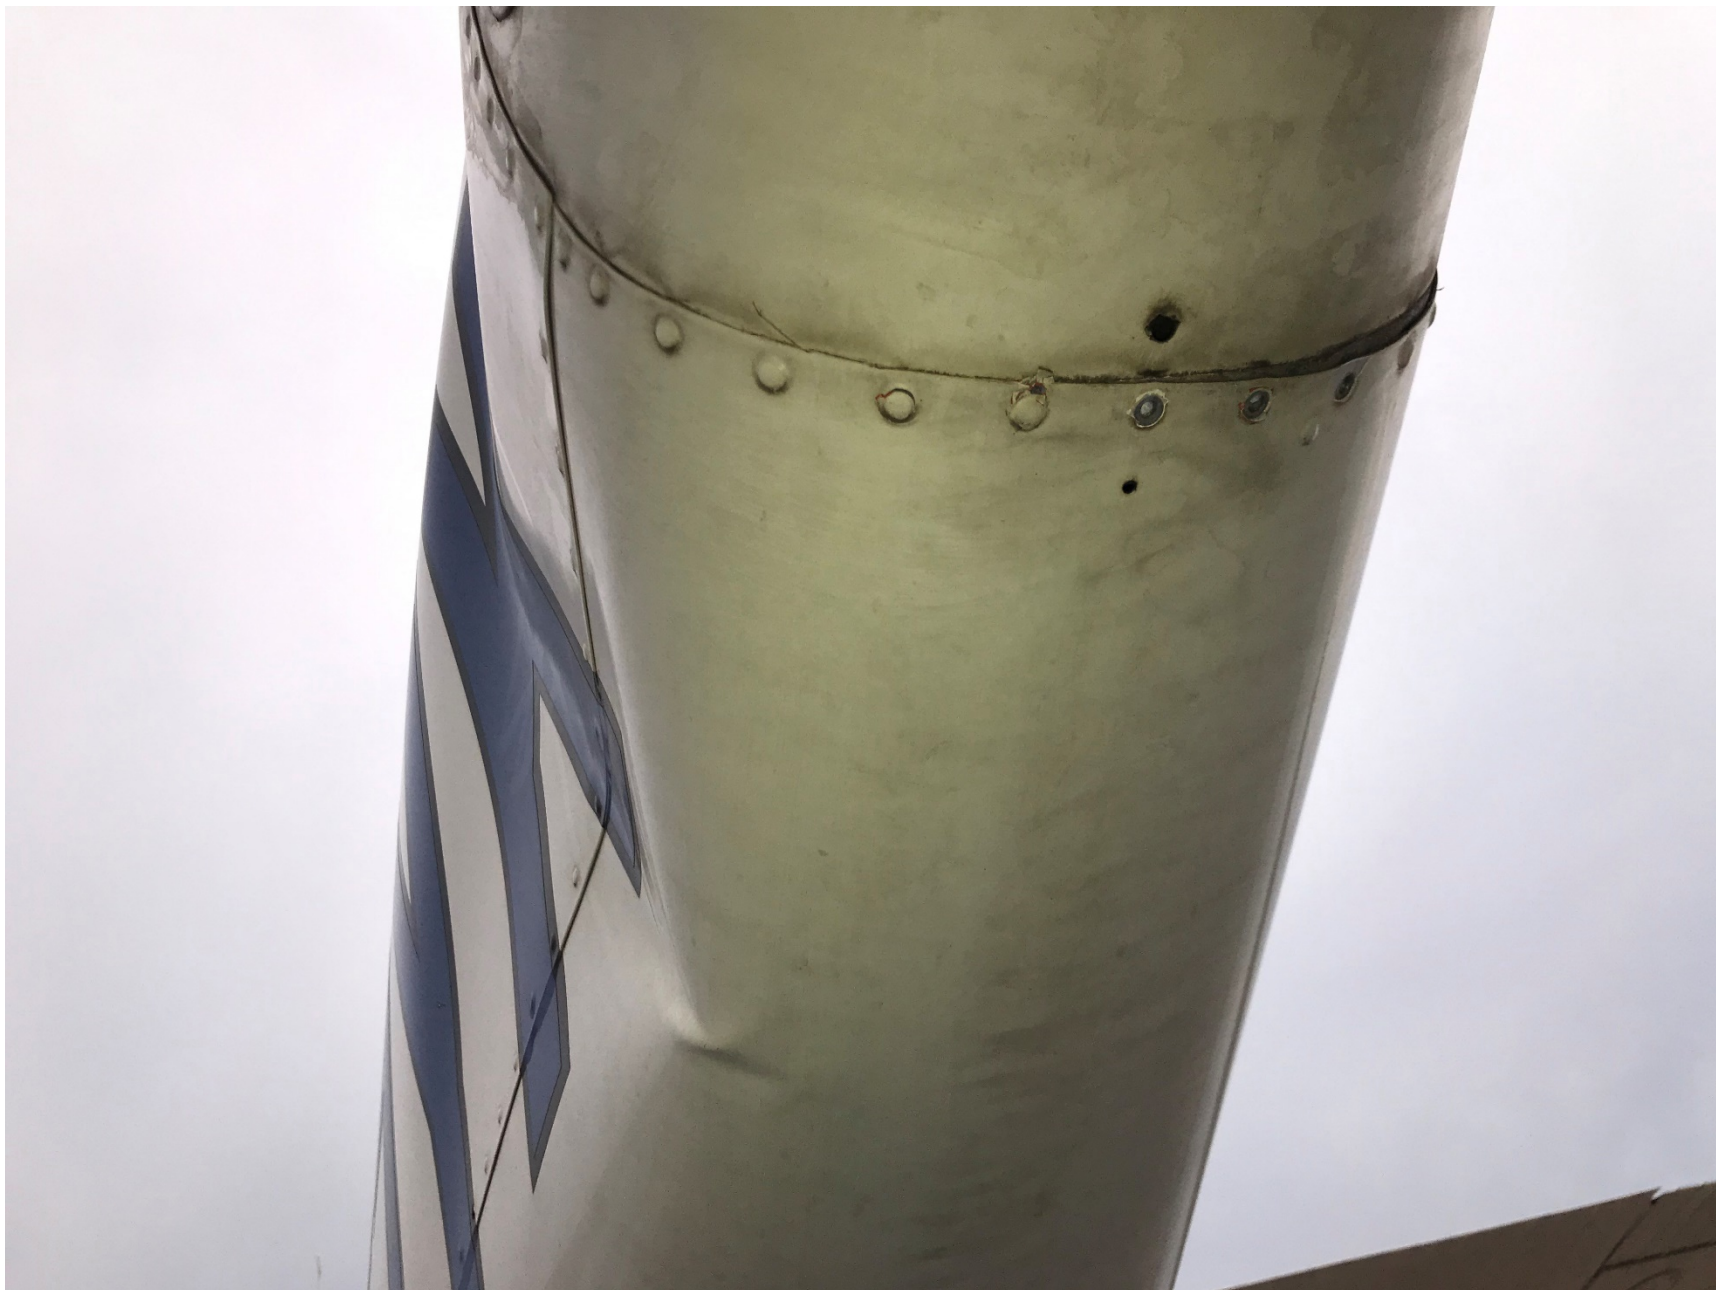
**Photo 2 – View of fuselage damage from underneath (Photo courtesy of the FAA)**
