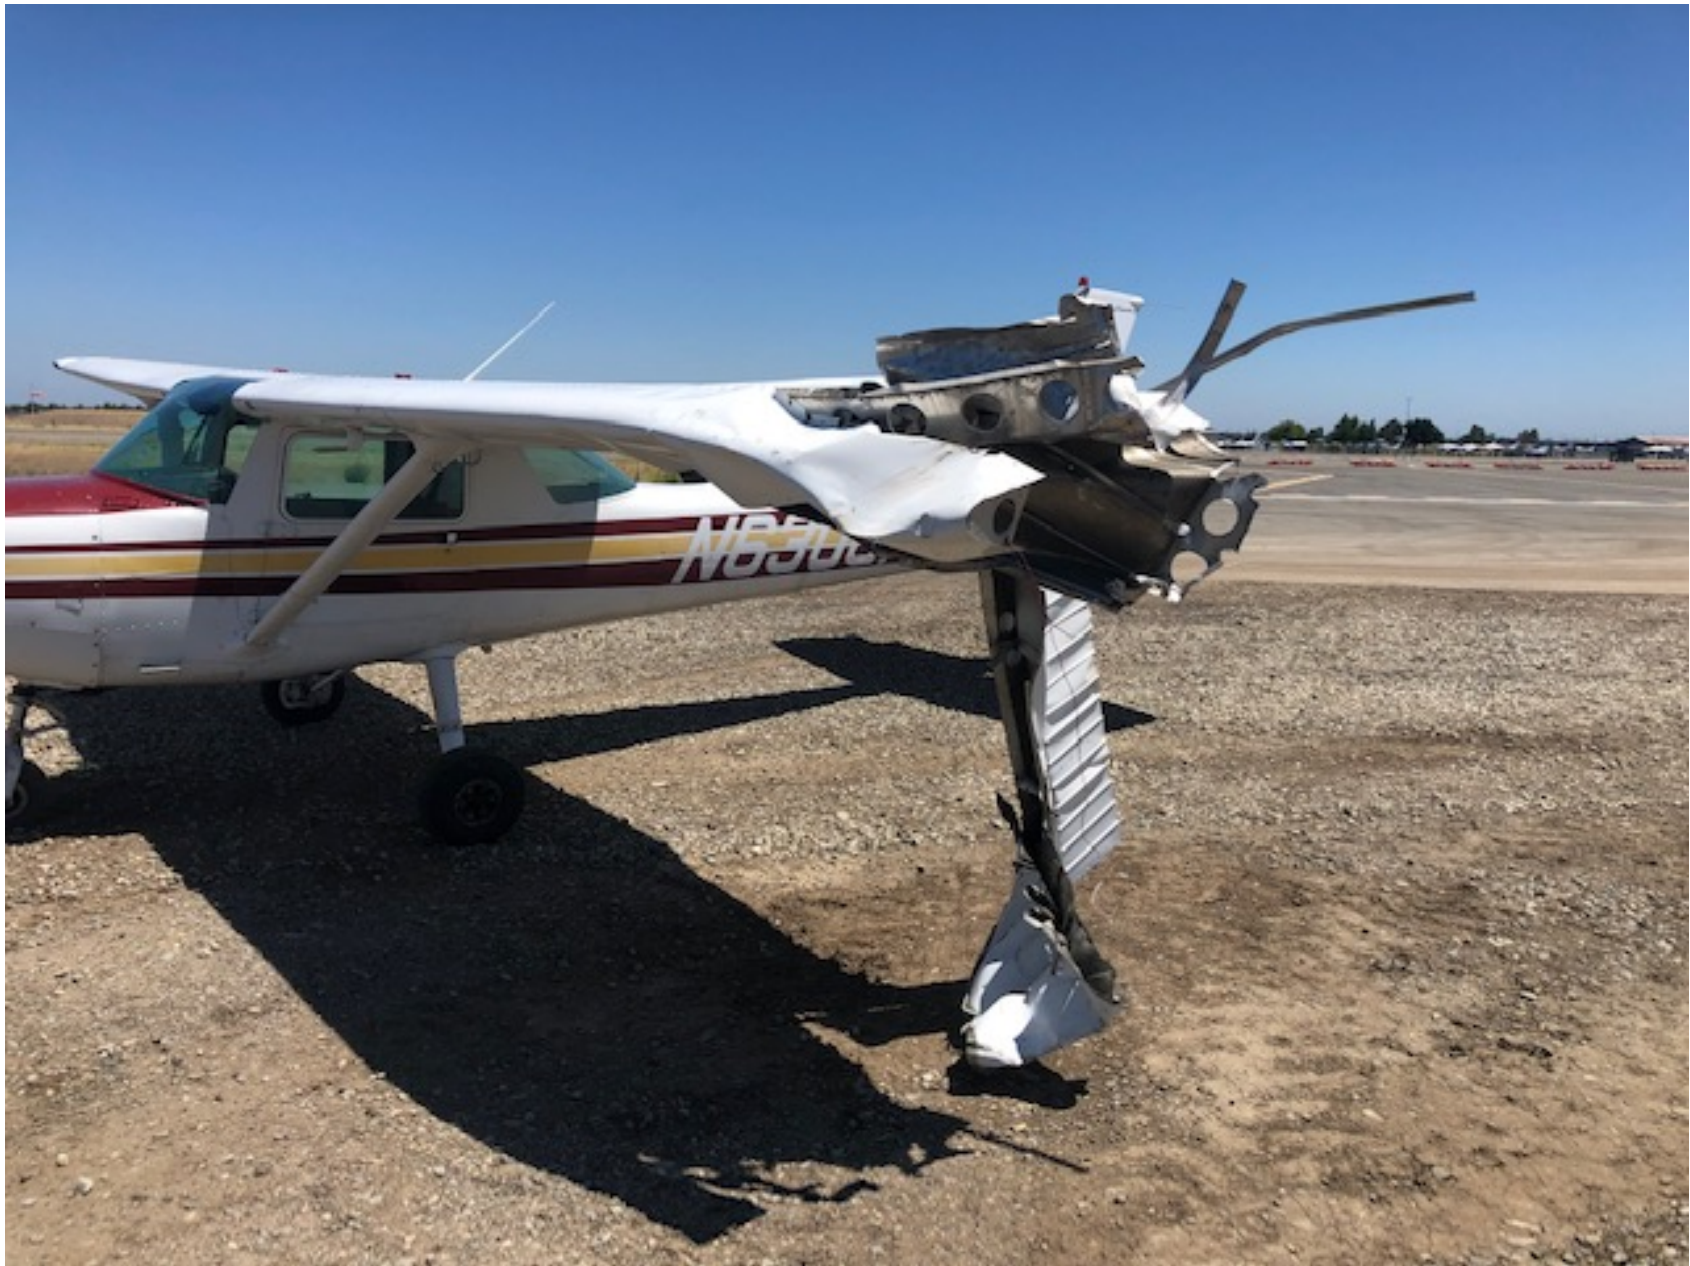
**Photo 1 – View of damaged left wing (courtesy of the operator)**
