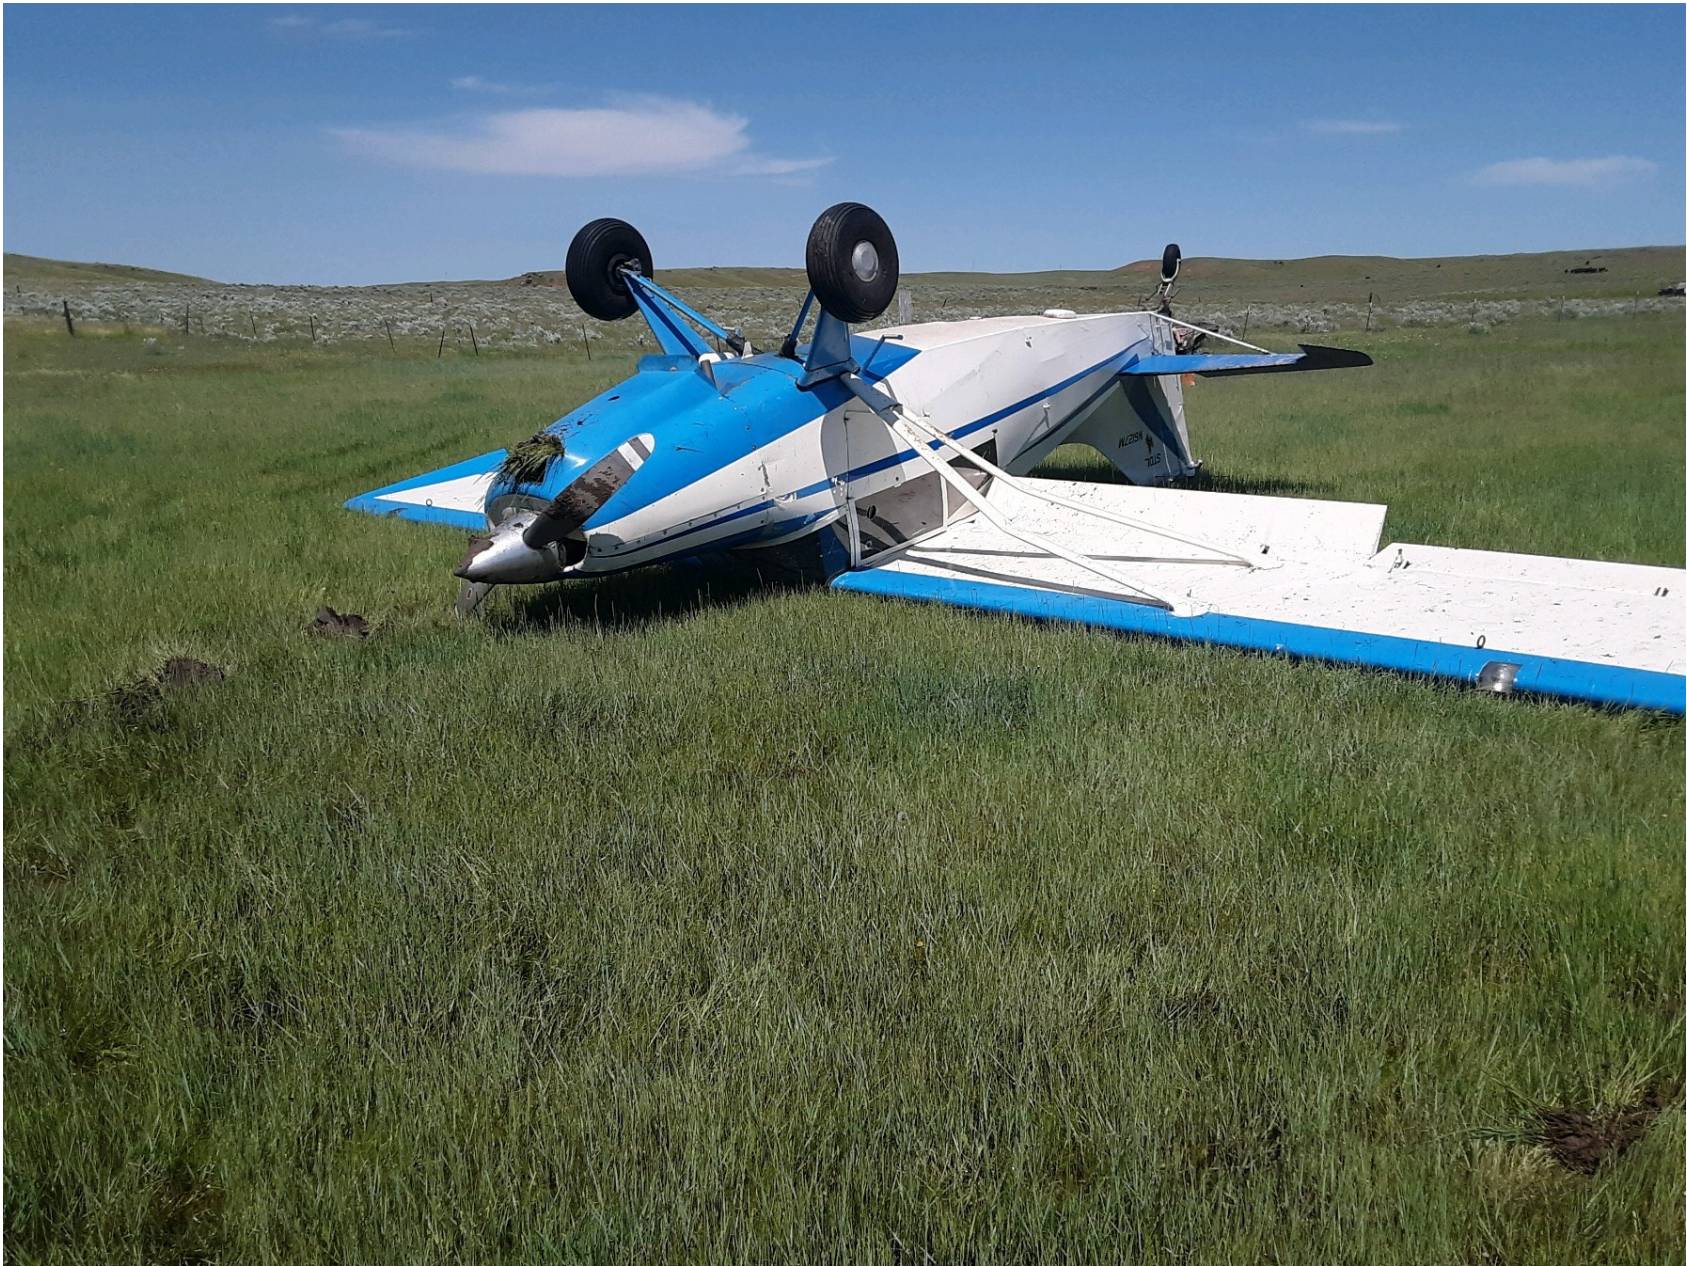
**Photo 1 – View of damaged right-wing lift strut (courtesy of the pilot)**
