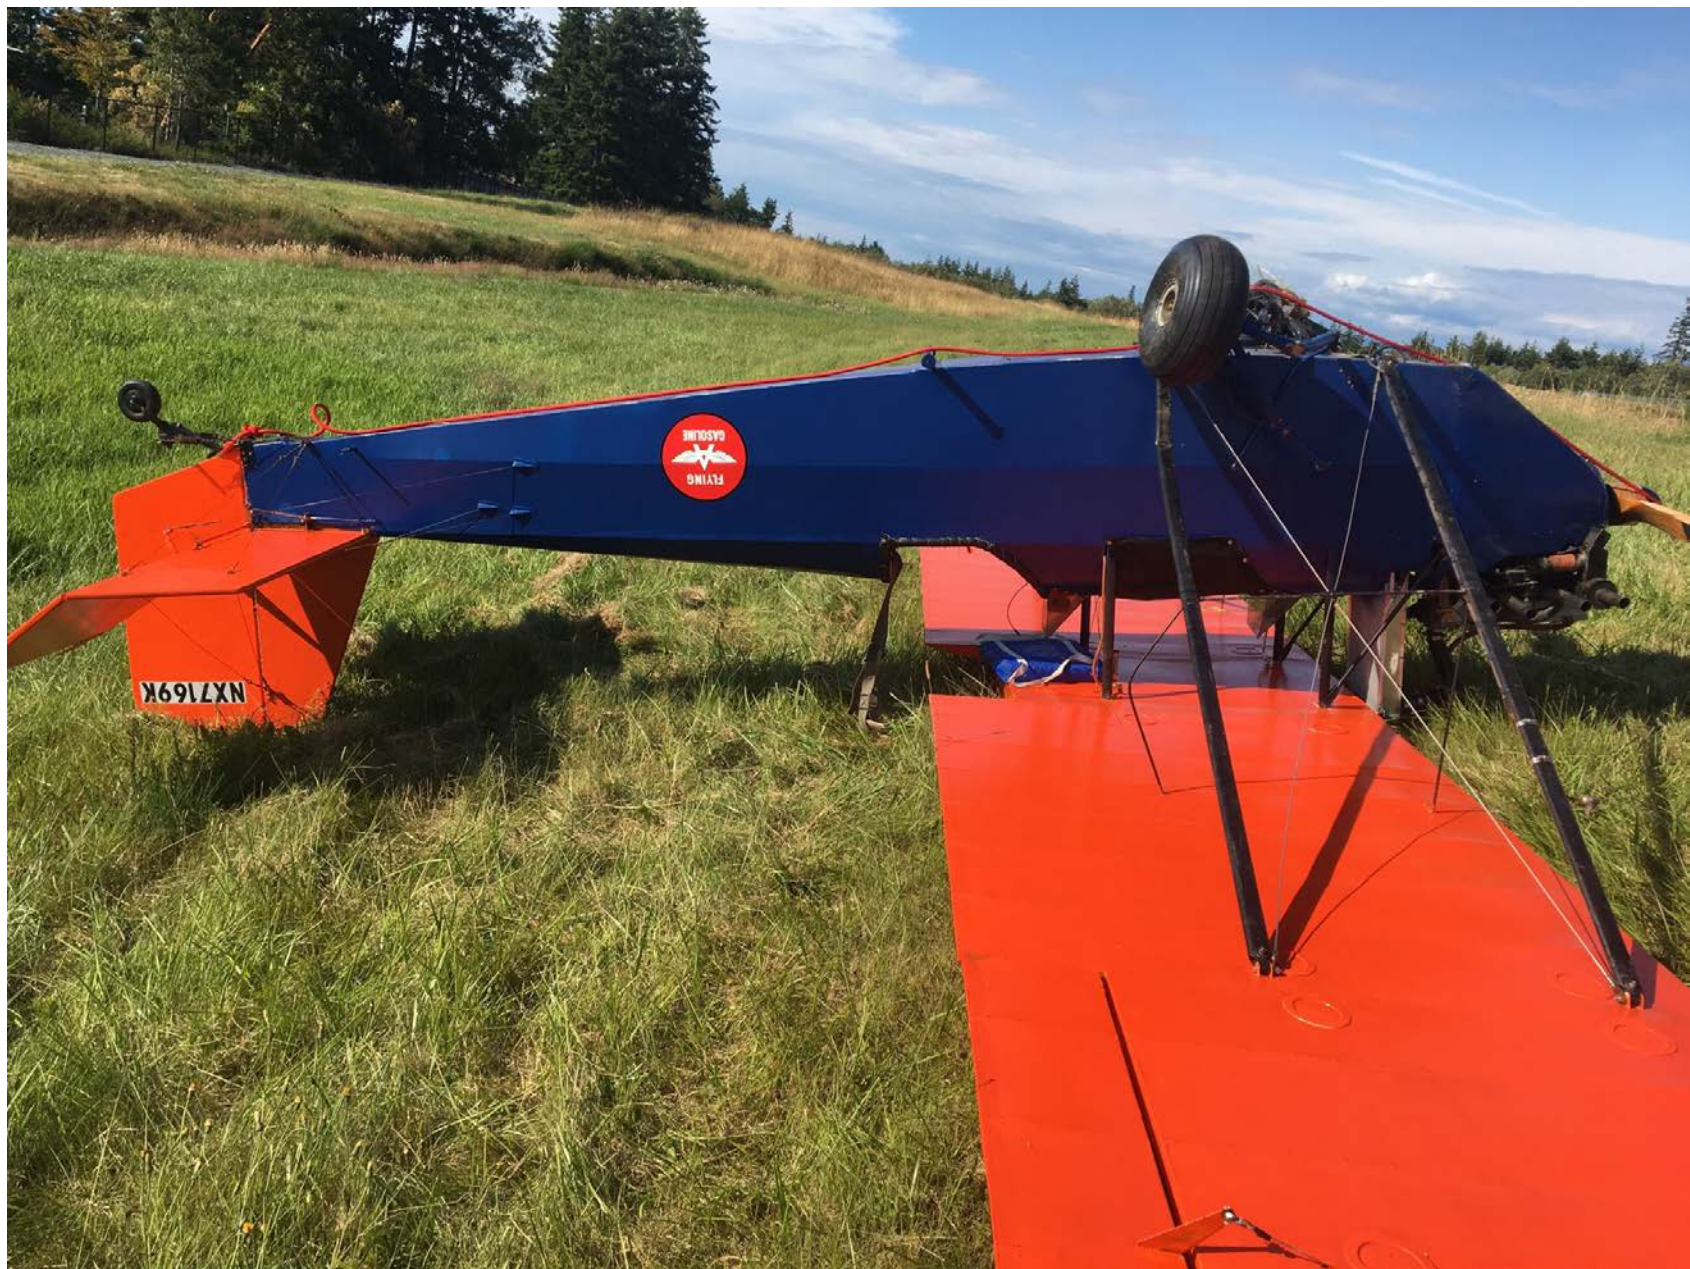
**Photo 1 – View of damage to the left wing lift strut (Courtesy of Operator)**
