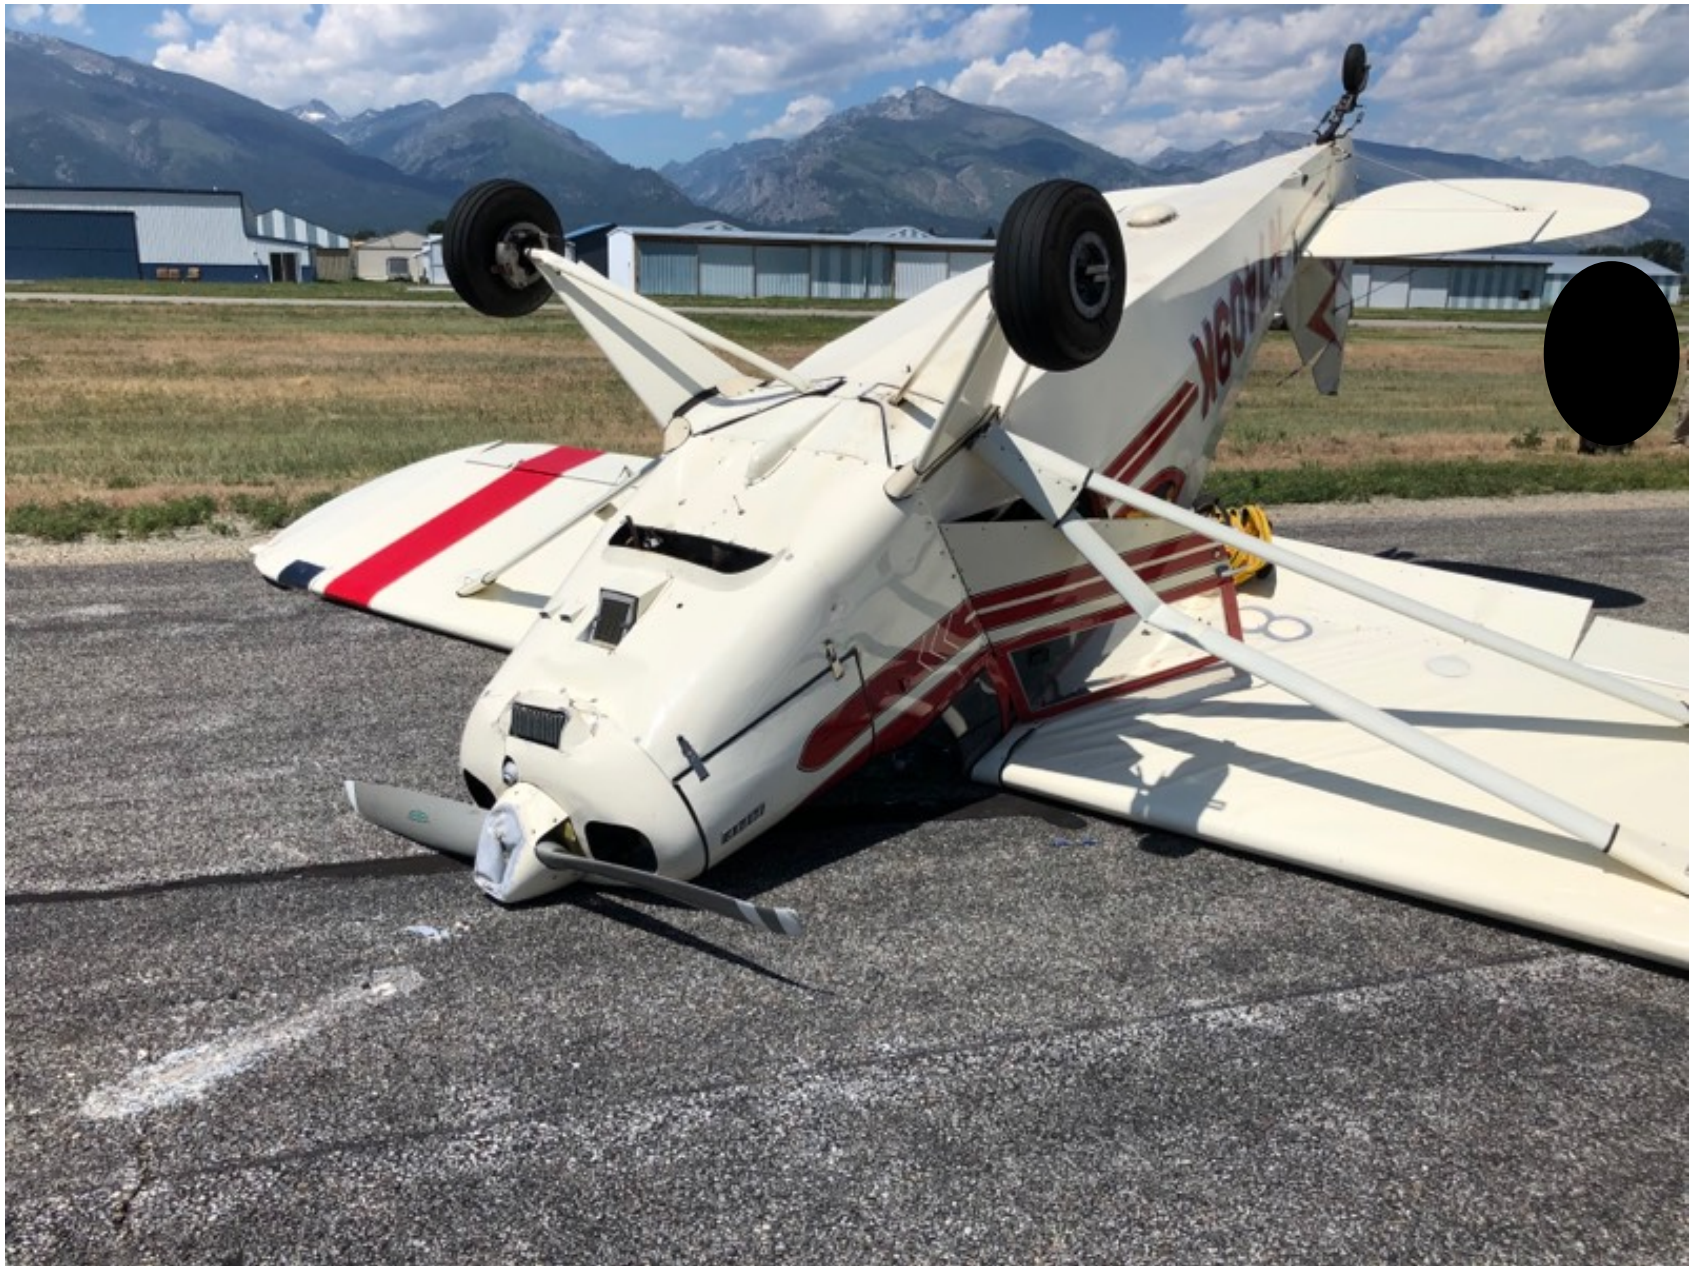
**Photo 1 – View of right wing lift strut damage (photo courtesy of the FAA)**
