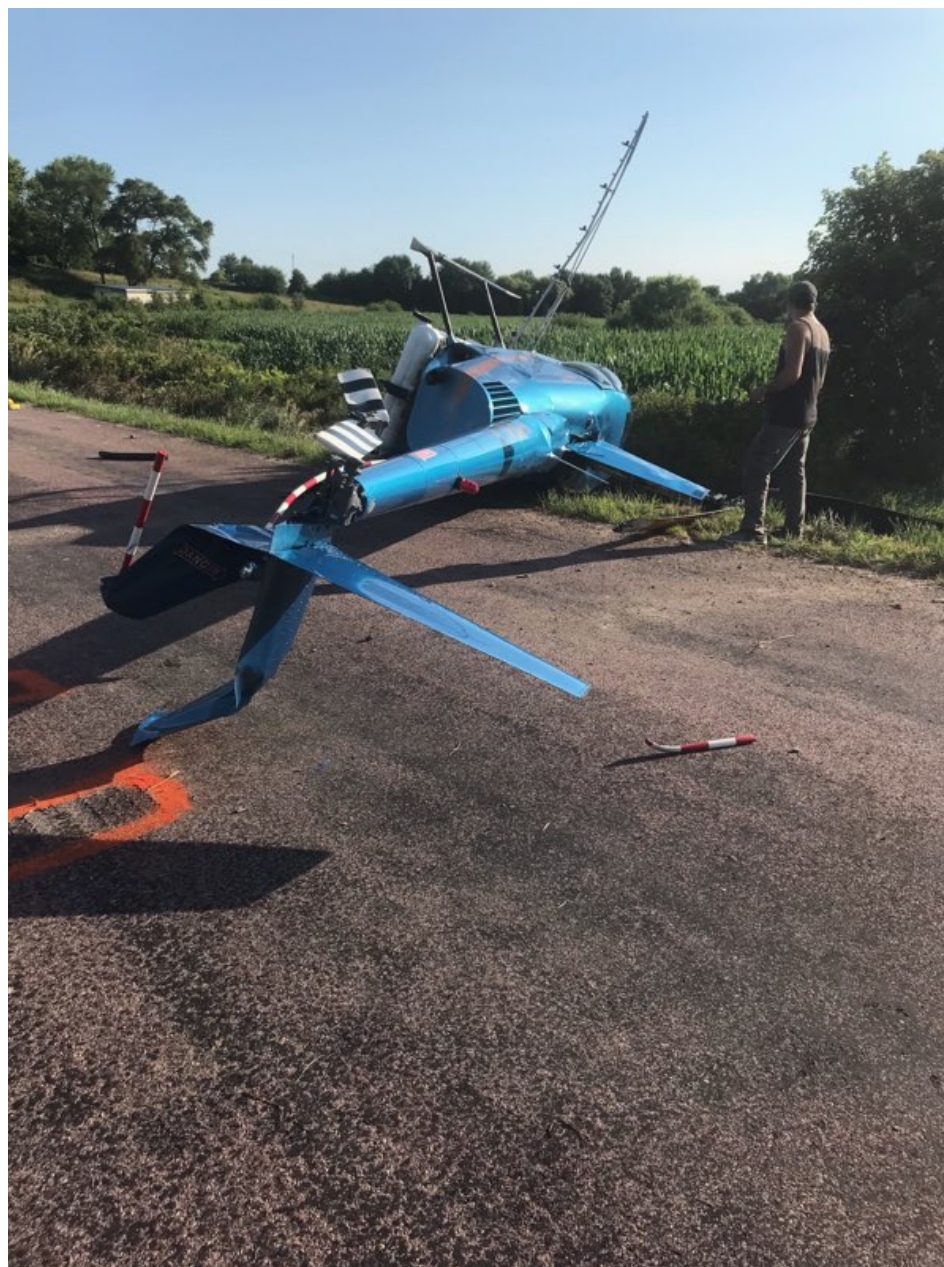
**Photo – View of damage to main & tail rotor systems, empennage and fuselage (courtesy of the operator)**
