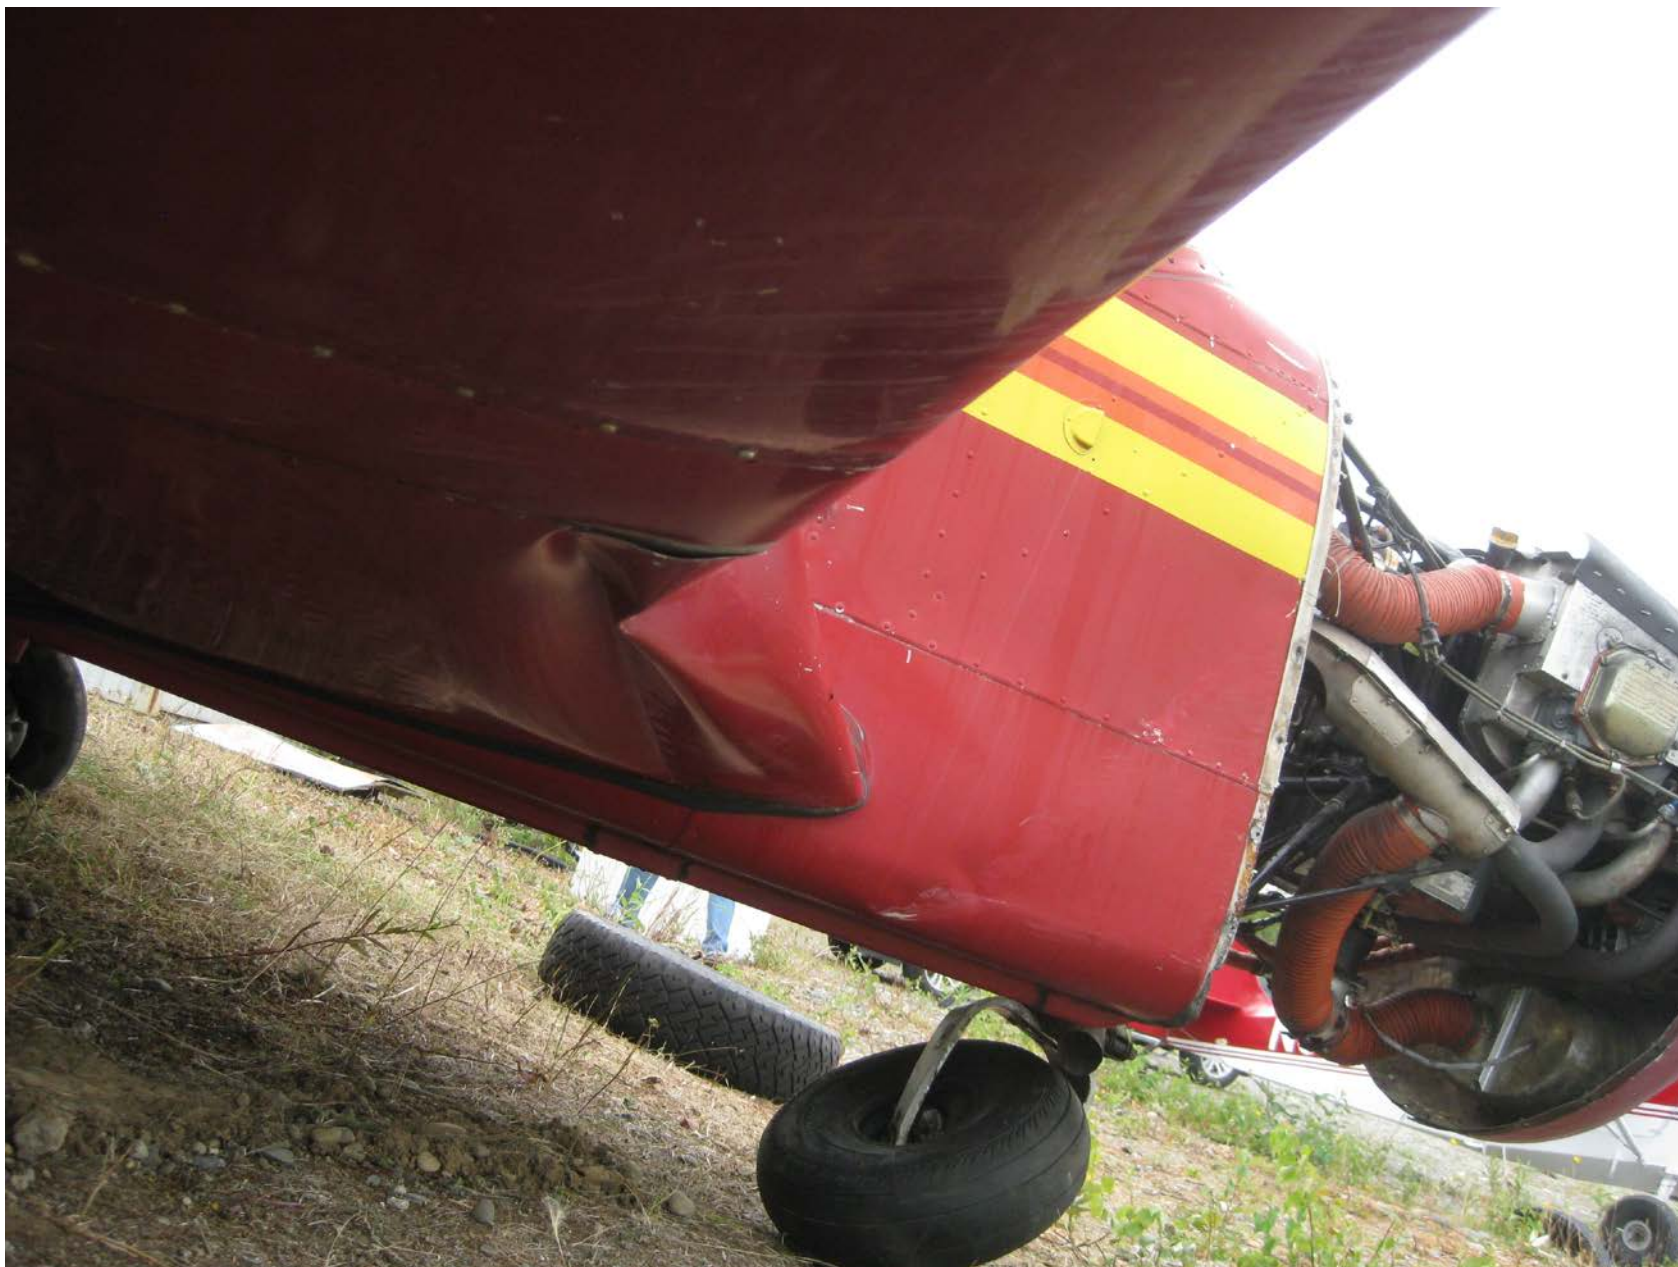
**Photo 1 – View of right wing damage (photo courtesy of the FAA)**

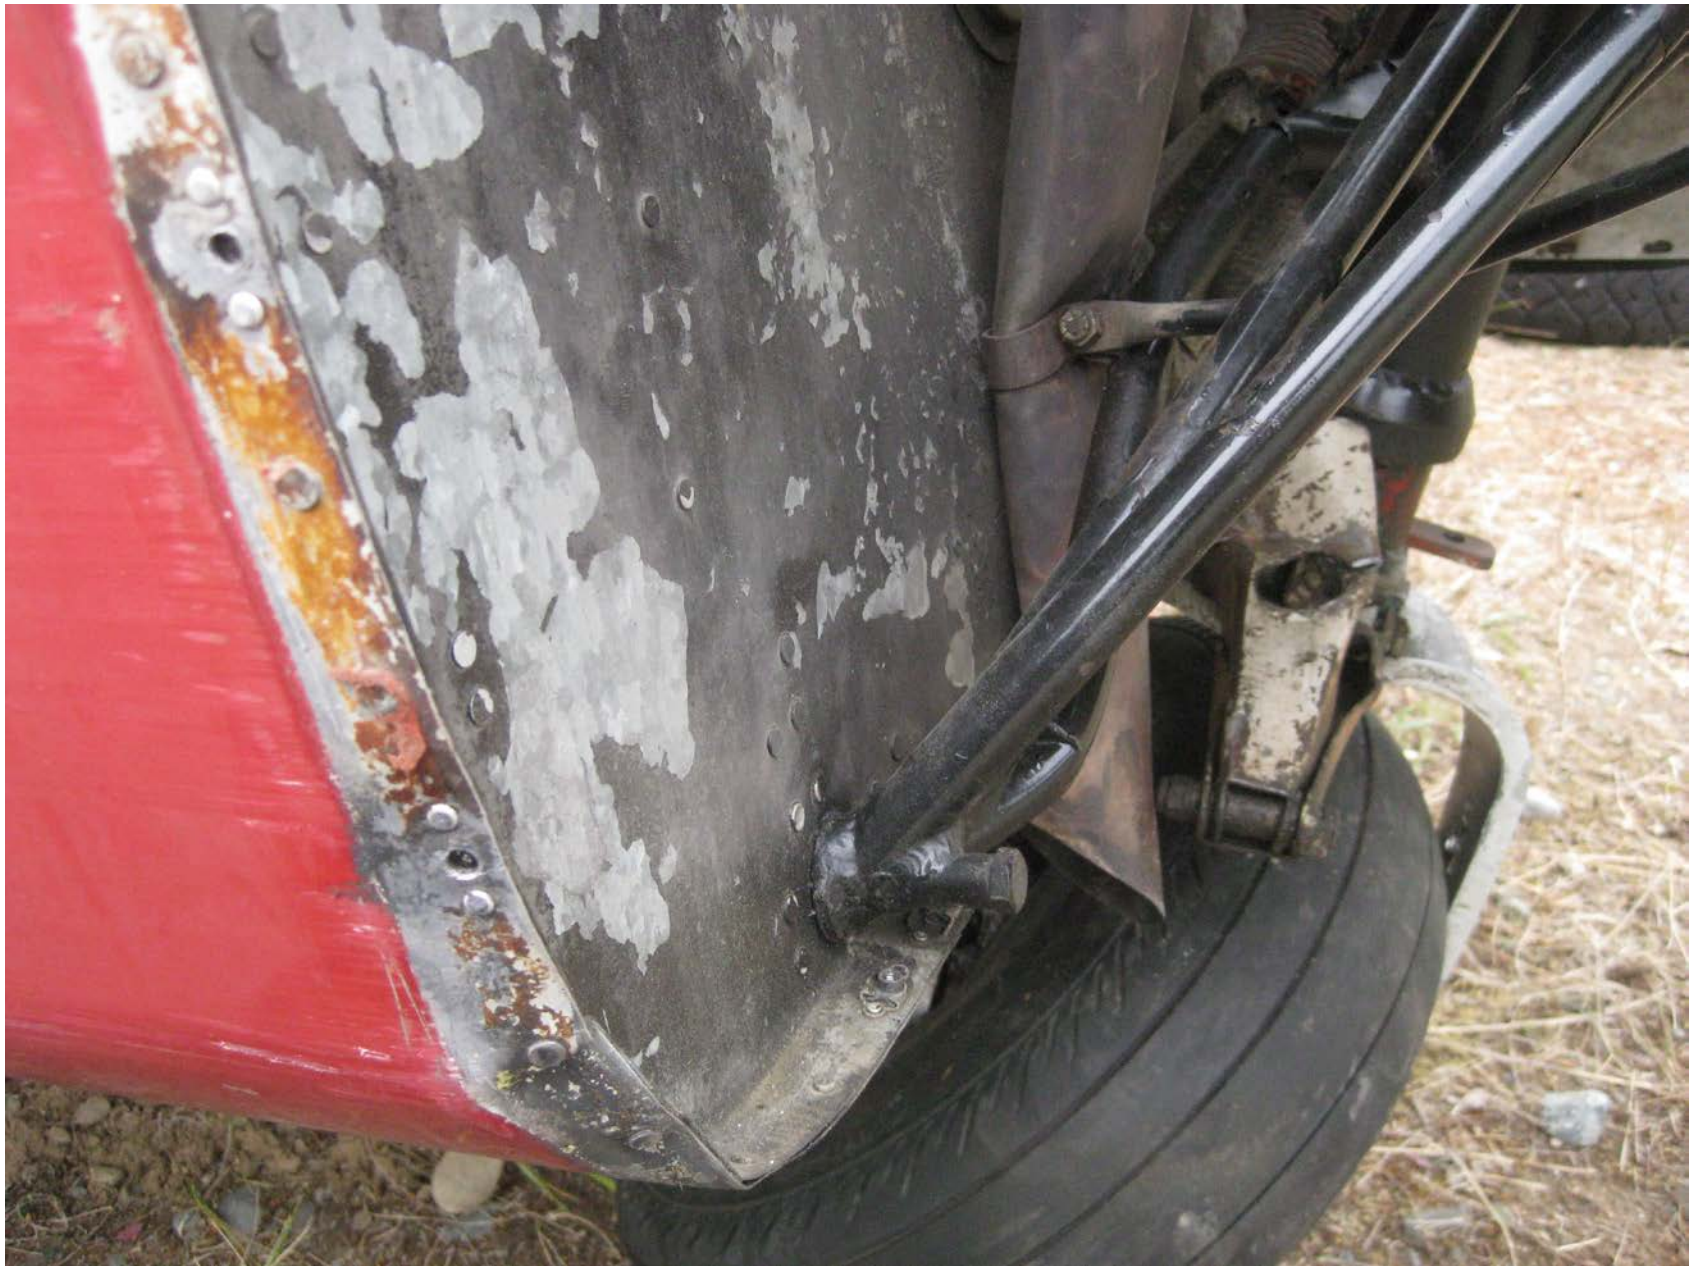
**Photo 2 - View of engine mount damage (photo courtesy of the FAA)**
