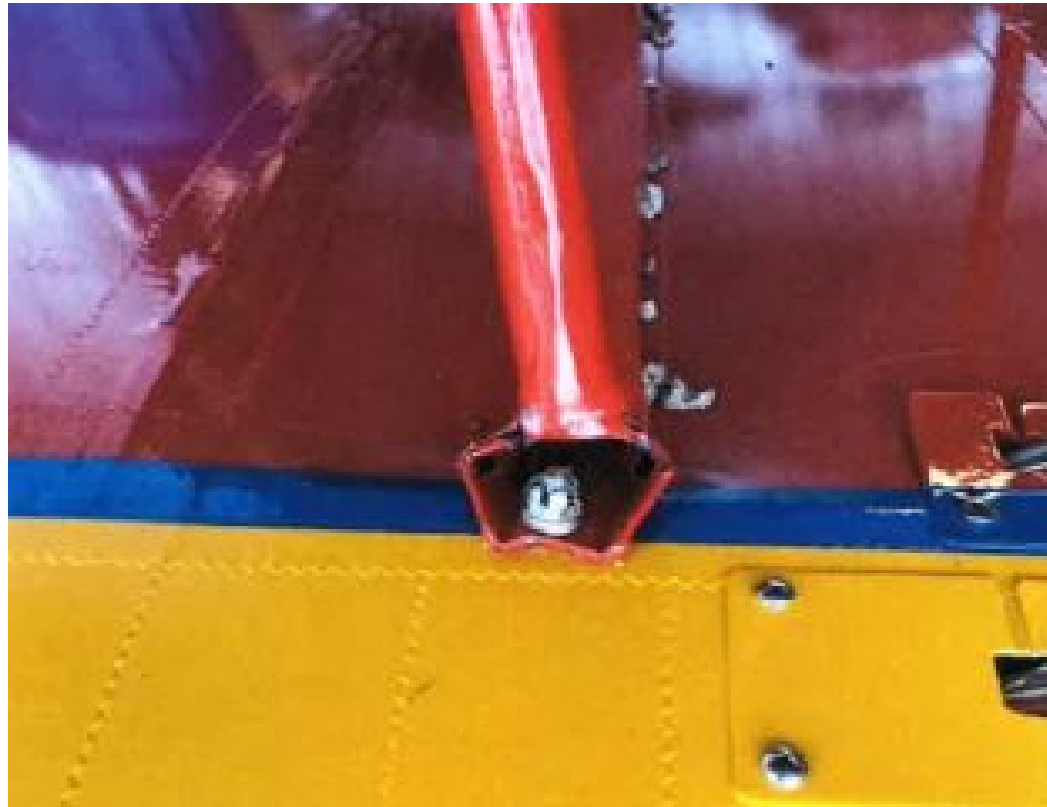
**Photo 1 – View of damaged right-wing I-strut (courtesy of the pilot)**
