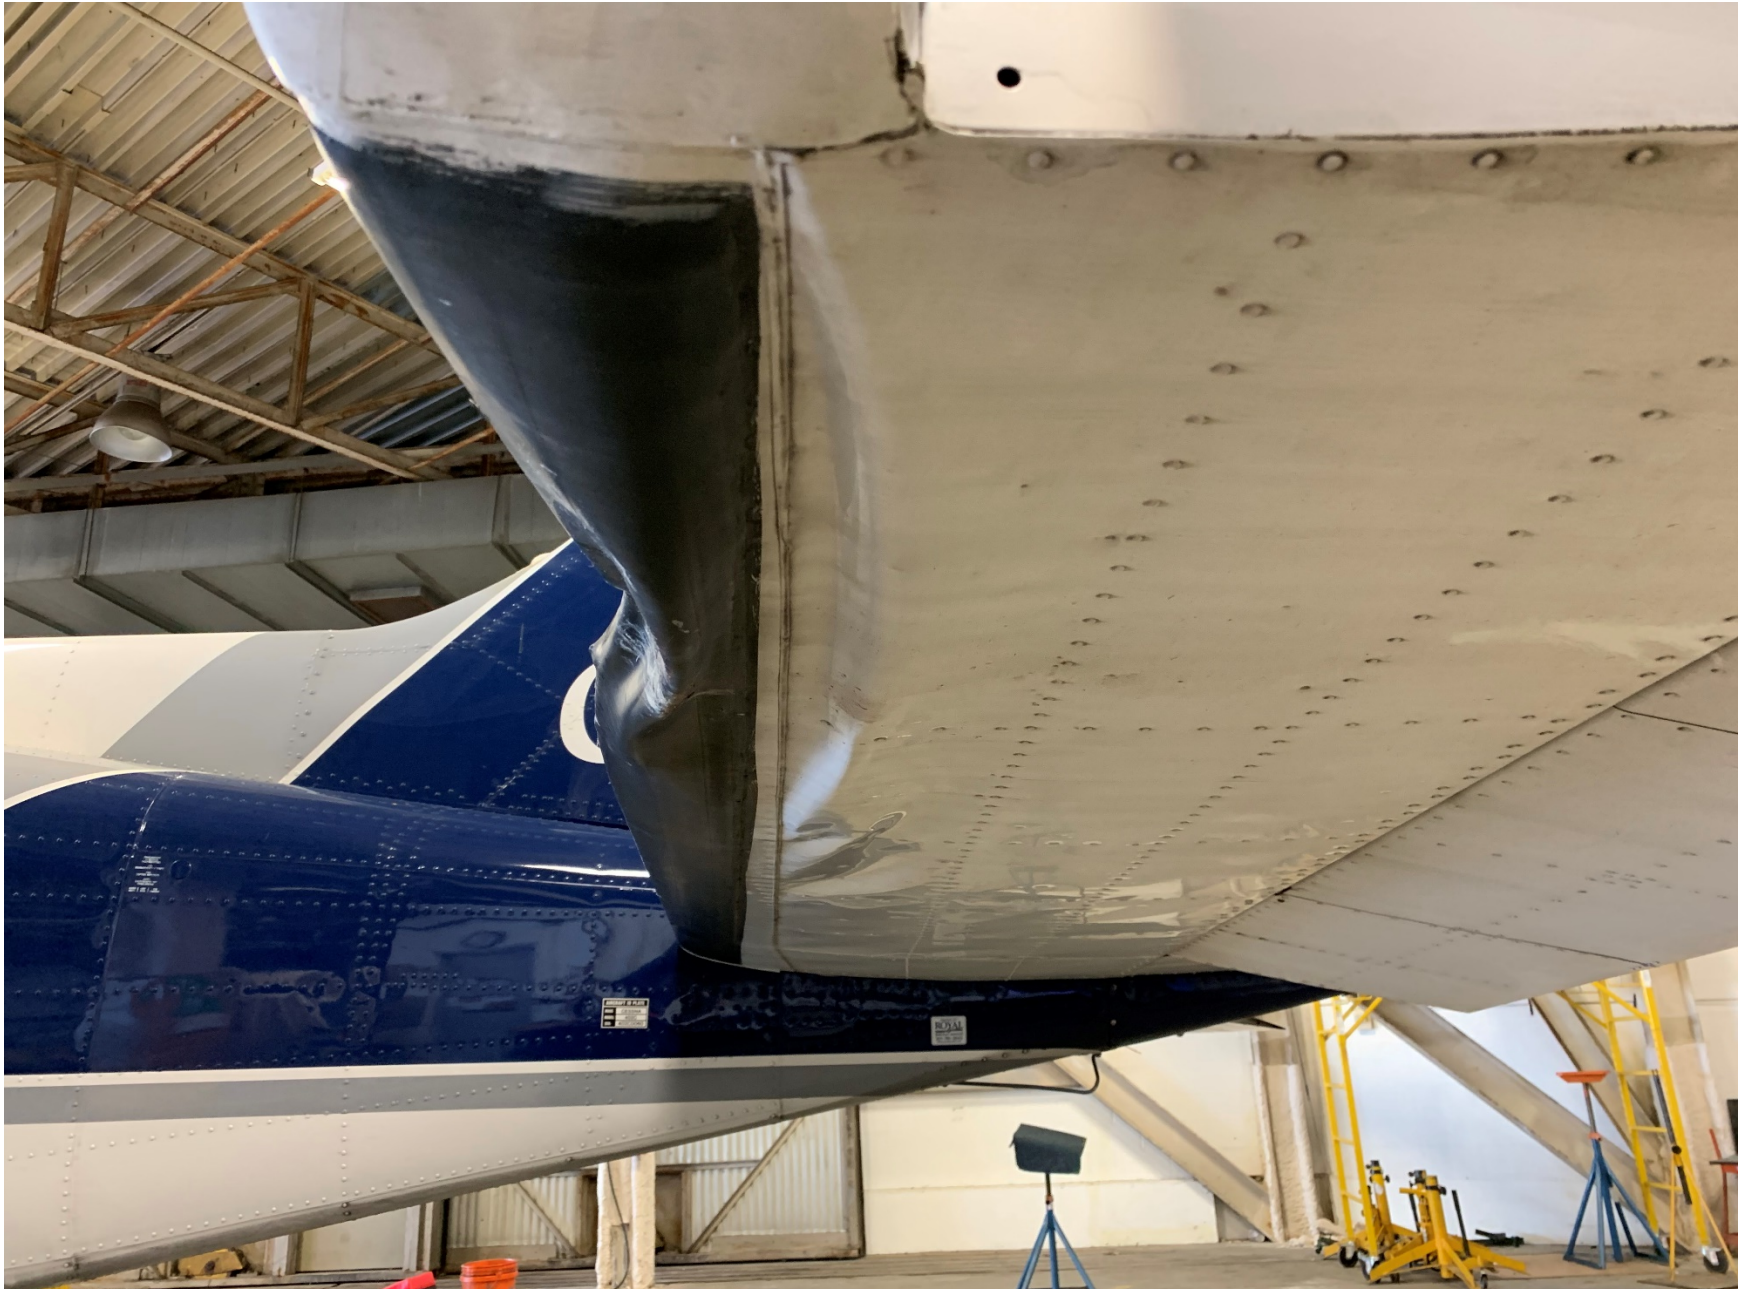
**Photo 1 – View of left horizontal stabilizer damage from underneath (Photo courtesy of the operator)**
