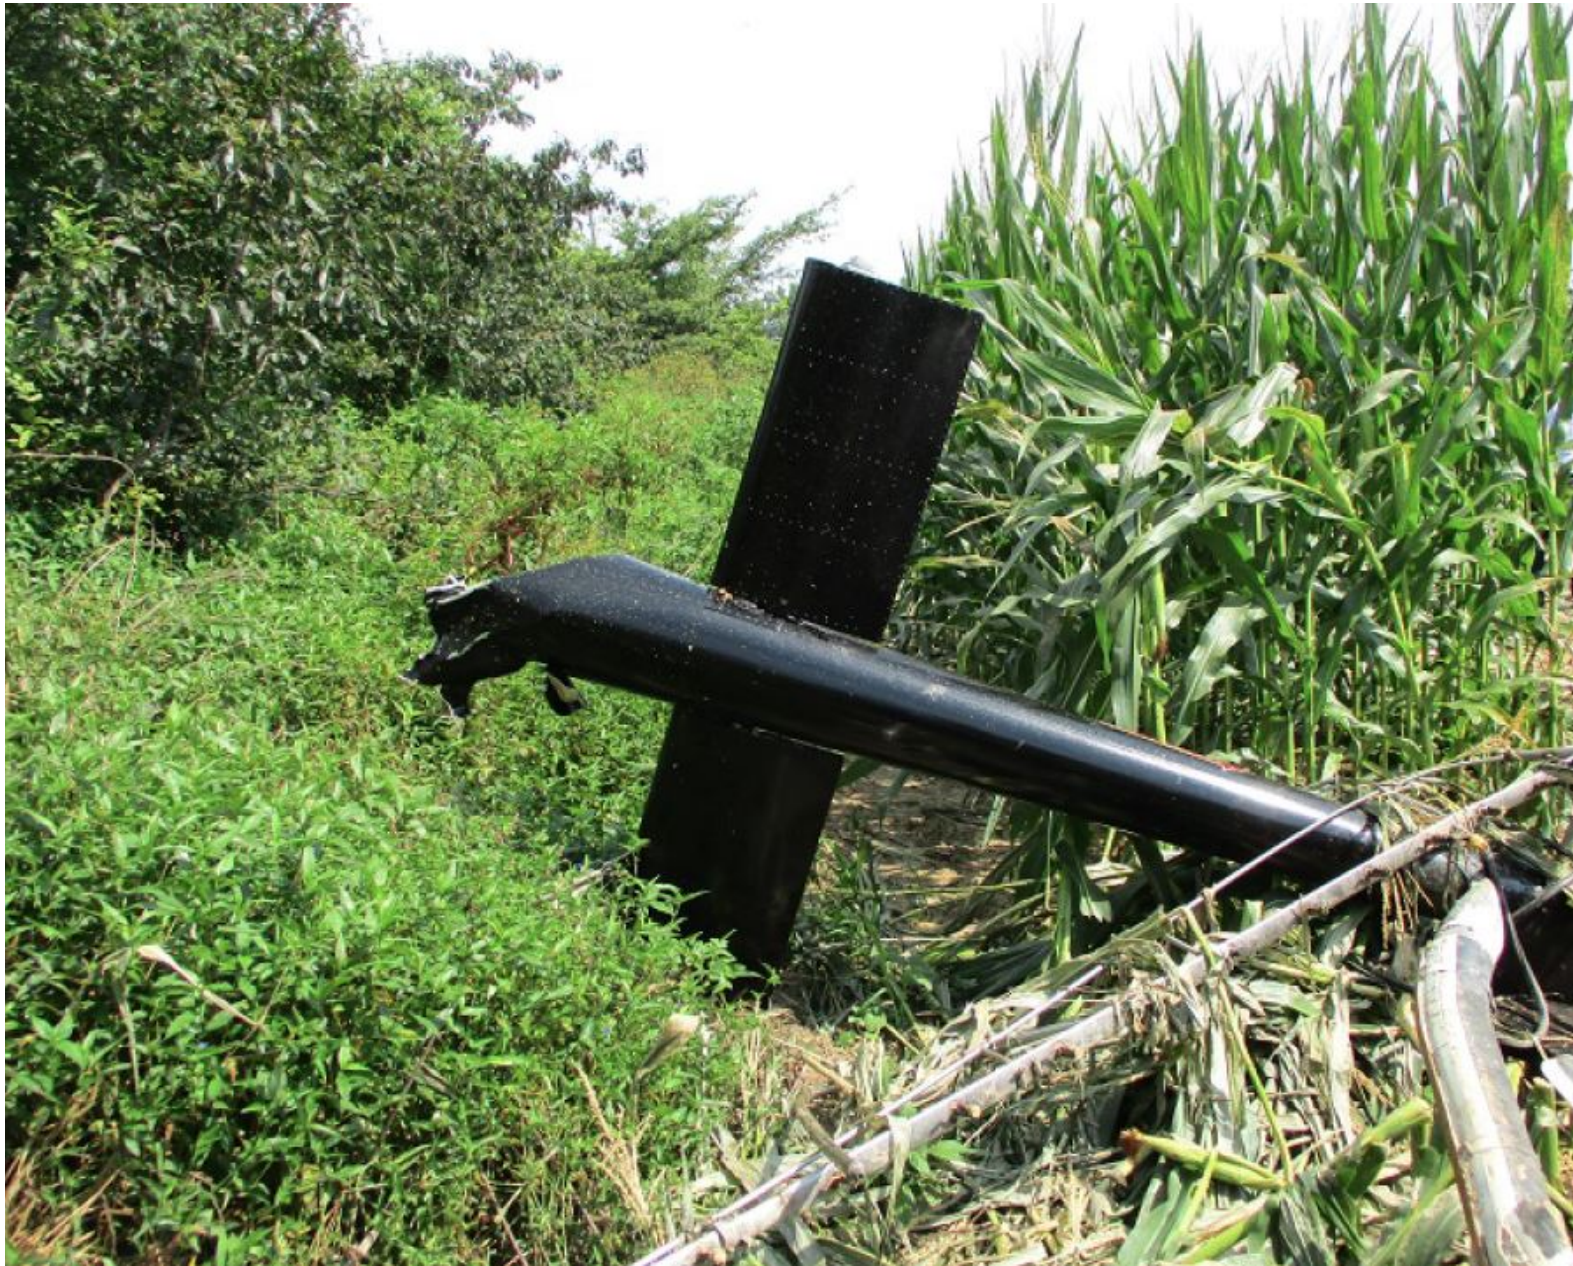
**Photo 1 – View of damaged and separated tailcone (courtesy of the pilot)**
