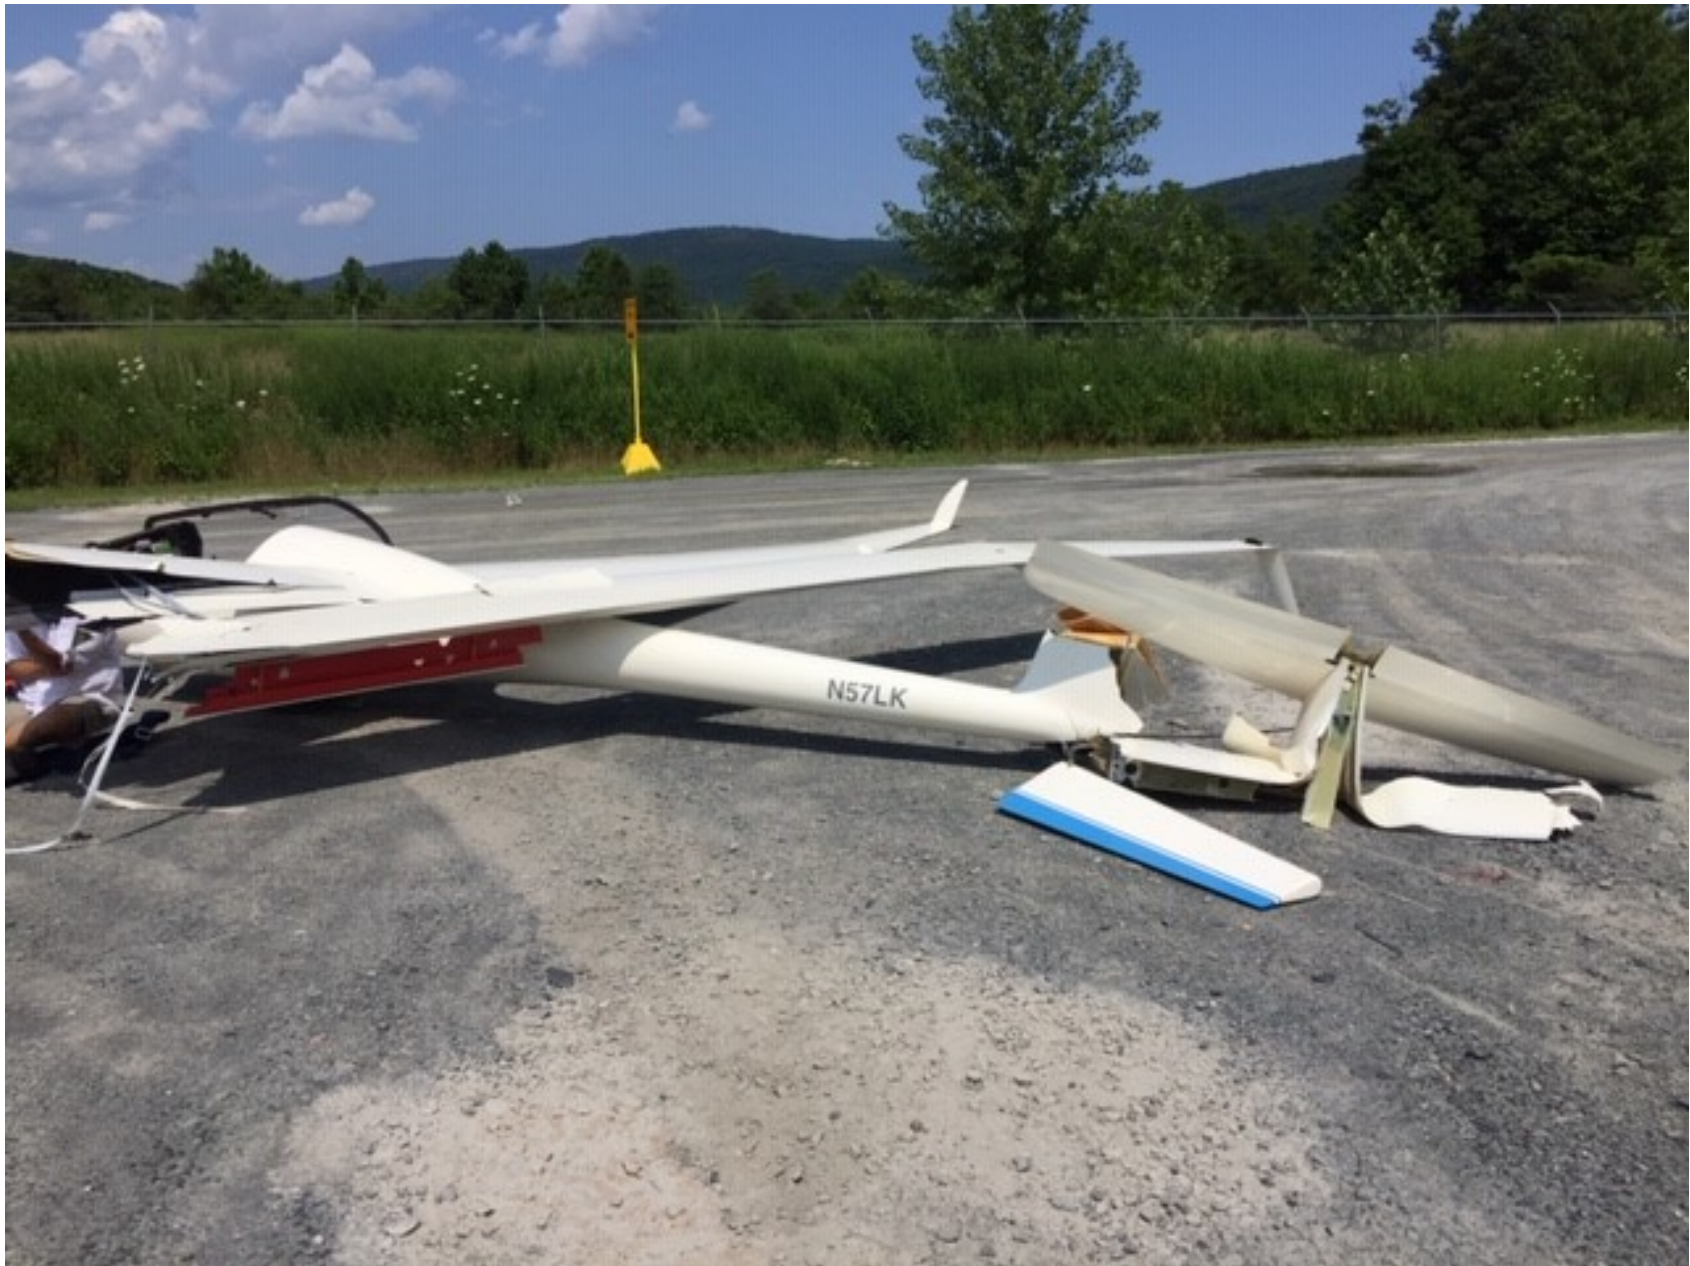
**Photo 1 – View of damage to empennage (Courtesy of FAA)**
