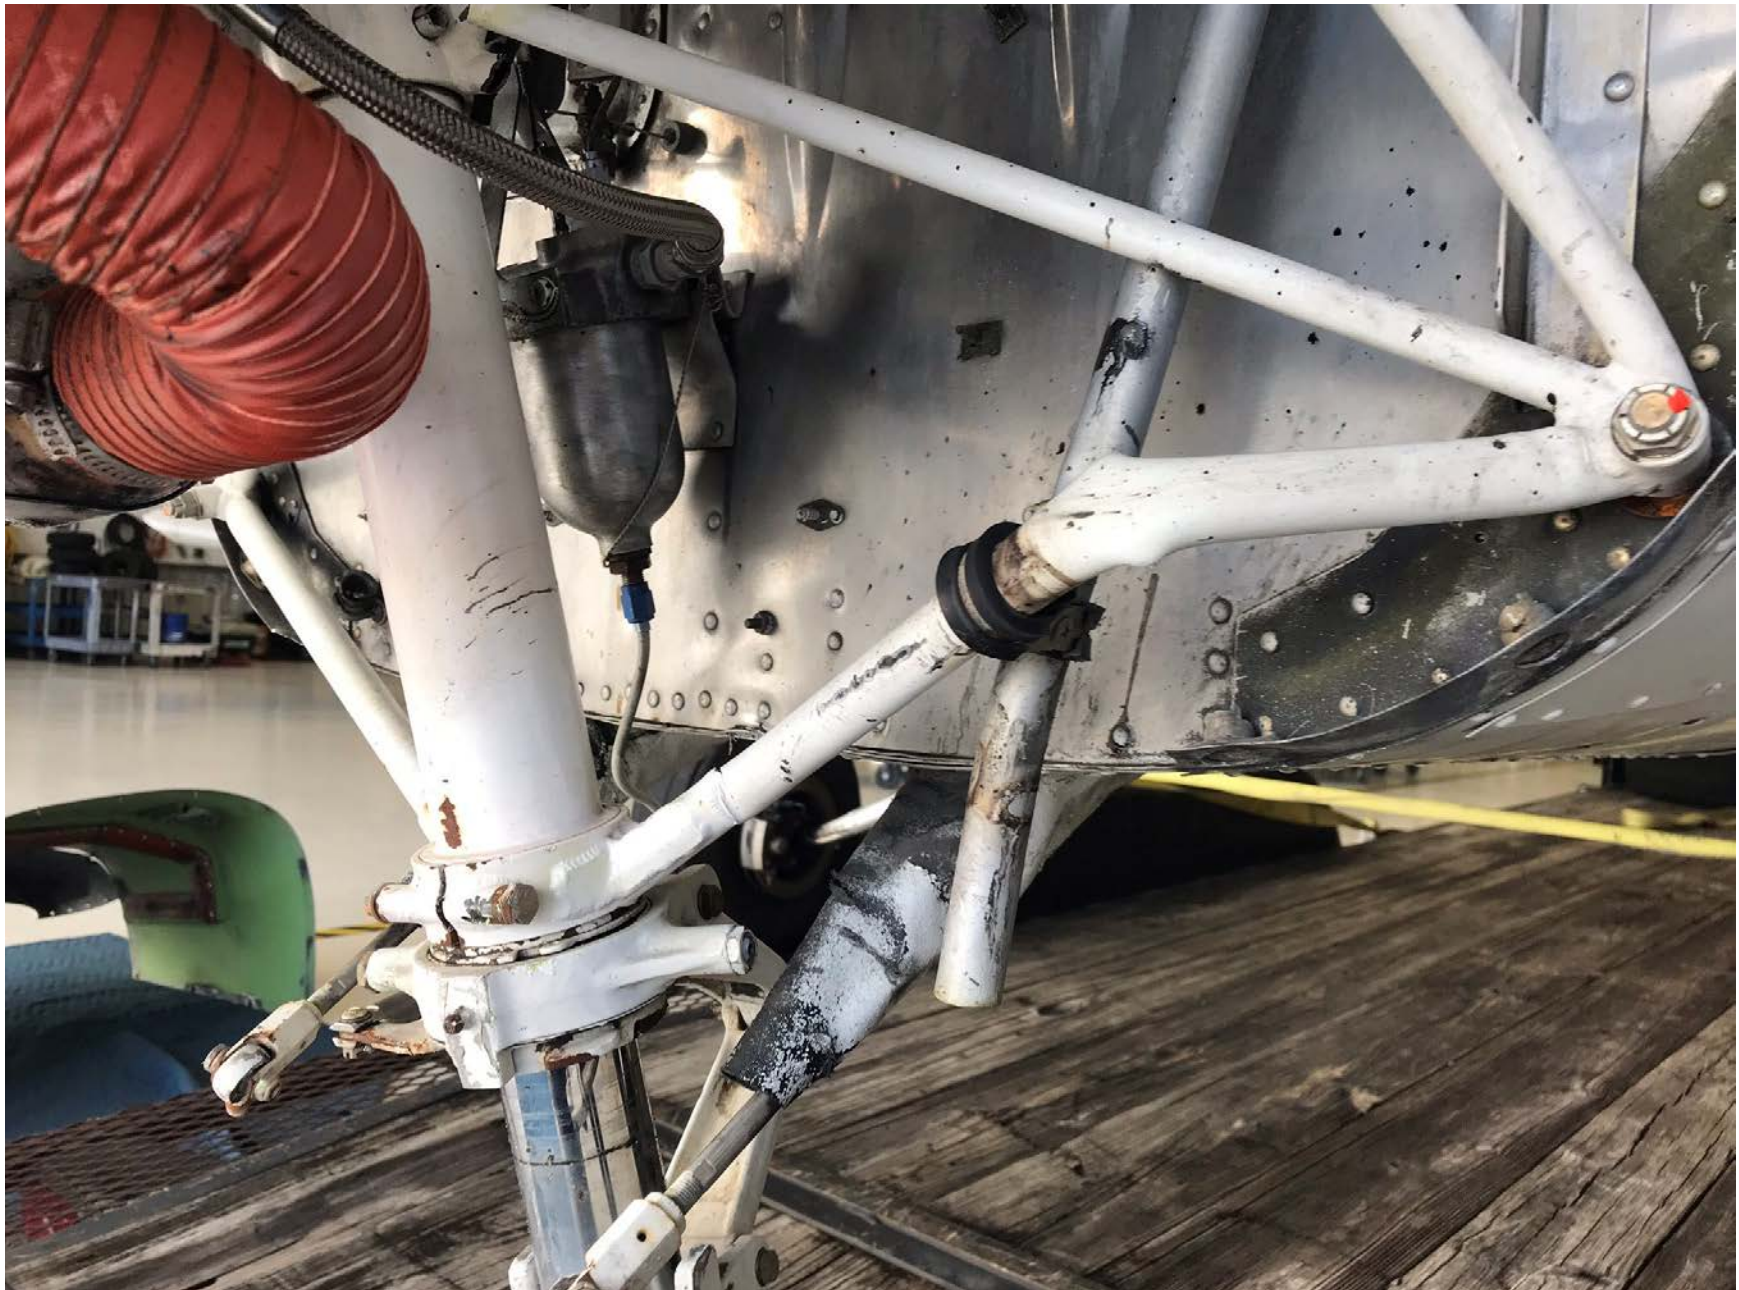
**Photo 1 – View of engine mount damage (Photo courtesy of the FAA)**
