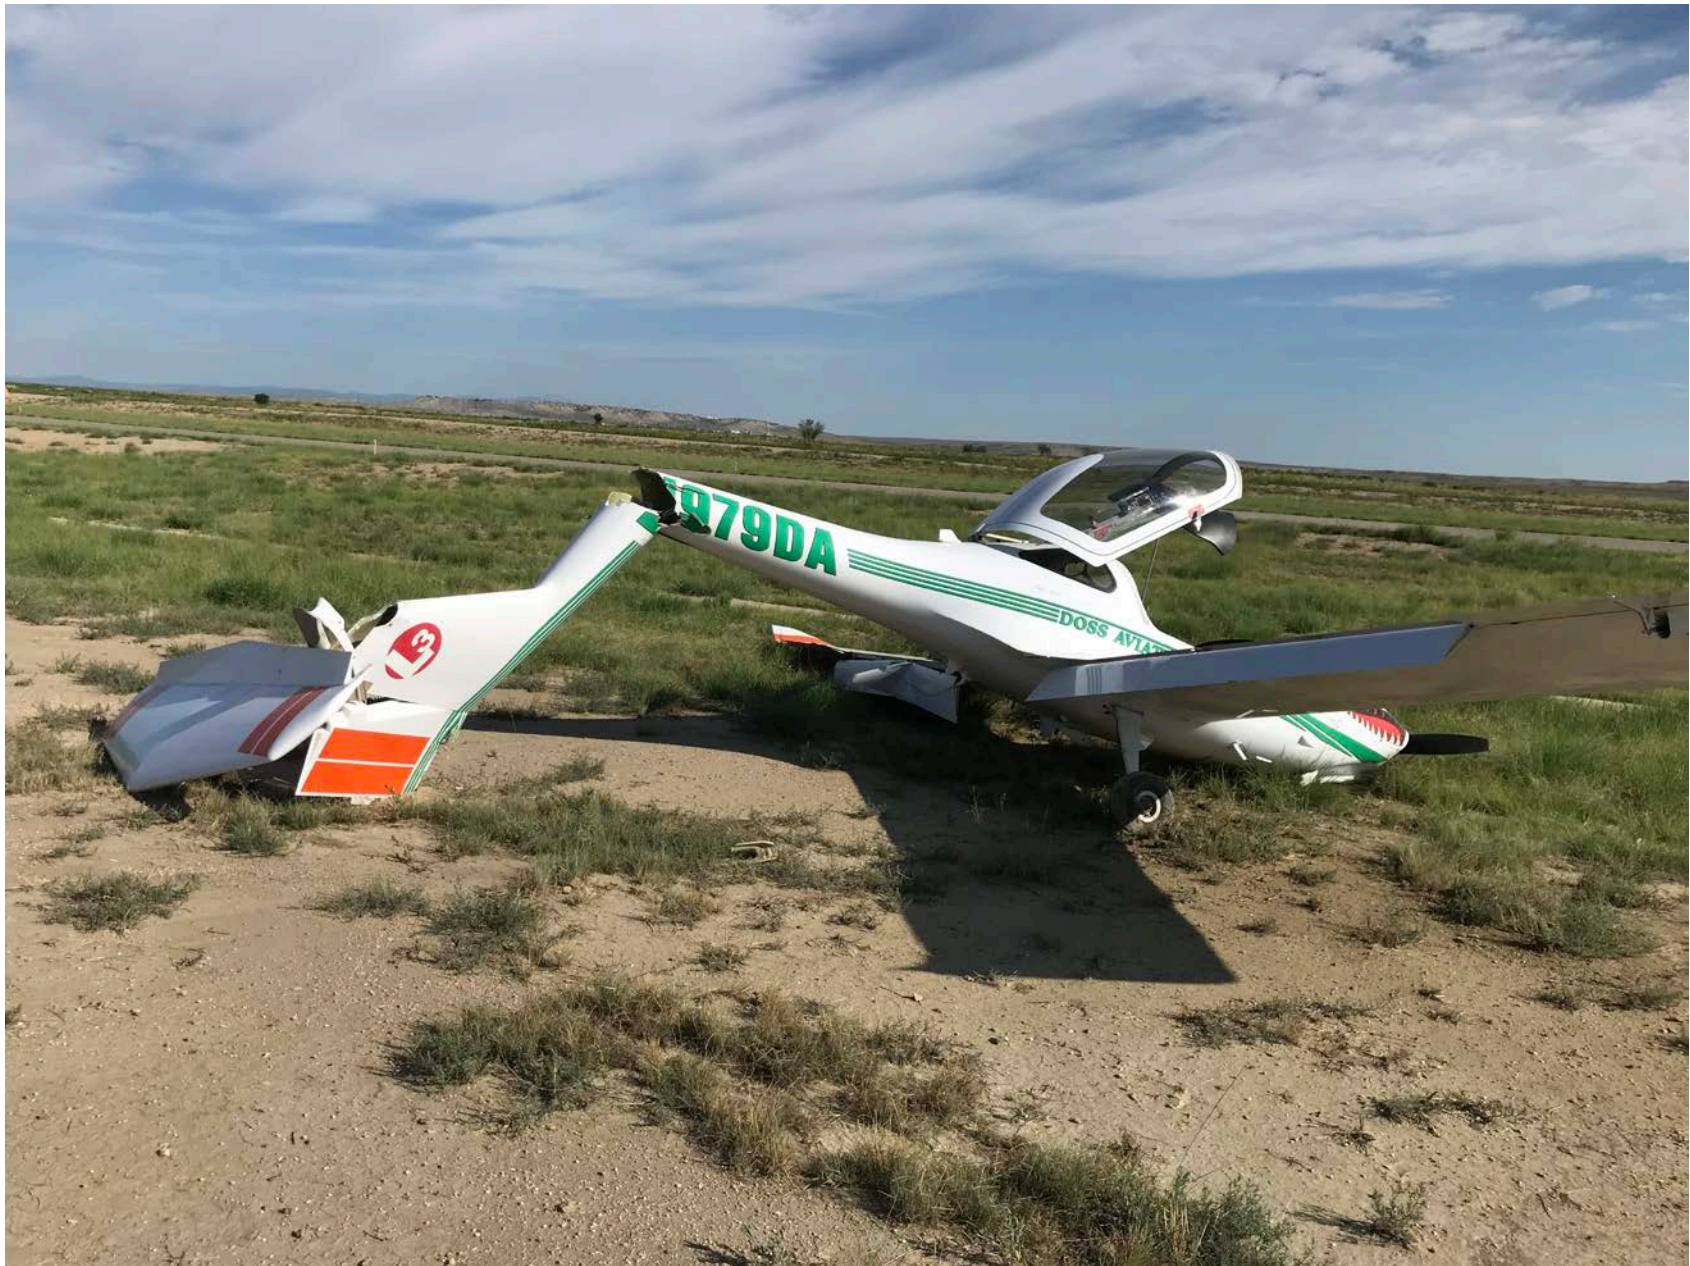
**Photo 1 – View of damage to the empennage (Courtesy of FAA)**
