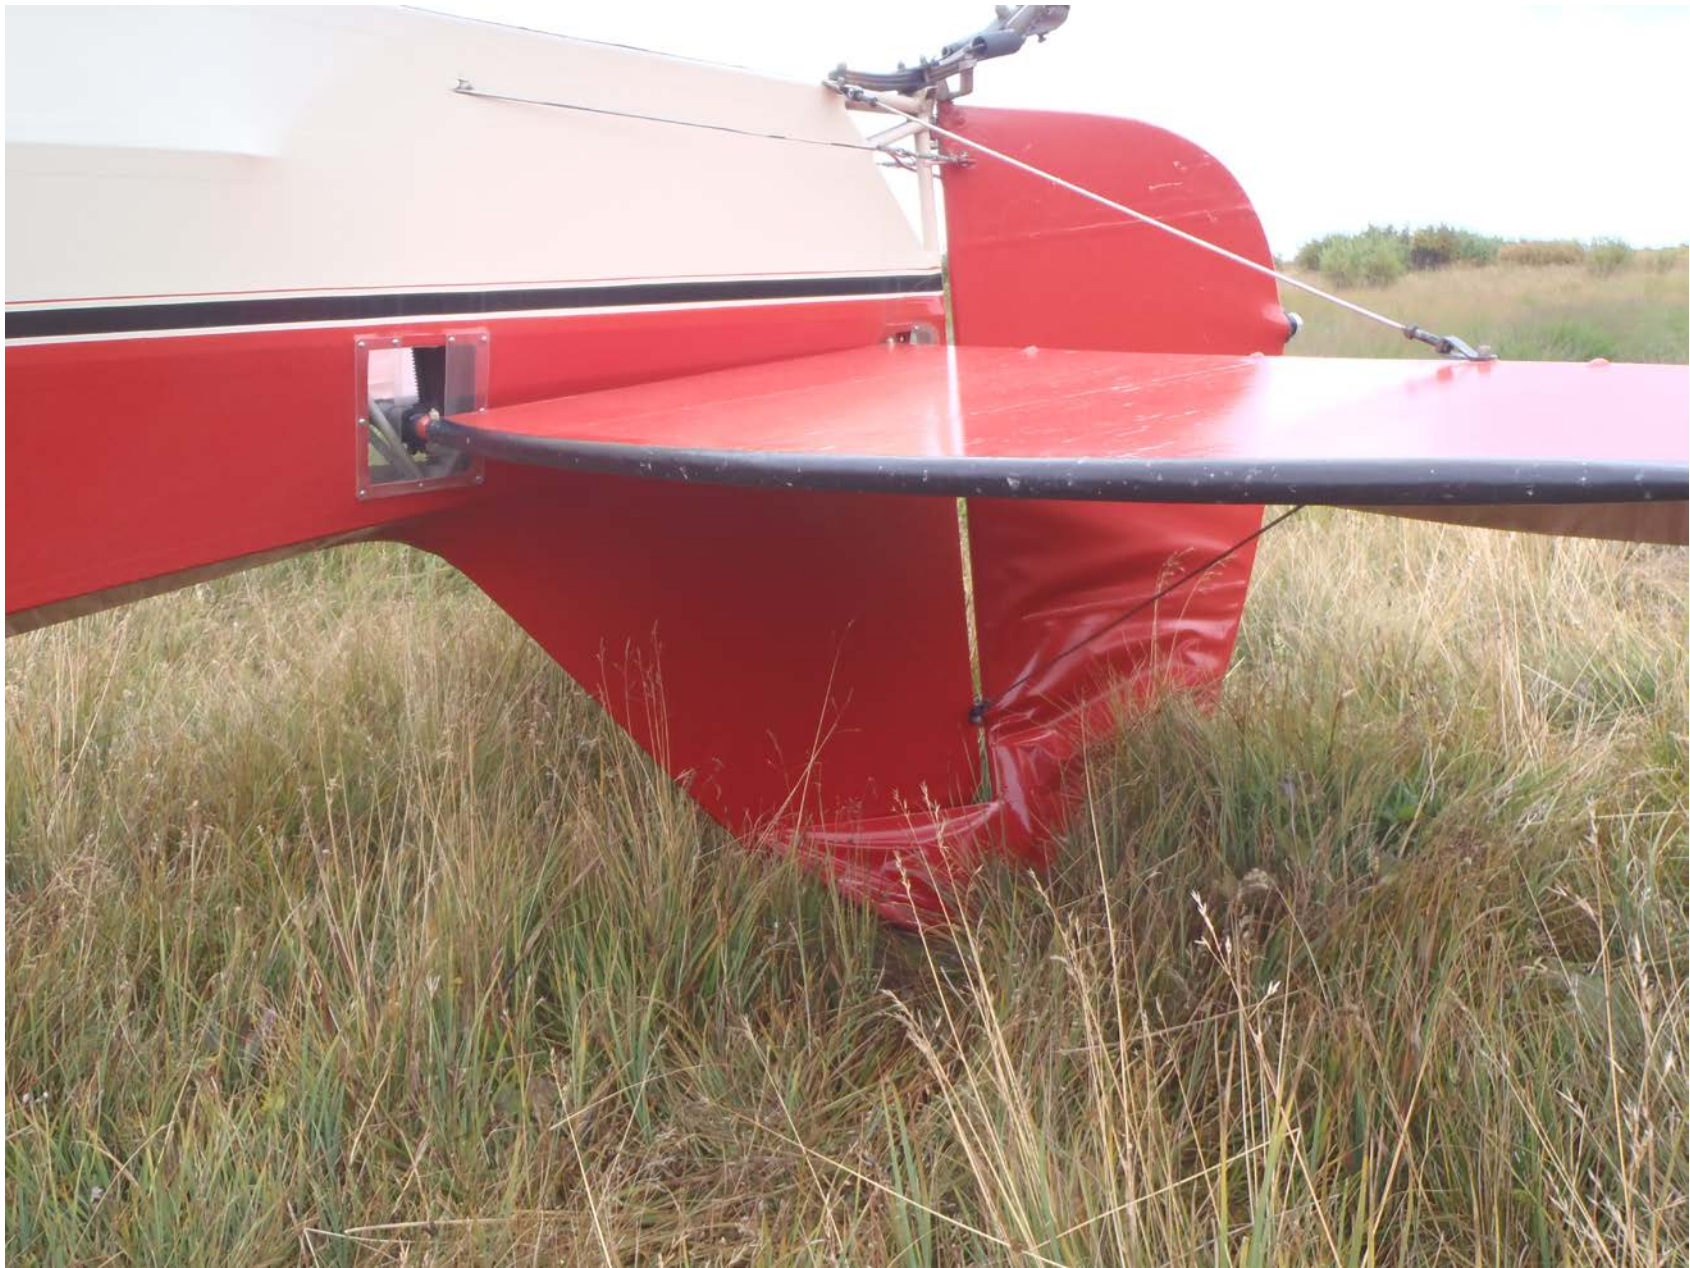
**Photo 1 – View of damaged empennage (courtesy of the pilot)**
