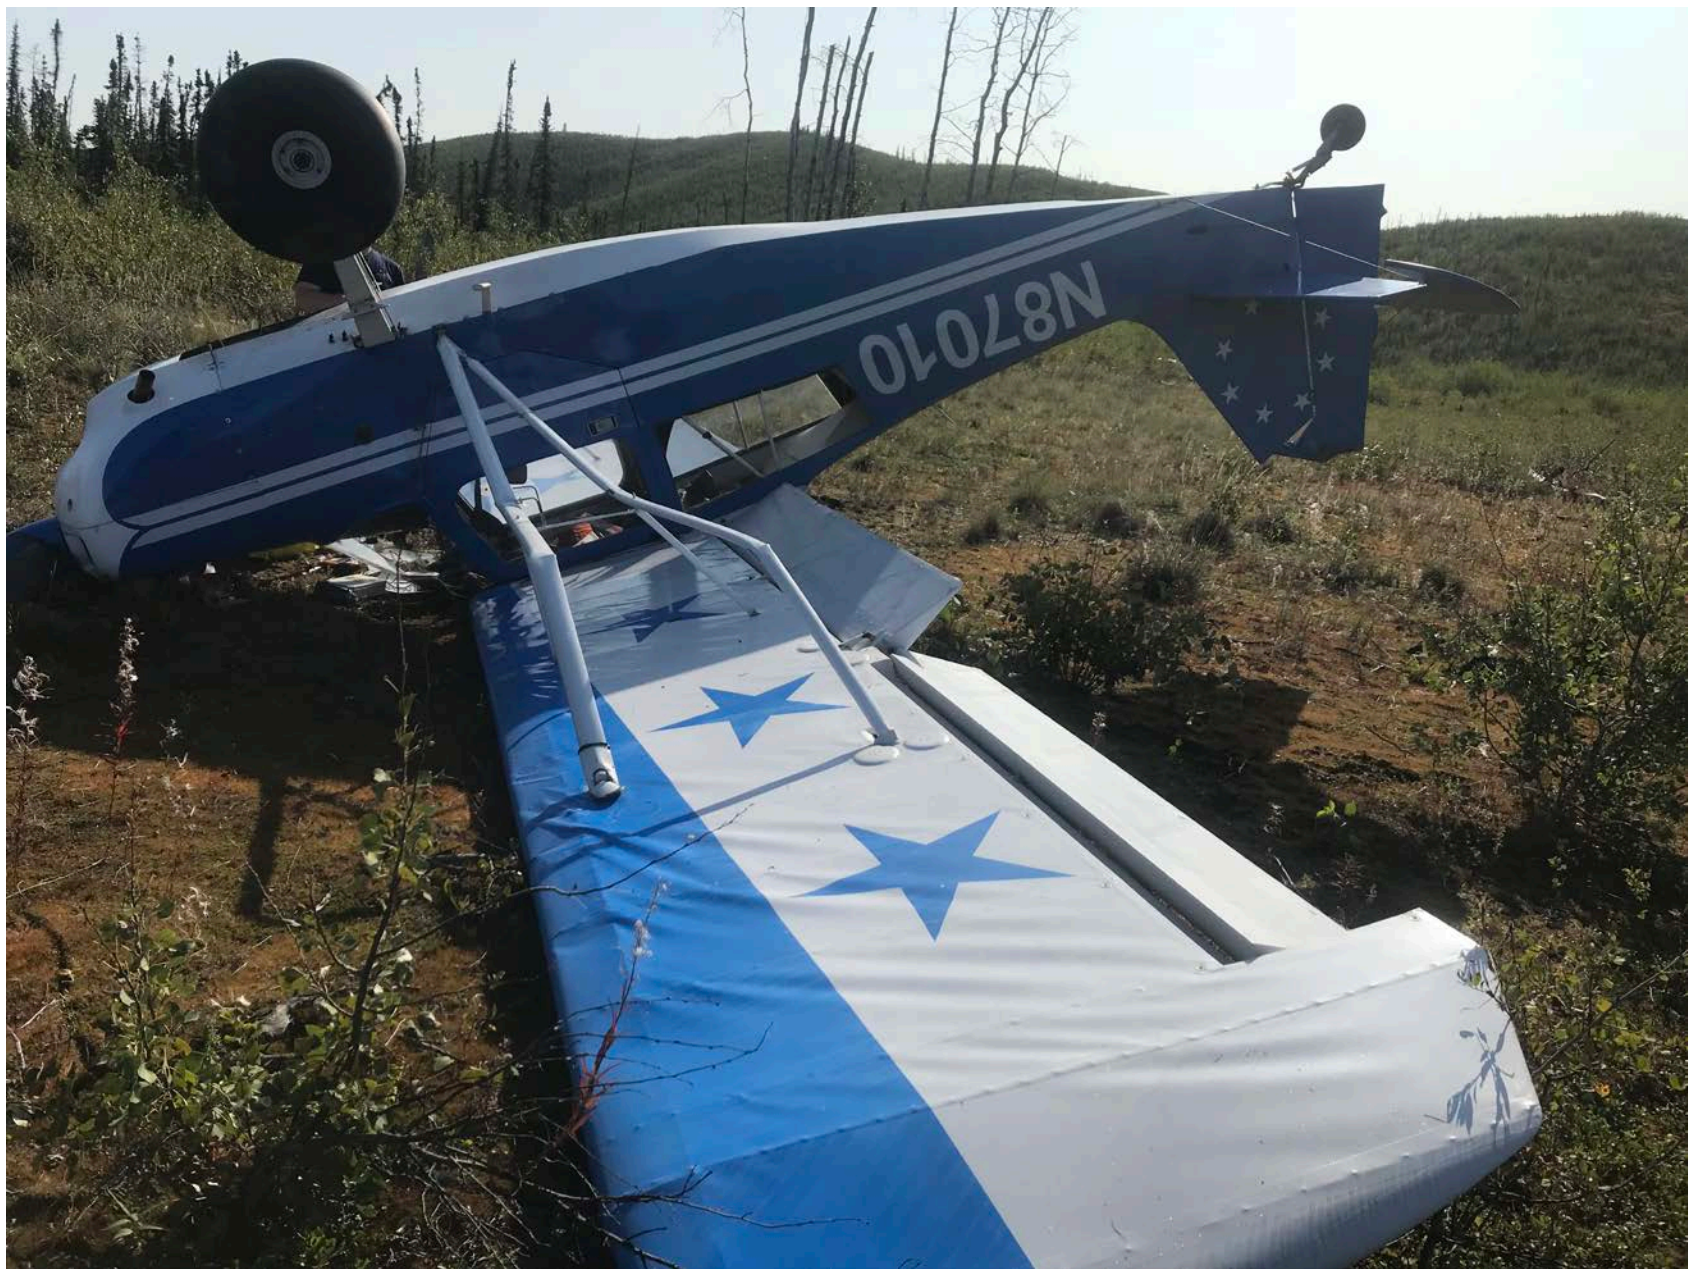
**Photo 1 – View of damaged right wing lift struts (courtesy of the pilot)**

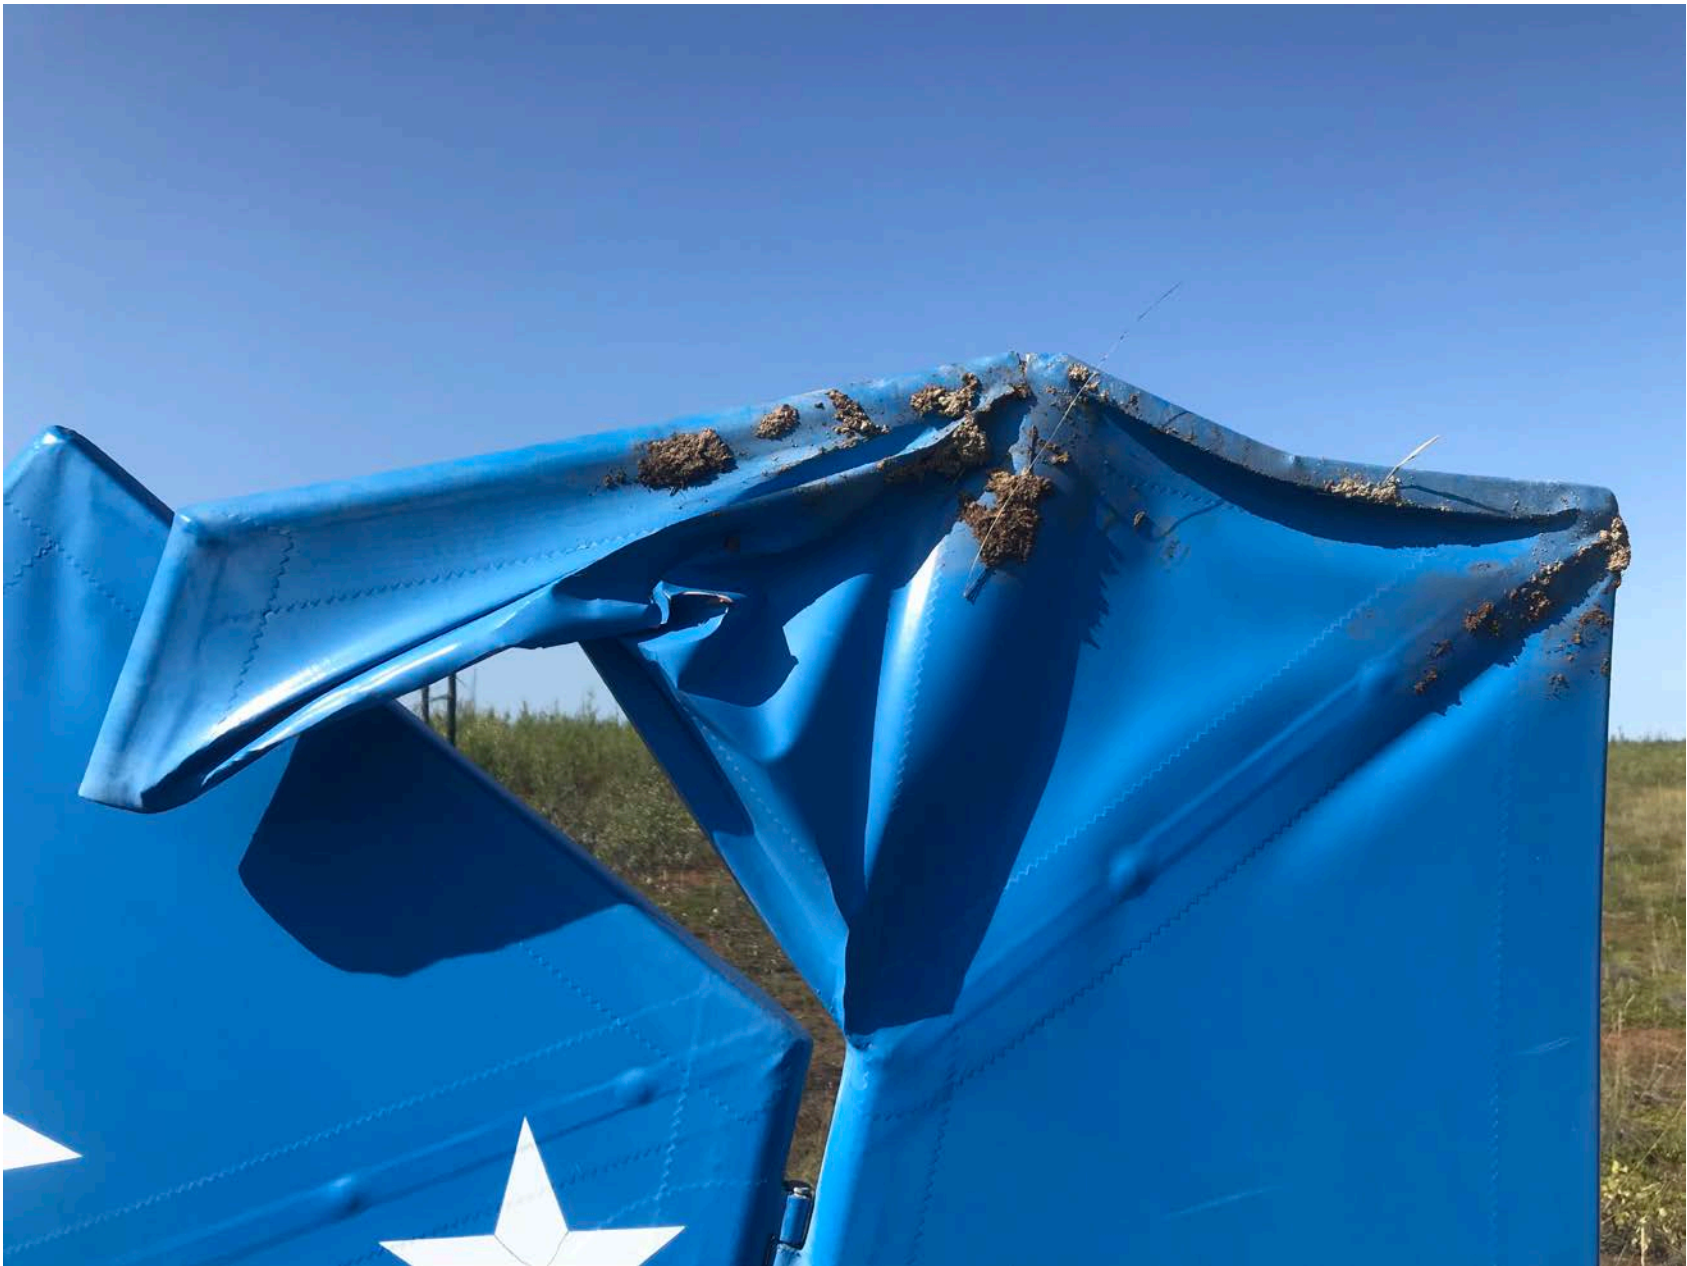
**Photo 2 – View of damaged rudder (courtesy of the pilot)**
