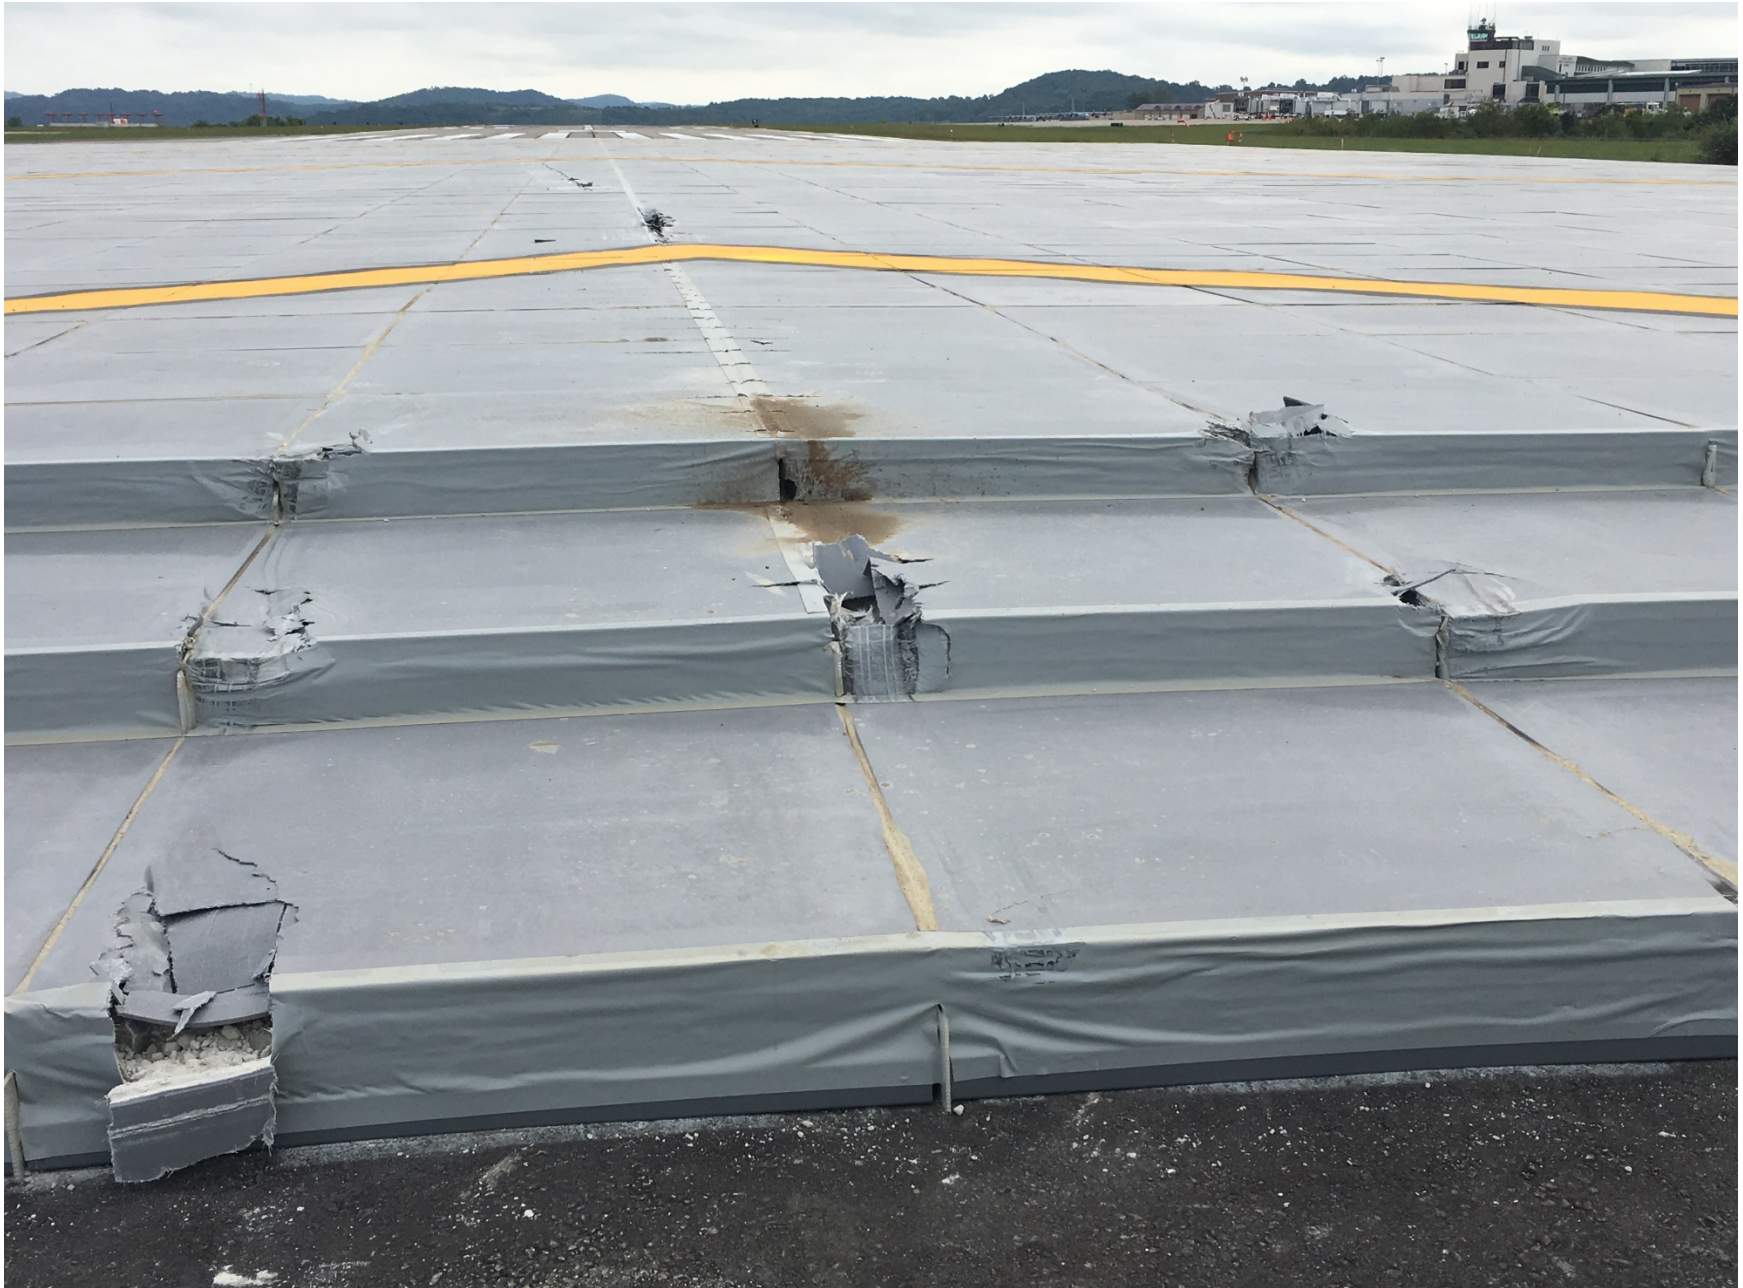
**Photo 1 – View of impact markings on engineered material arrestor system (Photo courtesy of the FAA)**

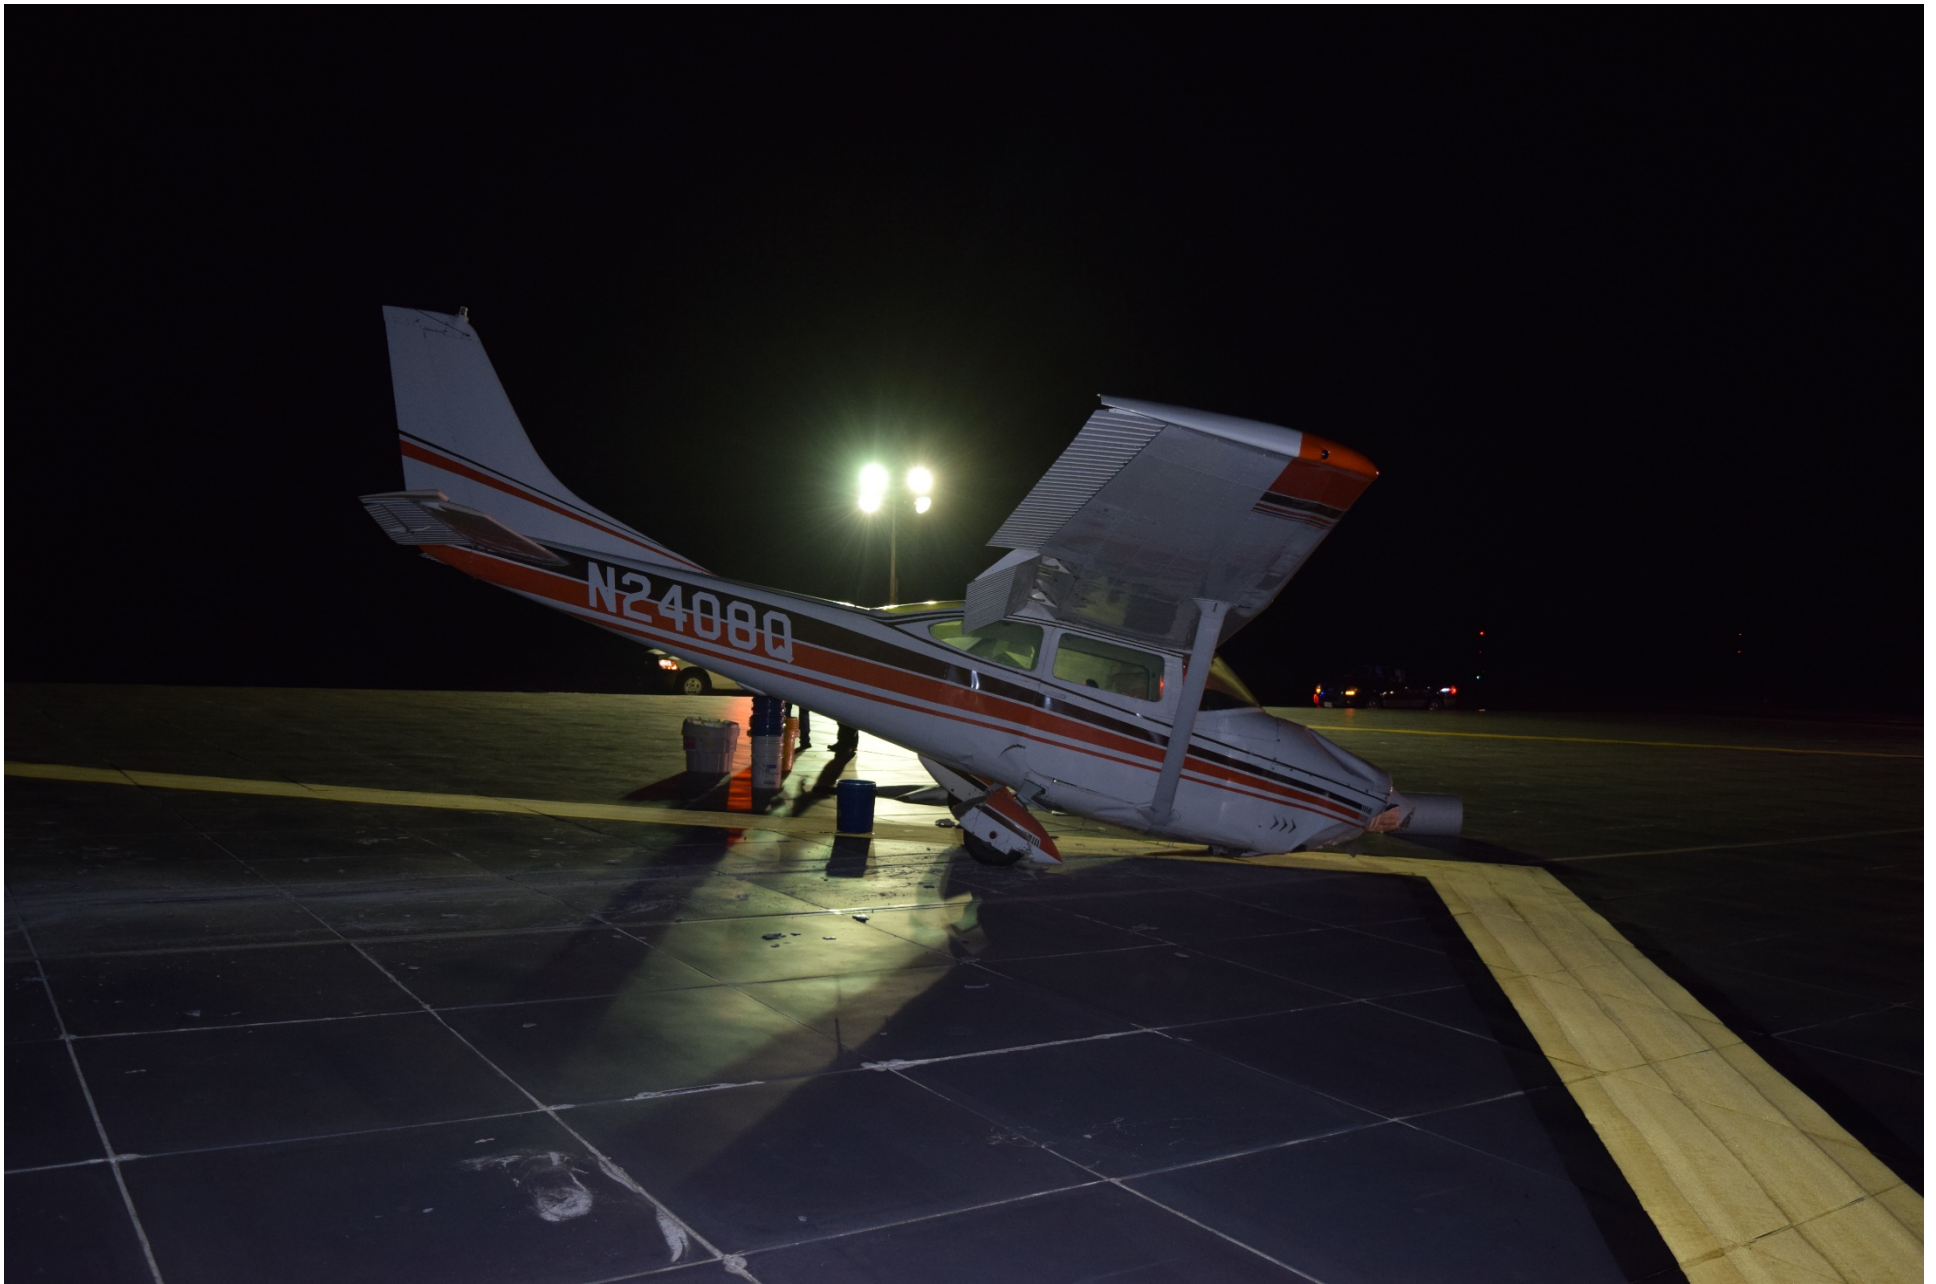
**Photo 2 – View of damaged fuselage (Photo courtesy of the FAA)**
