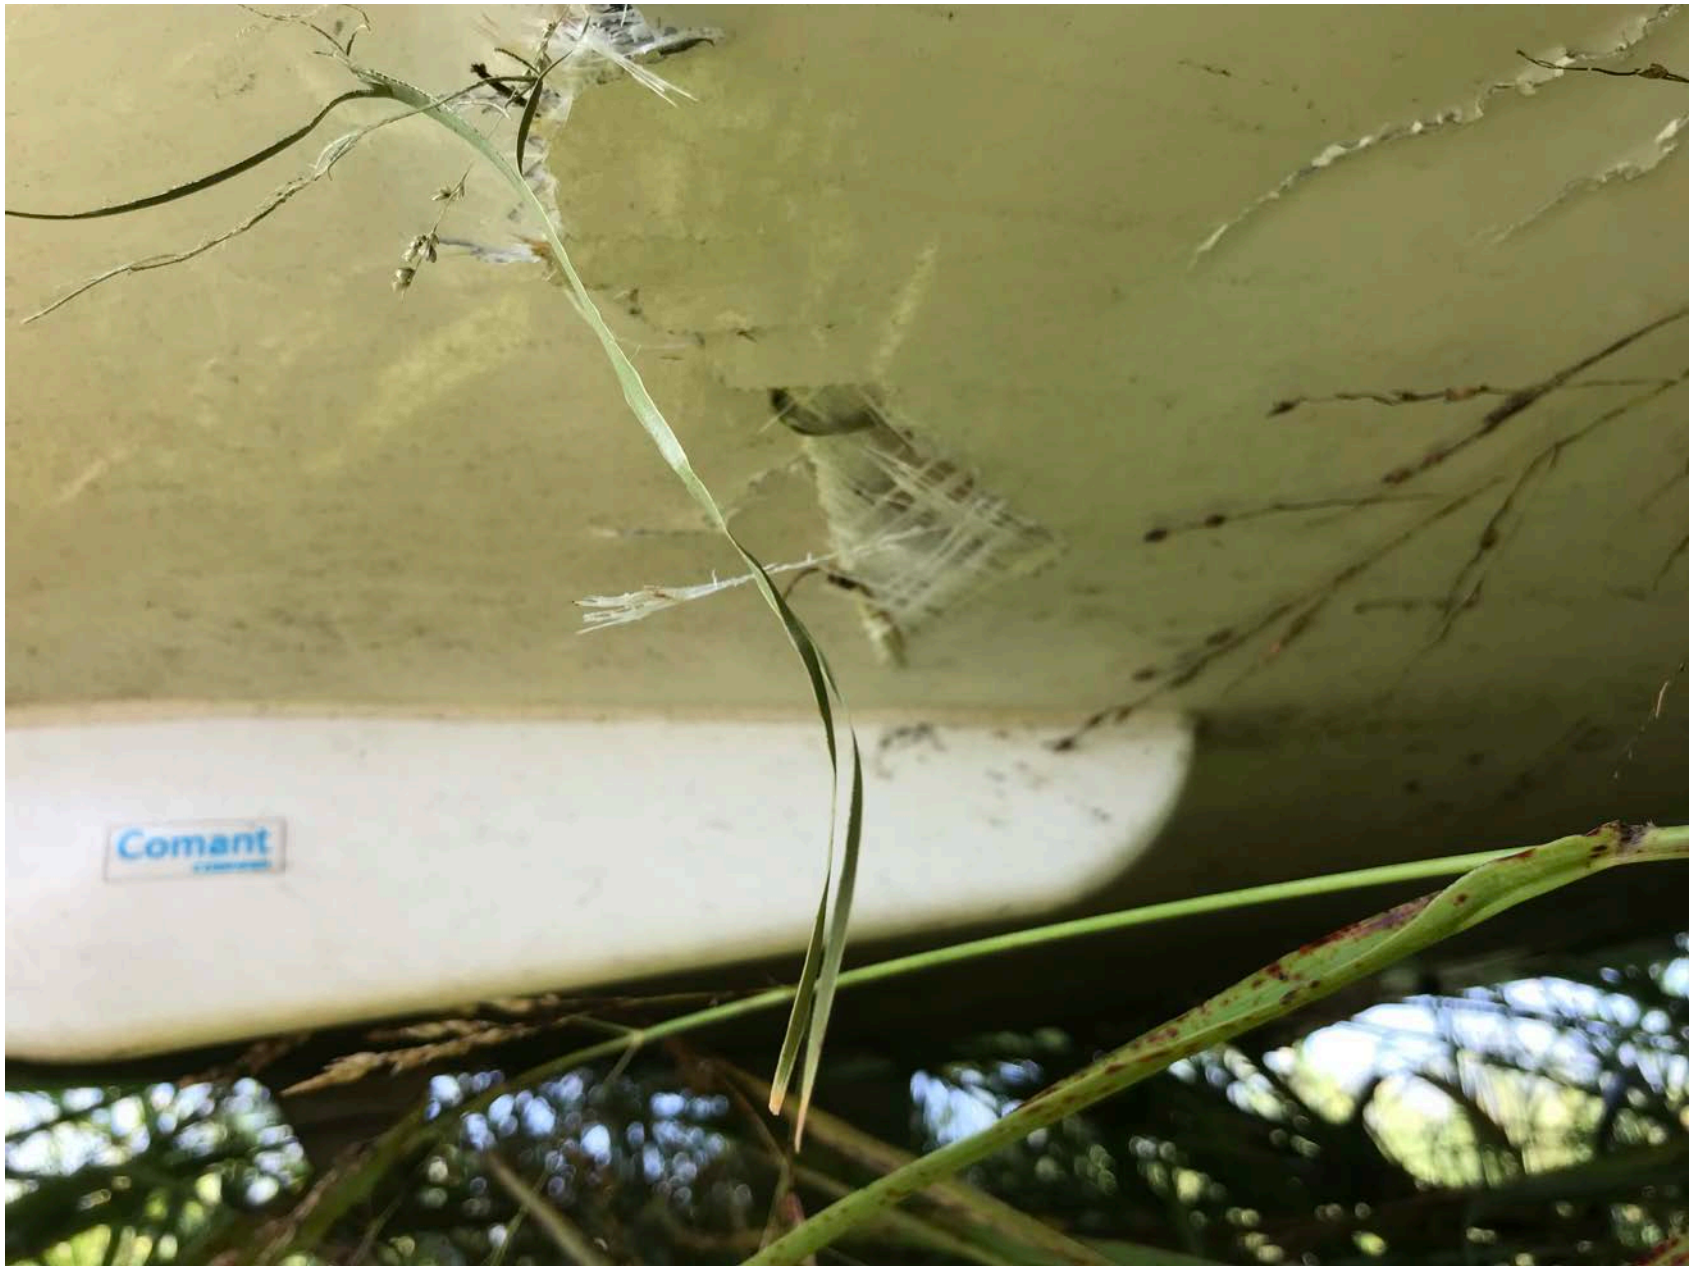
**Photo 1 – View of damage to the composite lower fuselage (Courtesy of FAA)**
