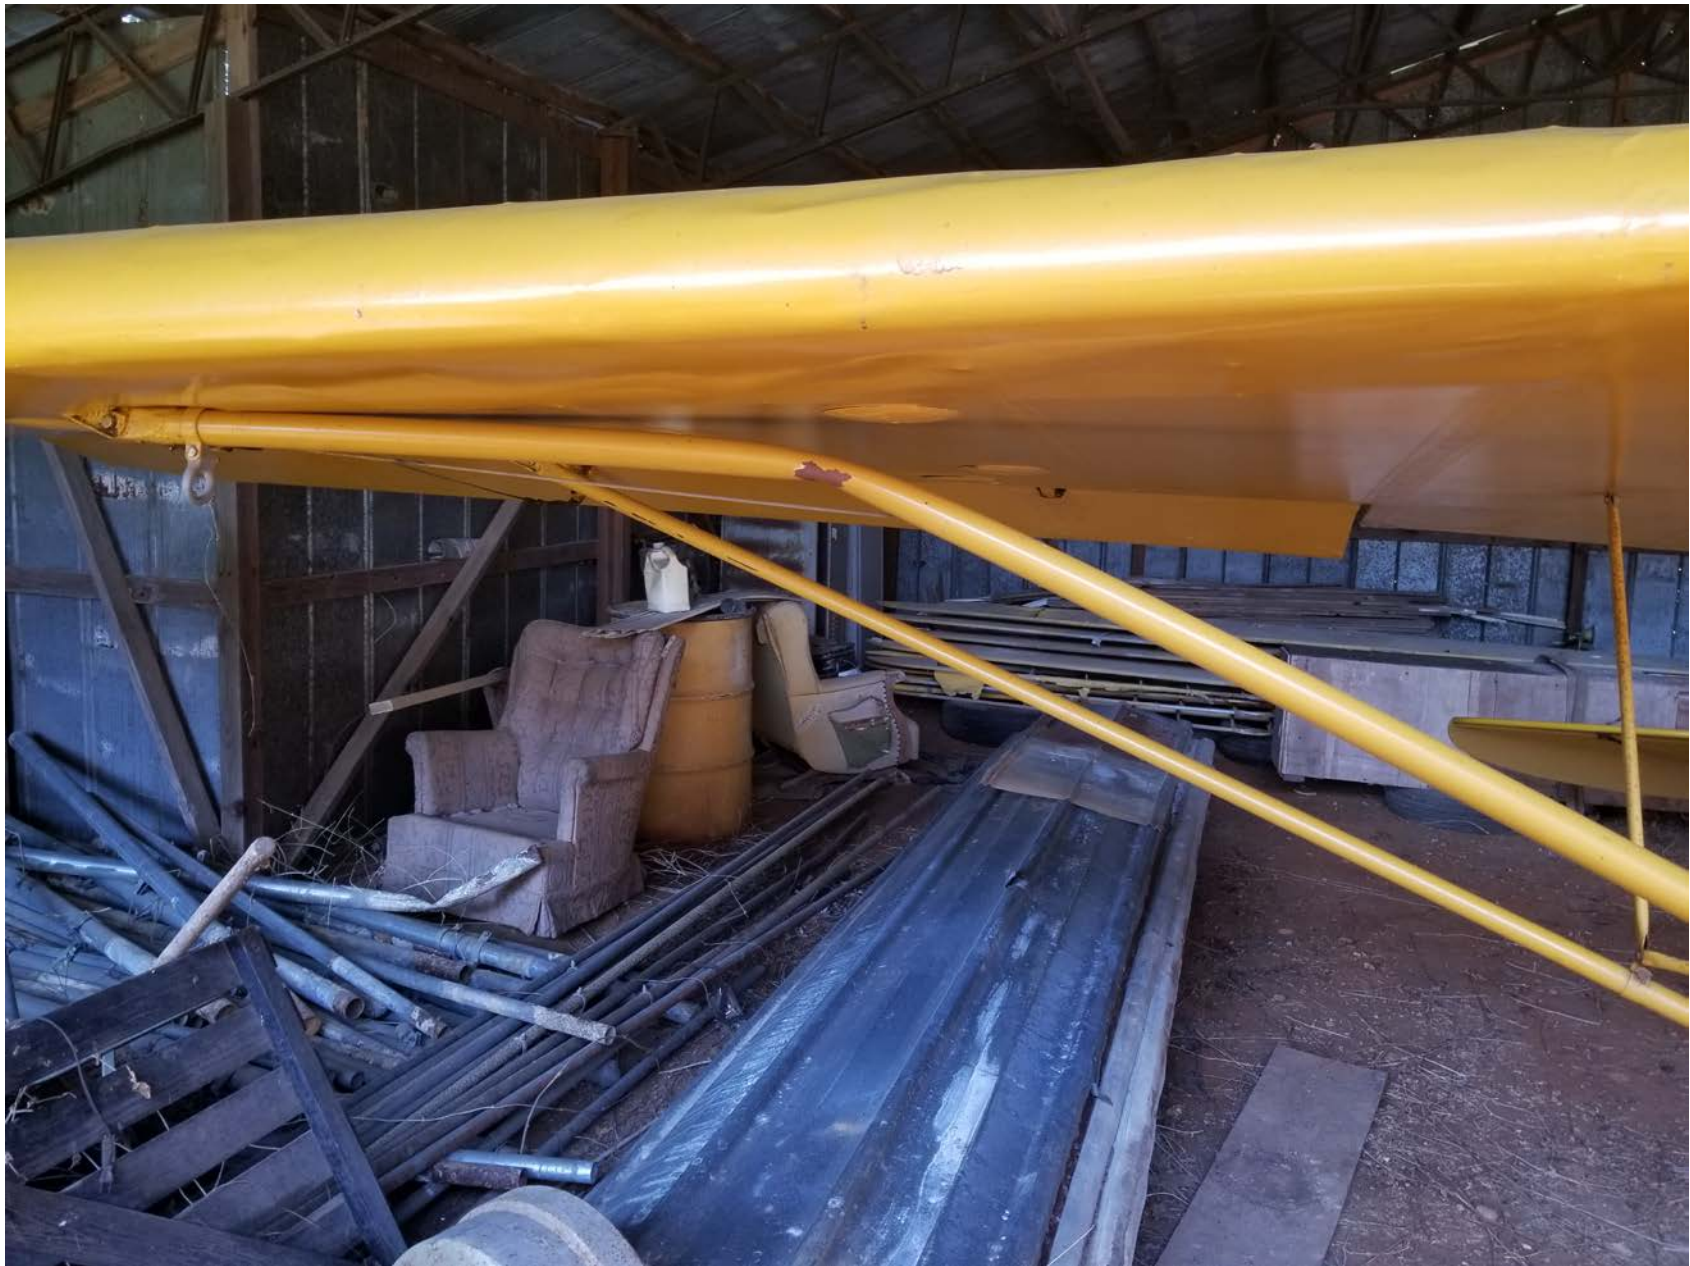
**Photo 1 – View of right wing lift strut damage (photo courtesy of the FAA)**

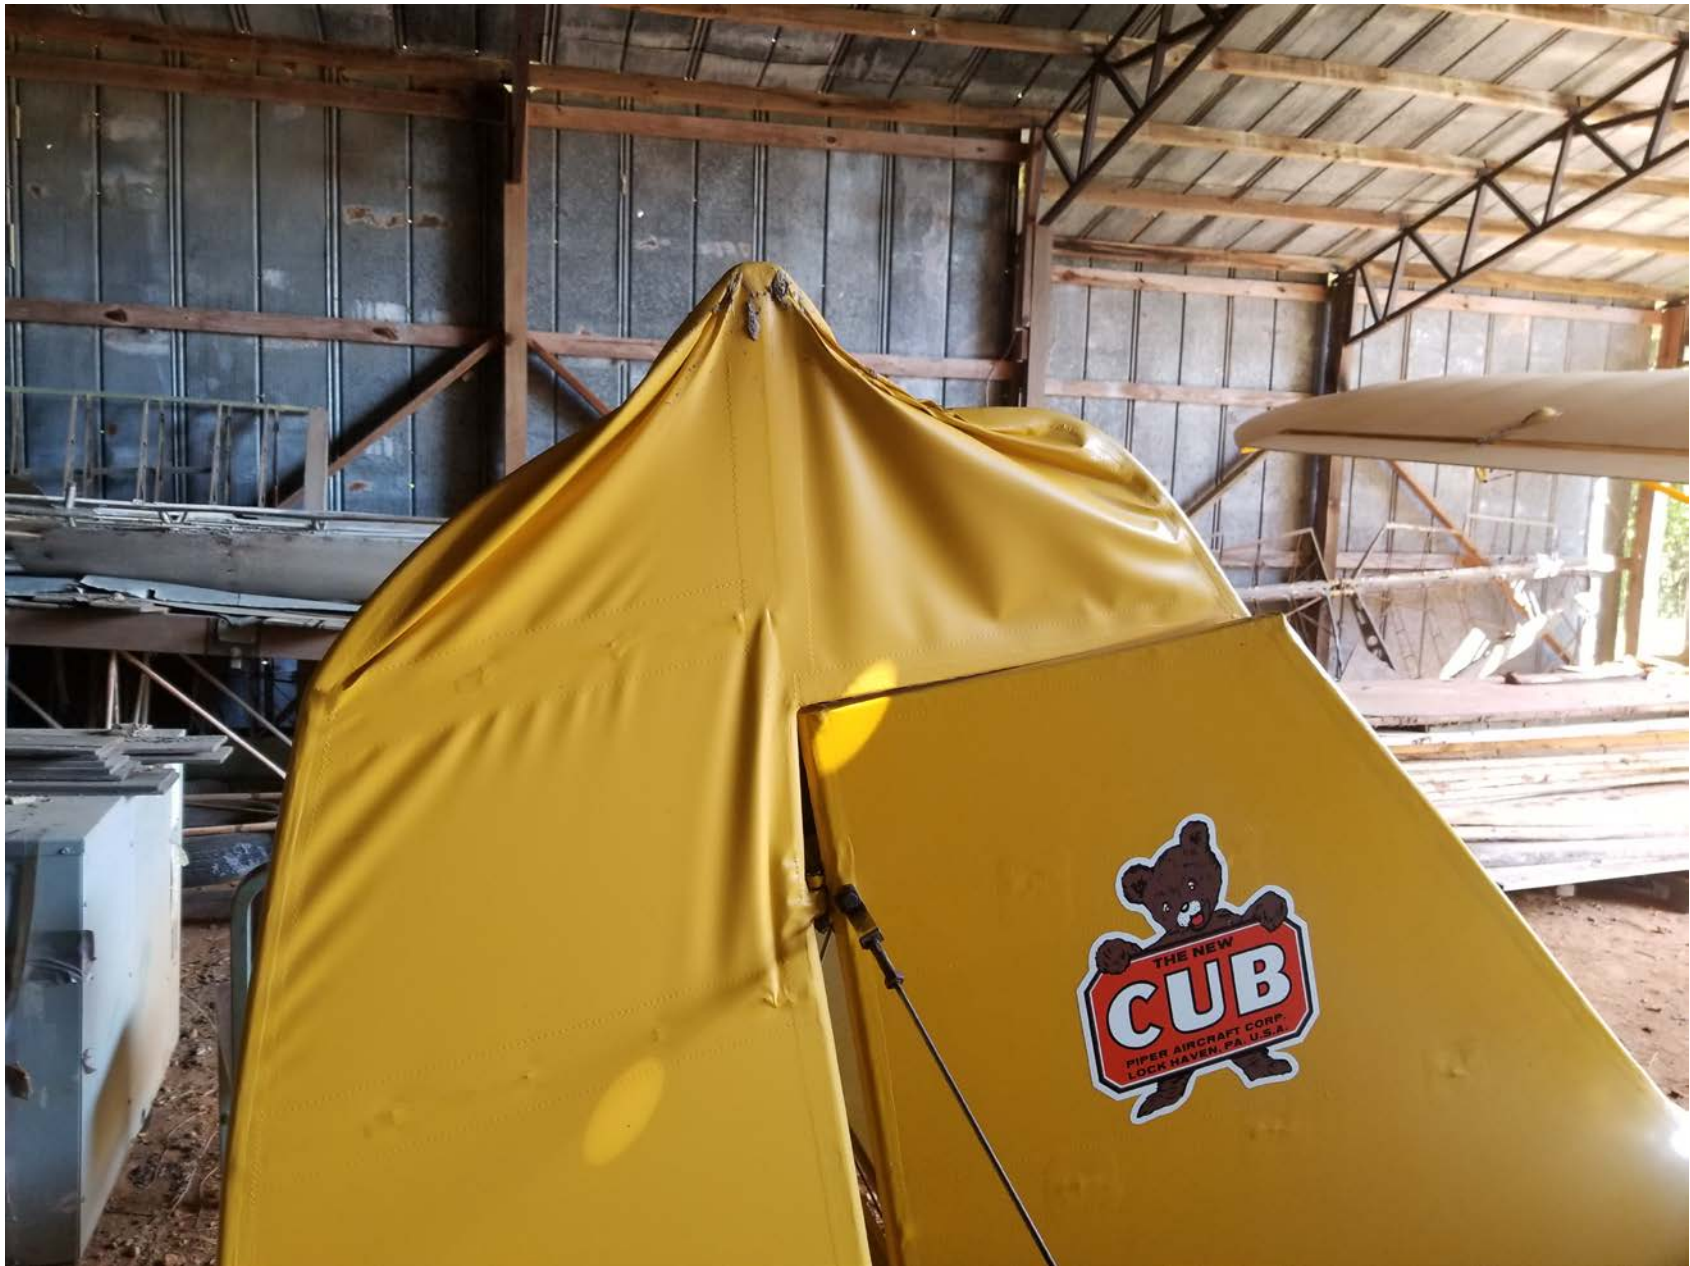
**Photo 2 - View of rudder damage (photo courtesy of the FAA)**
