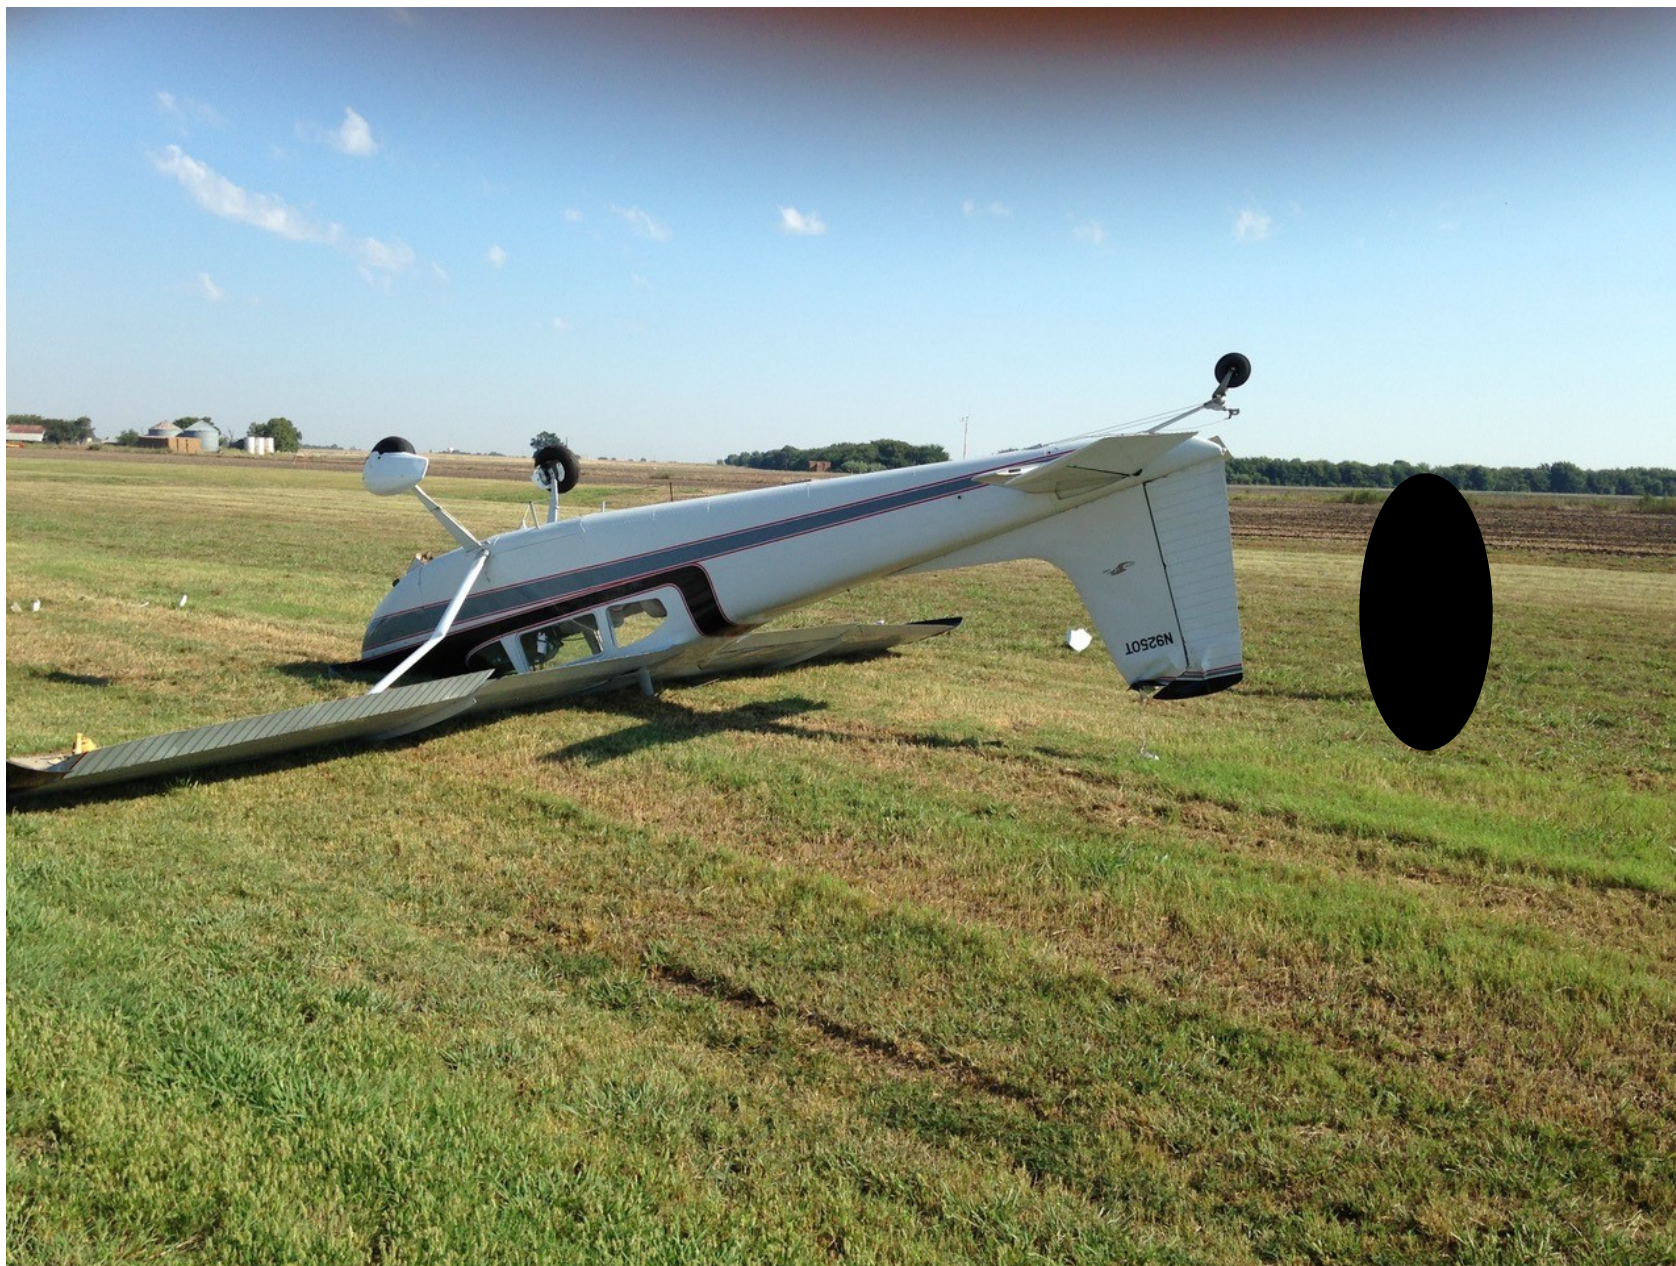
**Photo 1 – View of damaged right-wing lift strut and empennage (courtesy of the FAA)**
