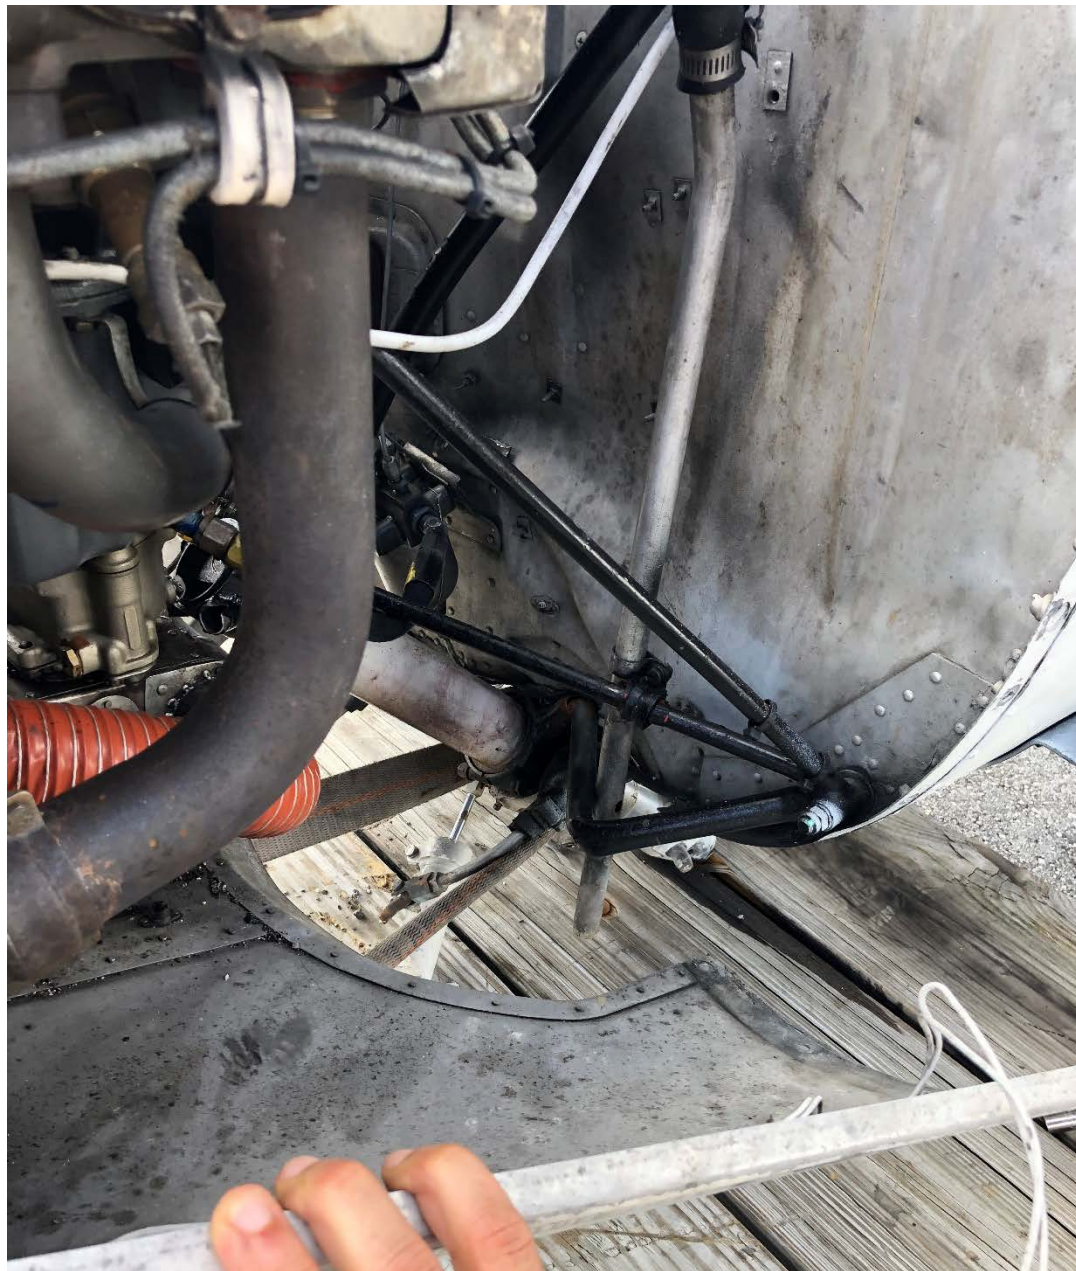
**Photo 1 – View of damaged engine mount (Photo courtesy of the operator)**
