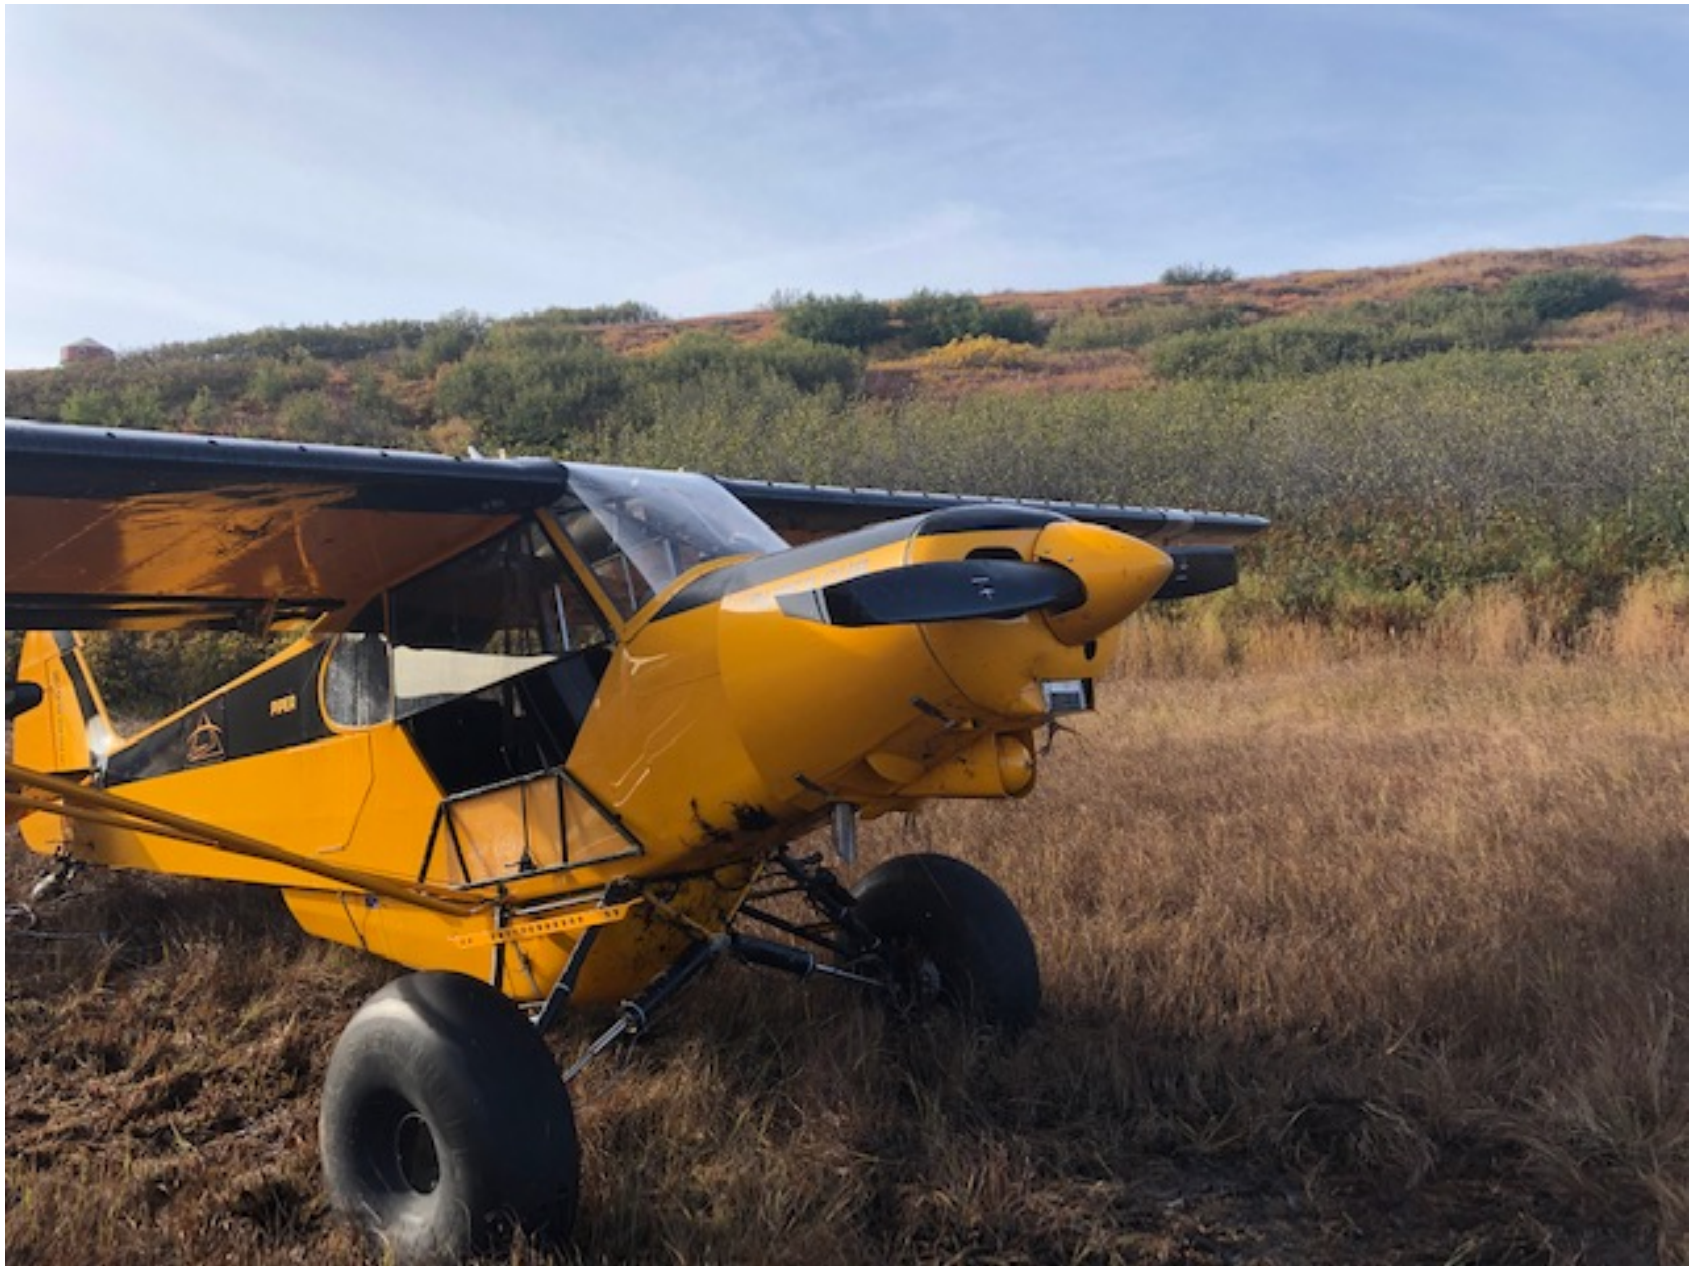
**Photo 1 – View of right wing lift strut damage (photo courtesy of the pilot)**
